SQ-3084  
SQ-3084

LILLOOET SOUTH 01 8.8km

2021 Inspection

| Crossing Name | South Creek |

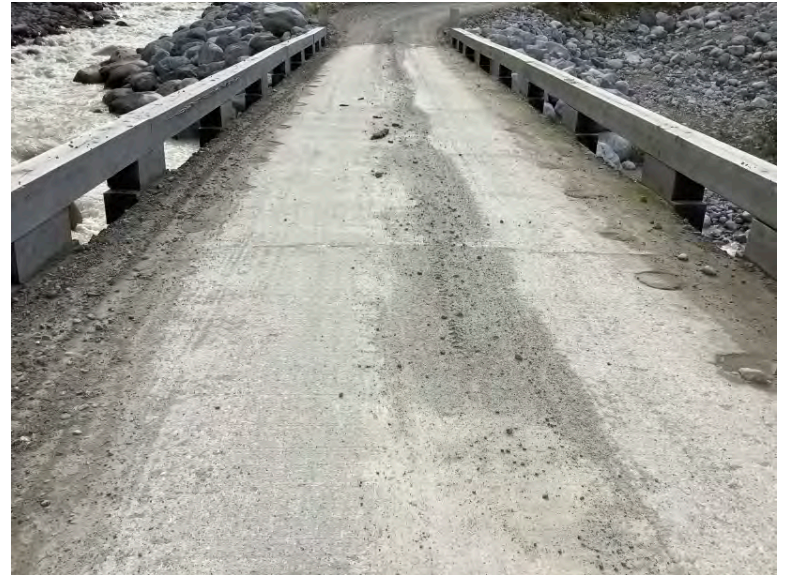
Deck

Grout Pockets Fair Fair to poor. - appear to still be functional but plan chip on and reinstall grout.

| 2 | Structure. Concrete structural maintenance. 1 m². Priority:Medium | Fair to poor. - appear to still be functional but plan chip on and reinstall grout |
