SQ-3090  
SQ-3090

GREEN RIVER 01 0.9km

2021 Inspection

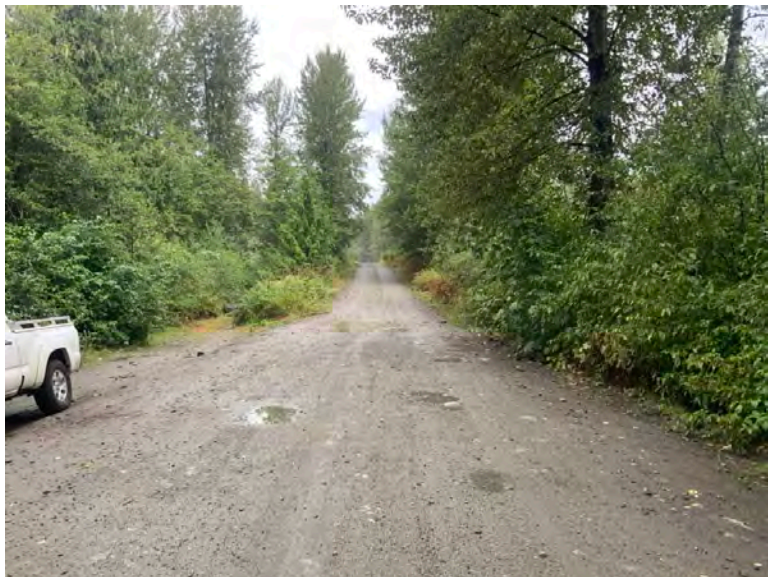
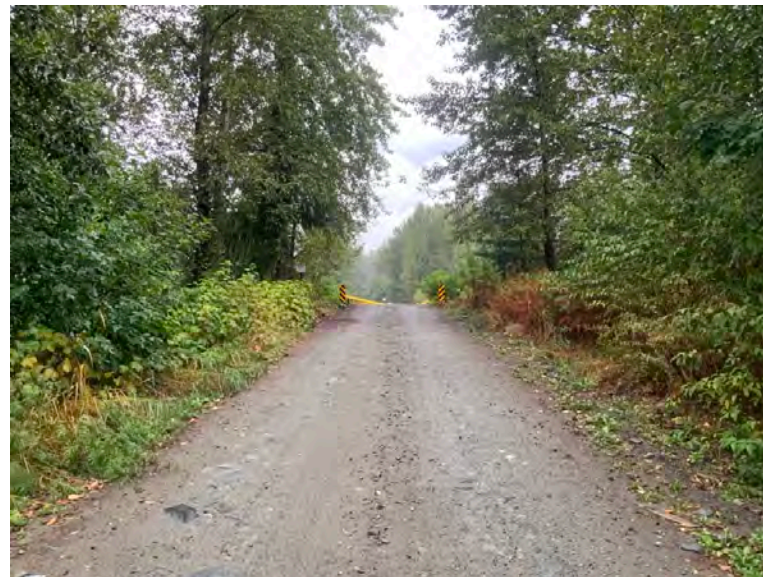
Approach from Right Bank when facing downstream

A few deck panels in middle of bridge not grouted, check structural. Old wooden structure on right bank appears burnt, but likely not critical, only retaining fill. Consider adding approach barriers.

Fender Condition Poor

| Repair Item | Repair Description |
|---|---|
| 1 Approach. Approach fenders (install). 4 # of units. Priority:MED | Missing all approach barriers. |

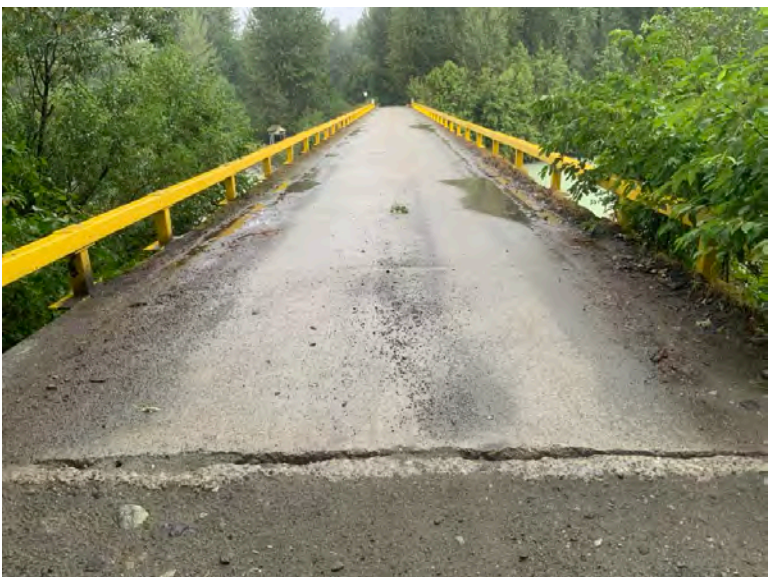
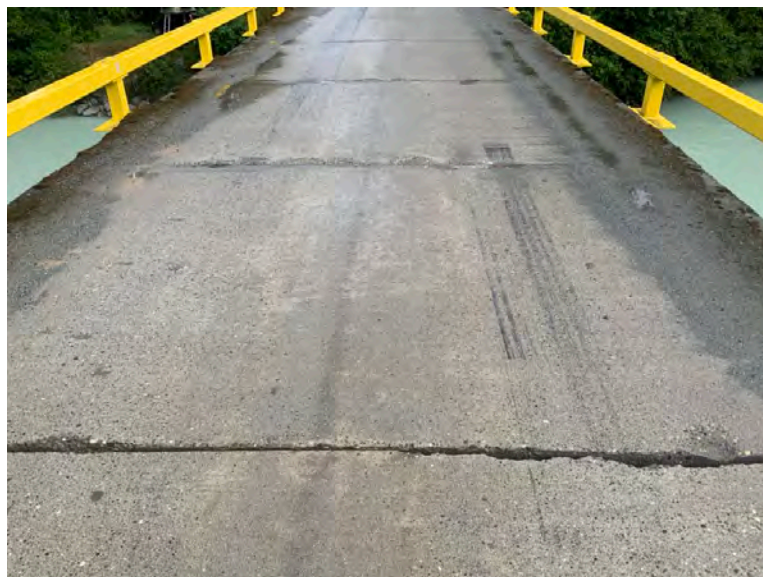
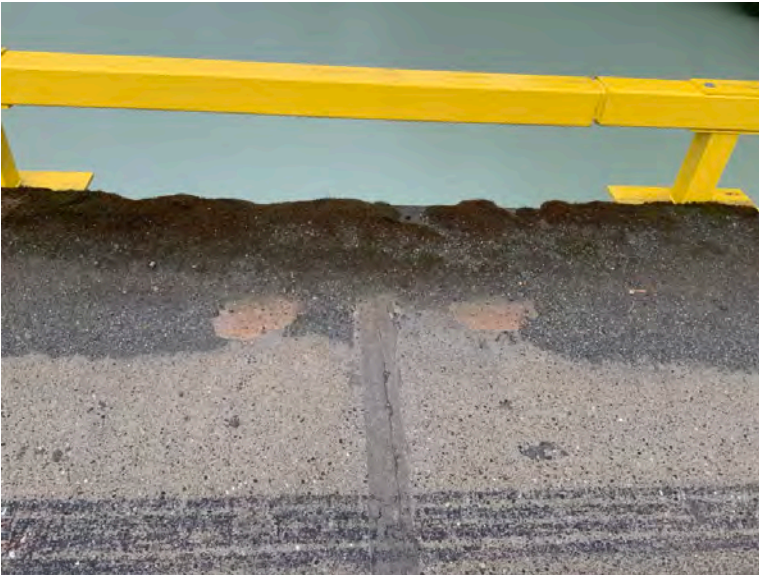
Deck Joints      **Good**      Some panels not grouted

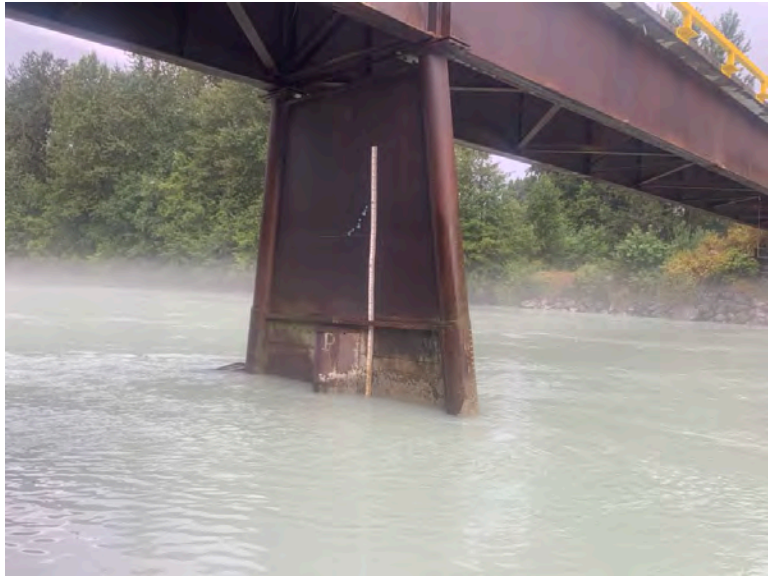
Pier Good

Appears good
