SQ-3091  
SQ-3091

GREEN RIVER 01 5.5km

2021 Inspection

| Crossing Name | Gravel Creek |

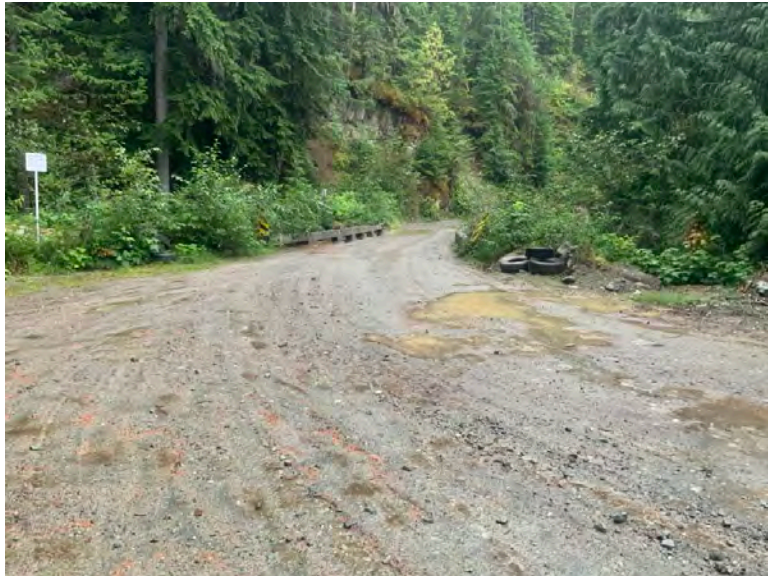
Approach from Right Bank when facing downstream

Missing ds right, rocks only

Large potholes

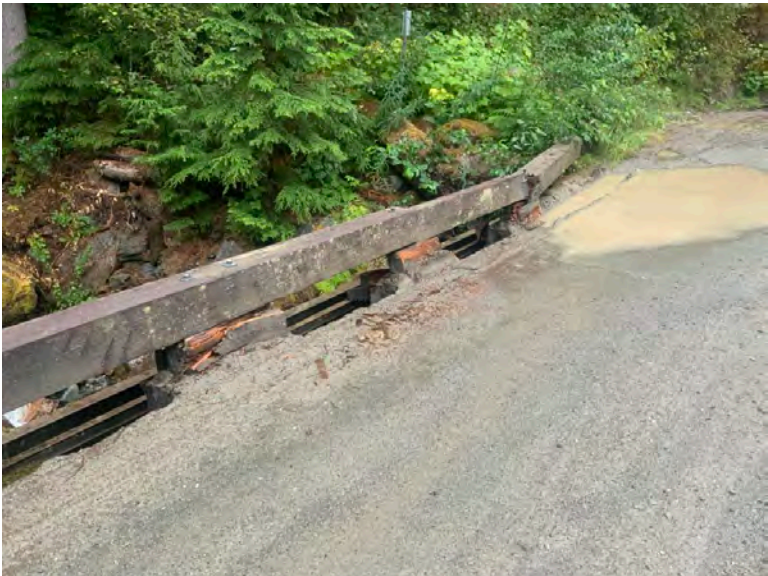
Guard Rail

Damage to guardrails. Remaining section showing signs of rot. Replace all.  
Riprap very steep and unsupported at base, but quite large. Monitor for further movement.

Curb Rail/Blocks/Posts      Poor      Rotting and damaged section

Overall Deck Condition      Fair      Guard rails in need of repair

Load Rated by: MFLNRORD, Greg Dohm, PEng., Nov. 12, 2021  
Load Rating: BCL625 or 63 tonnes  
Next Inspection: 2022  
Comments: replace broken guard rails

| Repair Item | Repair Description |
|---|---|
| 1 Structure. Full Curb Replacement. 1 . Priority:High | Repair damaged section of rail. Consider replacing all rails. |

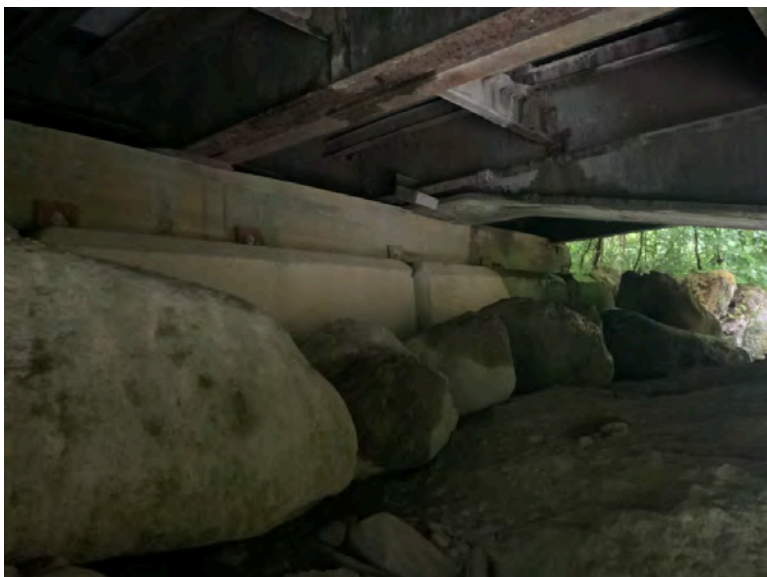
Bearing, right bank

Timbers starting to crush

Crushing timber sills

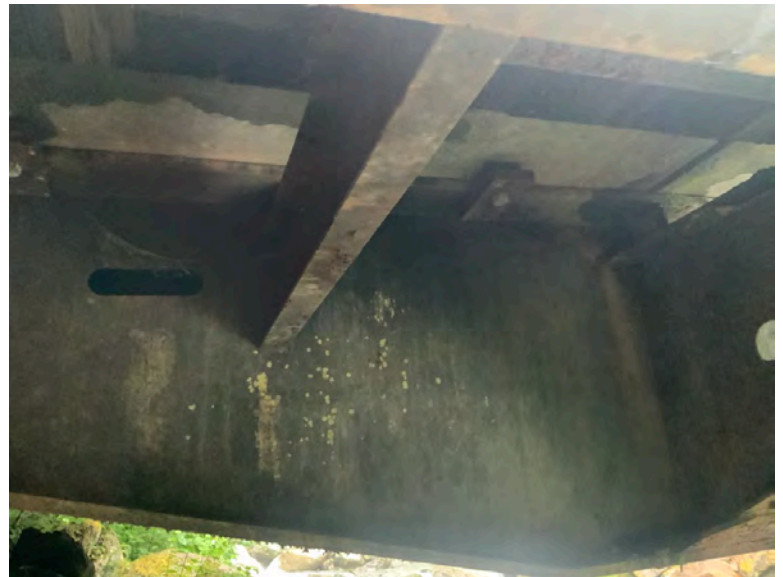
Deck clips

Deck to Girder Bolts      Fair      Clips

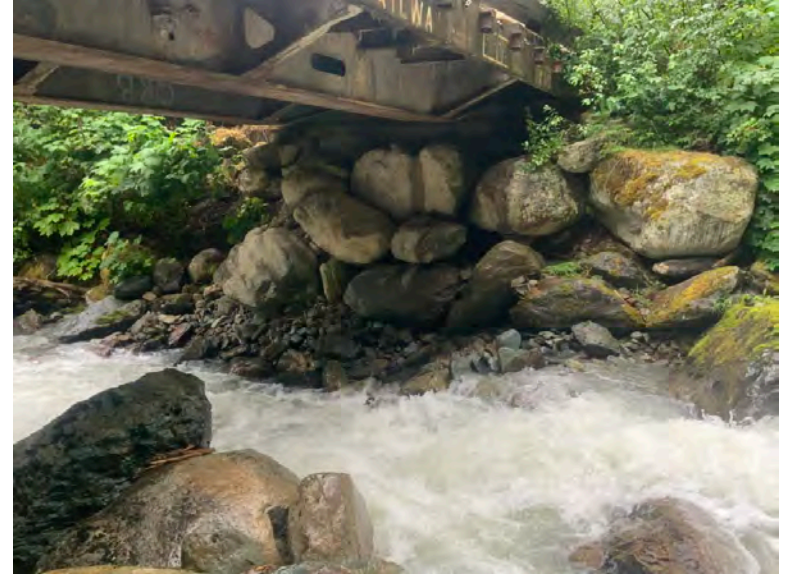
Right Bank Abutment when facing downstream

Riprap Poor

Steep and unsupported

| Item | Monitor Description | Frequency |
|---|---|---|
| 1 | Riprap for further movement | Routine Inspection |
