SQ-3105  
SQ-3105

FURRY CREEK 02 0km

2021 Inspection

Crossing Name Phylis Creek #1

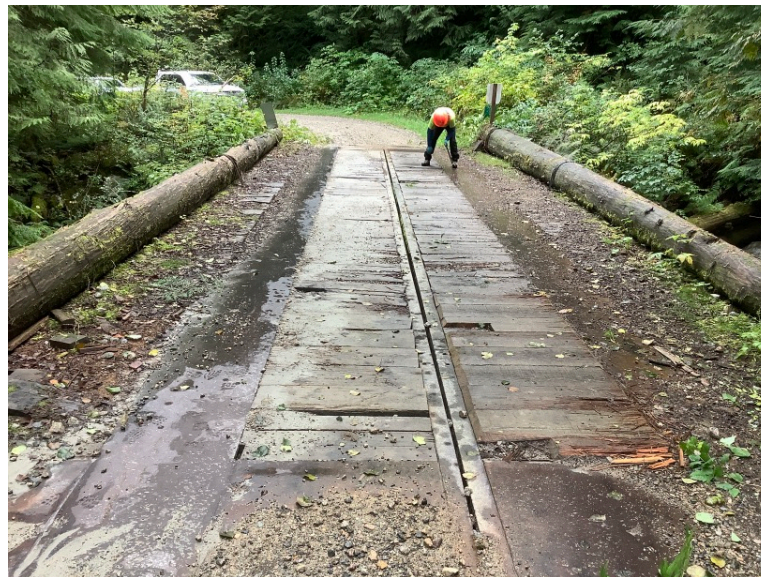
Comments: bridge closed due to deteriorated deck. Install standard Ministry timber deck or replace bridge.

Running Surface      Poor

Running Planks      Poor      Substandard

Overall Deck Condition      Poor      Due to substandard deck type for rail car

Close bridge. Load rating changed to zero tonnes until deck upgraded to ministry standard of tie and plank decking.

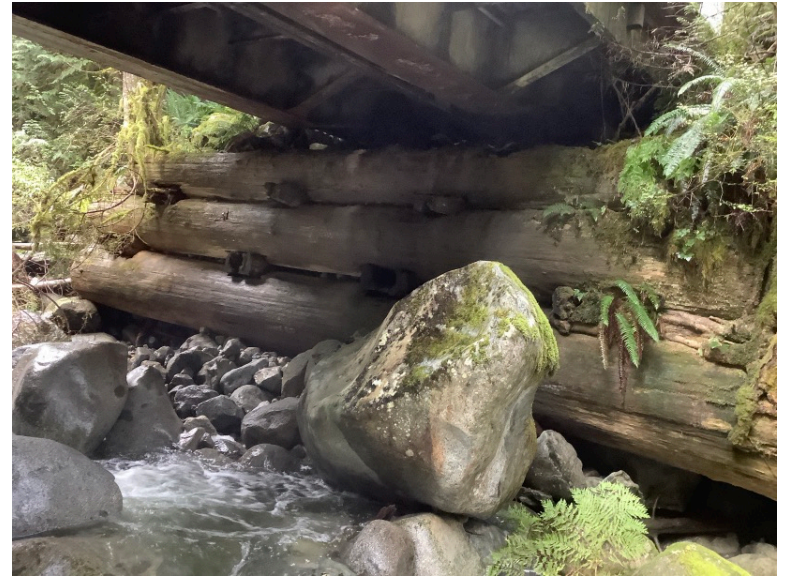
Left Bank Abutment when facing downstream

Log/Timber Cribs Fair Only used as fill retaining
