SQ-3109  
SQ-3109

## PHELIX CREEK 3.3km

2021 Inspection

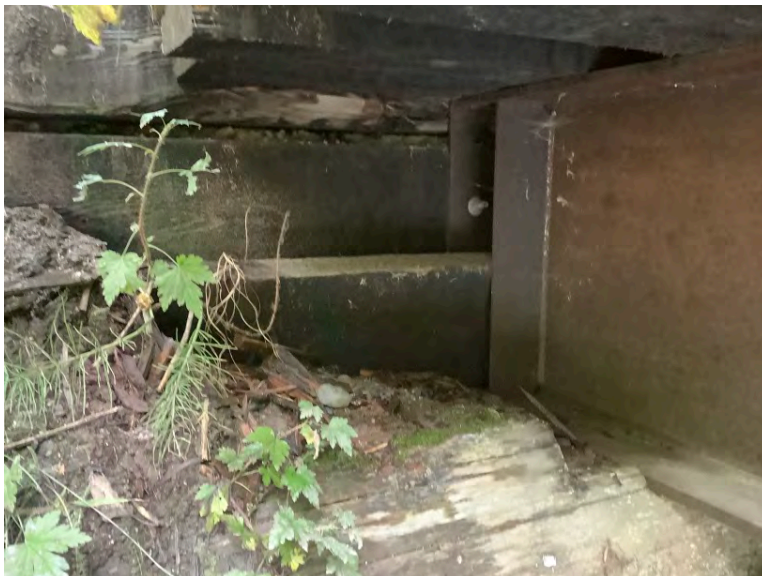
Ballast Wall Good

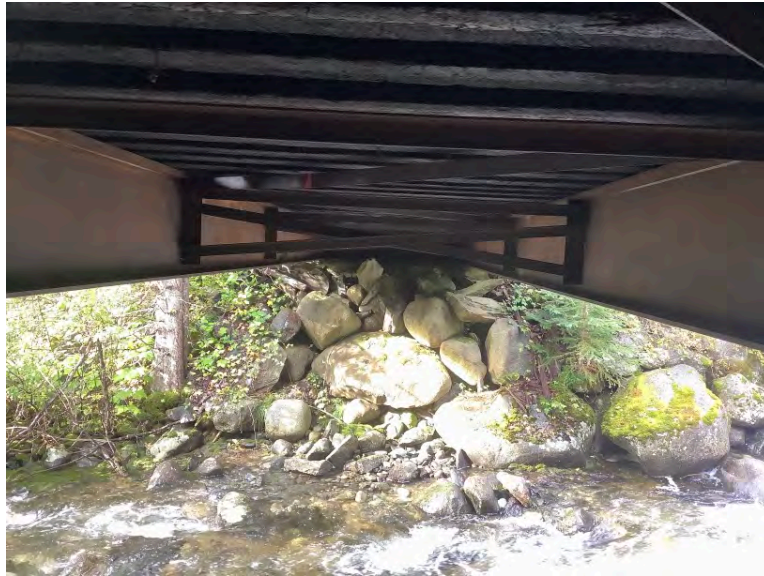
Right Bank Abutment when facing downstream

Log/Timber Cribs Fair

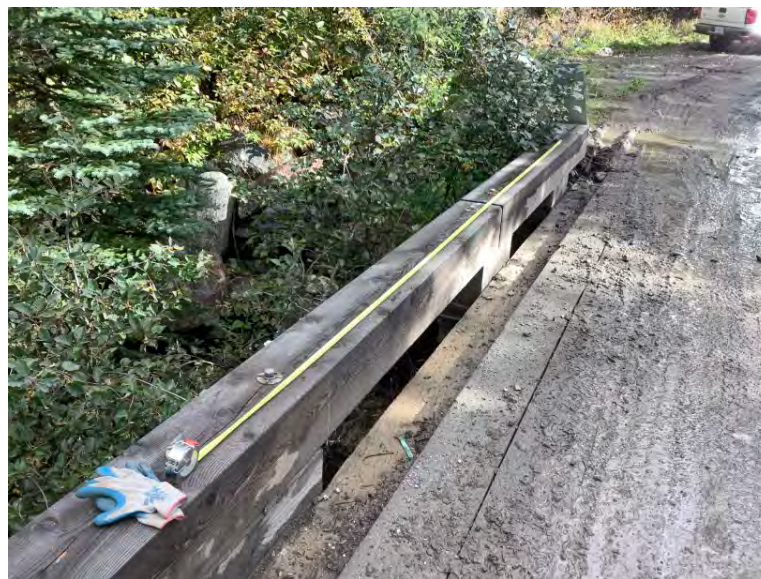
Curb Rail/Blocks/Posts      Fair      Needs woods side tie to curb connection to be repaired

Guard Rail - need to replace with continuous riser due to poor quality tie riser connection

| Repair Item | Repair Description |
|---|---|
| 1 Structure. Timber deck maintenance. 1 # of signs. Priority:Low | Guard Rail - should be replaced with continuous riser due to poor quality tie riser connection with a 4.8 x 0.25 x 0.25 see photos |
