SQ-3116  
SQ-3116

LILLOOET WEST 01 22.4km

2021 Inspection

Crossing Name Trib to Lillooet River

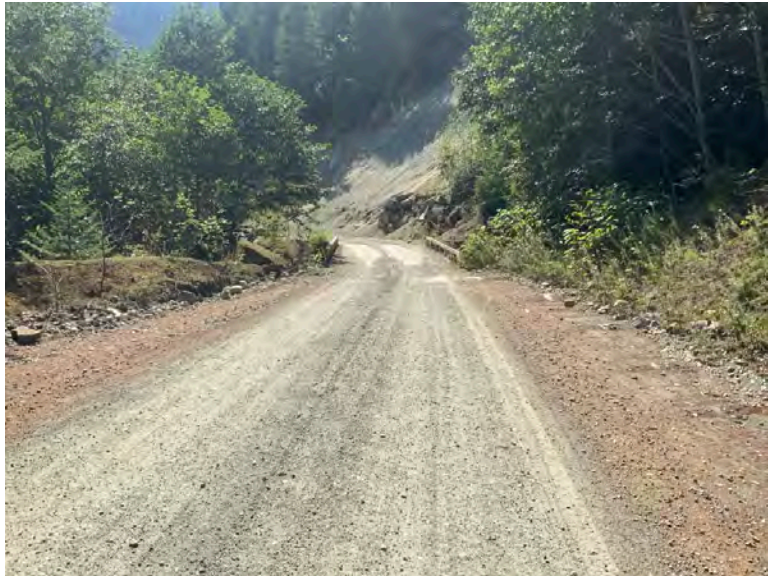
Approach from Left Bank when facing downstream

Delineator Missing  
Left ☒ 0 ☐ 1 ☐ 2 Not mounted

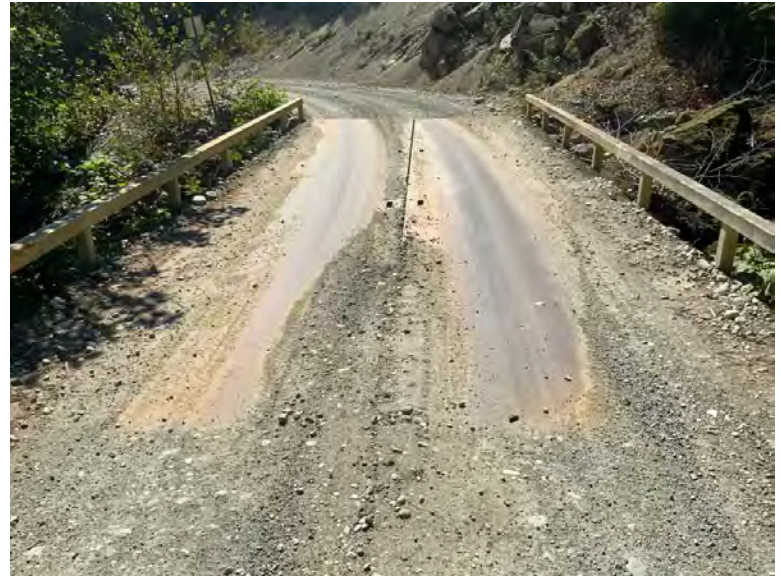
Deck

Running Surface      **Good**      Right approach in rock fall zone

Curb Rail/Blocks/Posts      **Good**      Damage at end from poor alignment

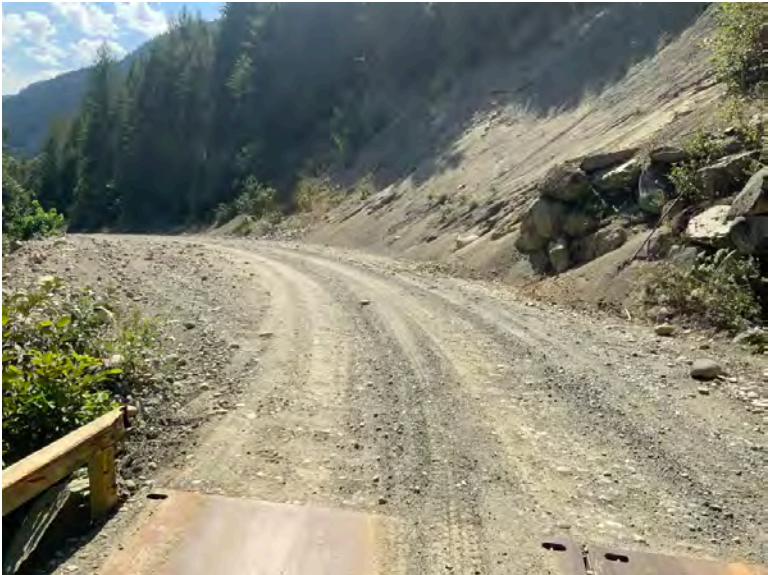
Approach from Right Bank when facing downstream

Bridge on active channel and rock fall zone at right approach. Add approach barriers and signage.

Road Surface Fair Right approach in rock fall zone

| Repair Item | Repair Description |
|---|---|
| 1 Approach. Add Warning Signs. 2 # of signs. Priority:High | Add delineators |
| 2 Approach. Approach fenders (install). 4 # of units. Priority:High | Install approach barriers |

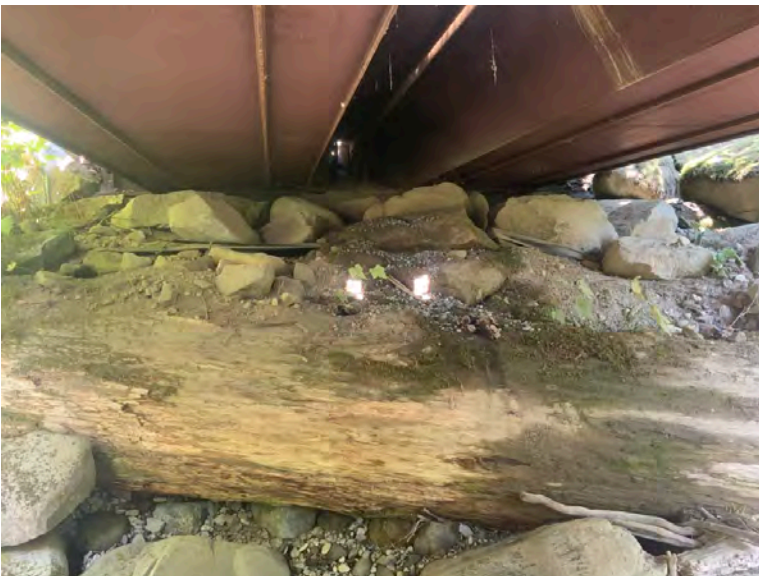
Left Bank Abutment when facing downstream

Caps or Sills Unrated Log sills wrapped In geotextile, can't access

Hardware Unrated Fill covering lag bolts

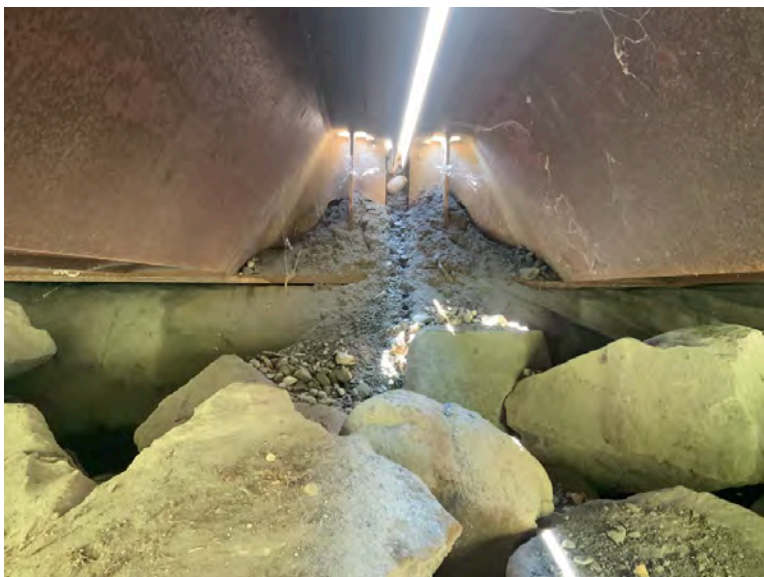
Bearing

Bearings Good
