SQ-3119  
SQ-3119

LILLOOET WEST 01 37.3km

2021 Inspection

Crossing Name Chief Paul Creek

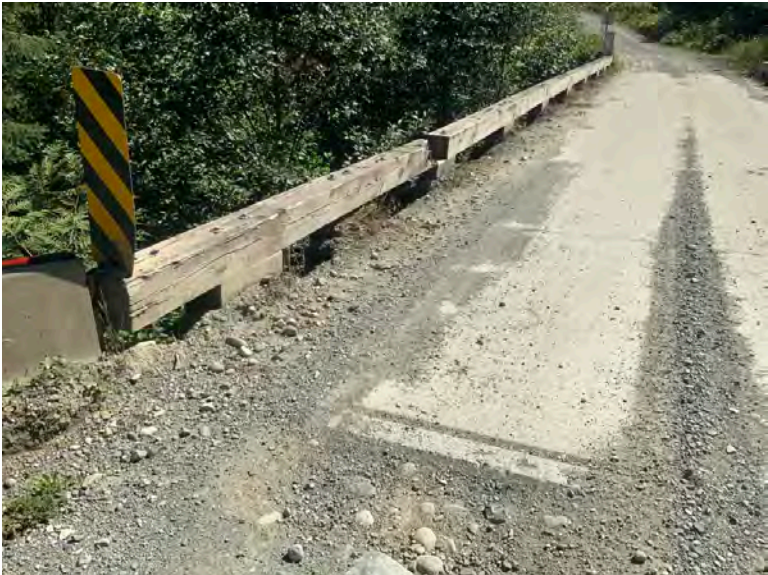
Guard Rail

Curb Rail/Blocks/Posts      **Poor**      Damaged. Risers rotten. Rails loose.

Hardware      **Poor**      Loose guard rails

Overall Deck Condition      **Poor**      Due to guardrails

Replace guard rails.

| Repair Item | Repair Description |
|---|---|
| 1 Structure. Full Curb Replacement. .<br>Priority:High | Replace all timber rail components |
