SQ-3123  
SQ-3123A

RING CREEK SOUTH 01 0.5km

2021 Inspection

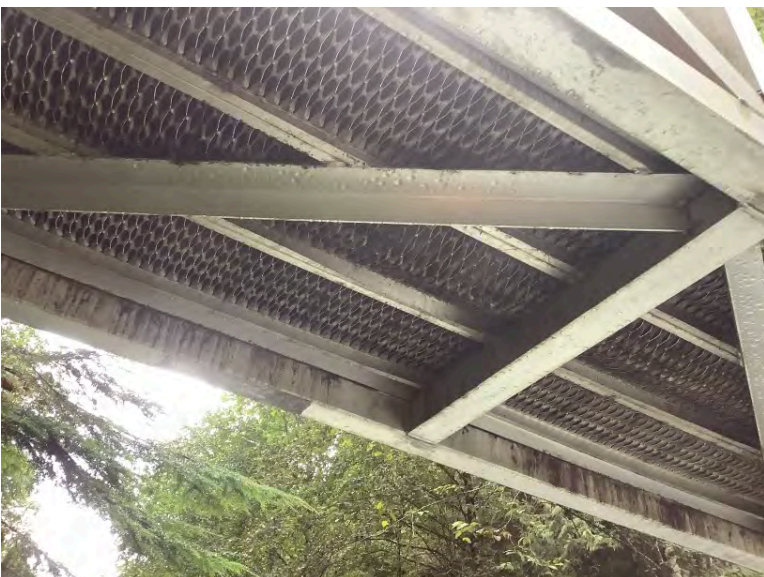
Deck Grating torn at one location and twisted stringer. Currently adequately supported by 3x8 transverse planks

Deck - underside of deck torn. Planks above support live loads now

| Repair Item | Repair Description |
|---|---|
| 1 Structure. . 1 . Priority:Low | Deck Grating torn at one location and twisted stringer. Currently adequately supported by 3x8 transverse planks |
