SQ-3130  
SQ-3130

MAMQUAM 01 4.5km

2021 Inspection

| Crossing Name | Stawamus River |

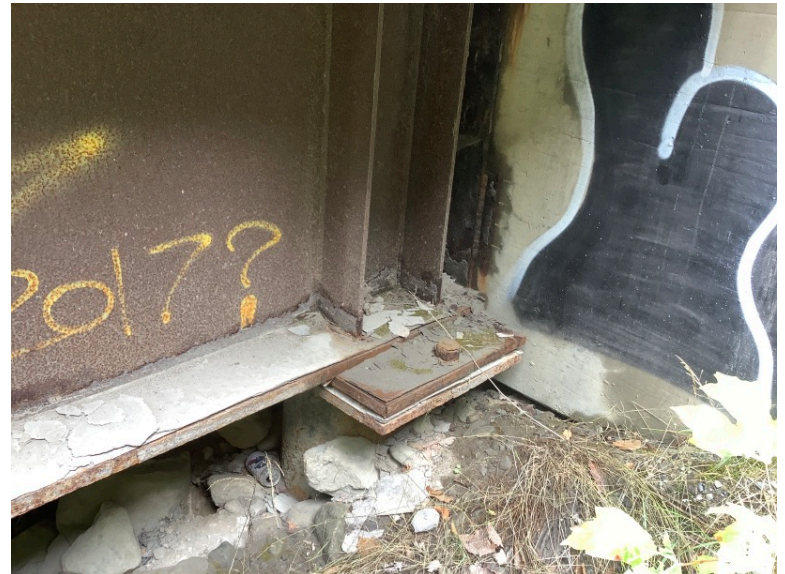
Bearing

Bearings Fair Corroding bearing plates - monitor
