SQ-3135  
SQ-3135

MAMQUAM 01 19.2km

2021 Inspection

| Crossing Name | Martin Creek |

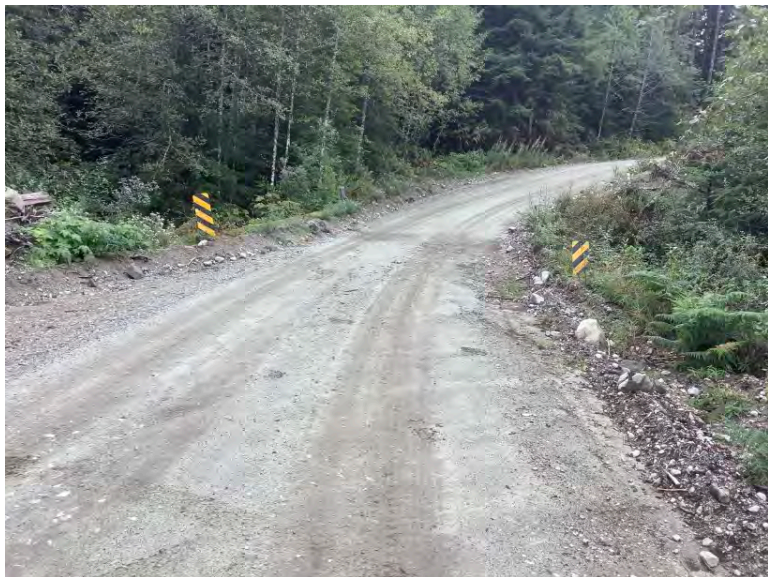
Approach from Right Bank when facing downstream

Fender Condition Poor Missing on all 4 corners

2 Approach. Approach  
fenders (install). 4 # of  
units. Priority:Medium

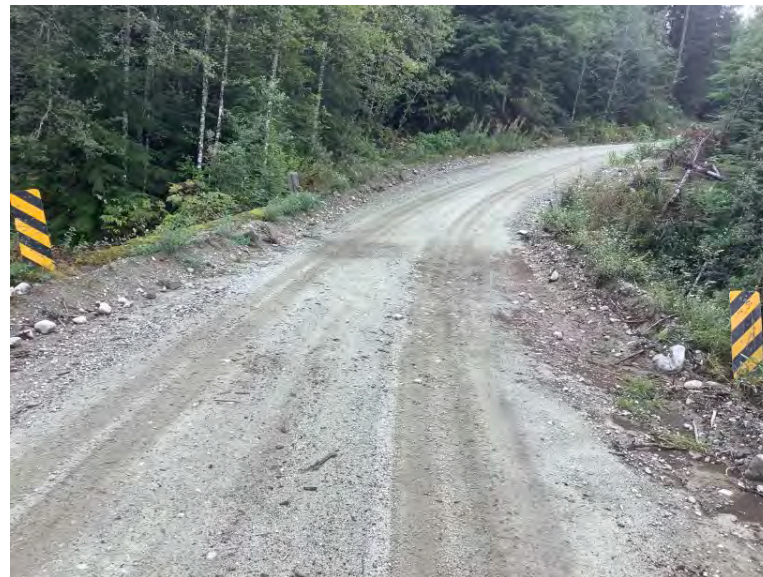
Curb Rail/Blocks/Posts      Poor      Needs a functioning curb rail on downstream side. Upstream side not ideal .

Overall Deck Condition      Poor      Port due to downstream curb rail

Log Curbs    Poor    Too low

Comments: Curb logs on bridge need to be modified so they provide a min. 250mm height above road grade.

1 Structure. Curb  
Maintenance. 1 # sites.  
Priority:High
