SQ-3142  
DQ-3142-A

MILLER BENCH 01 1.1km

2021 Inspection

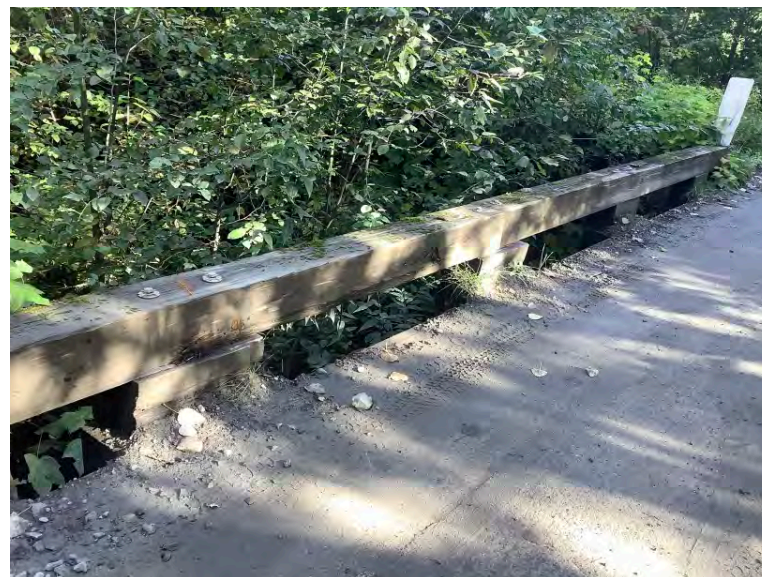
Guard Rail

| Repair Item | Repair Description |
|---|---|
| 1 Structure. Curb Maintenance. 1 # sites. Priority:Medium | 2 curb risers needing replacement as are cracked and rotting |
