SQ-3145  
SQ-3145

## ASHLU RIVER 33.4km

2021 Inspection

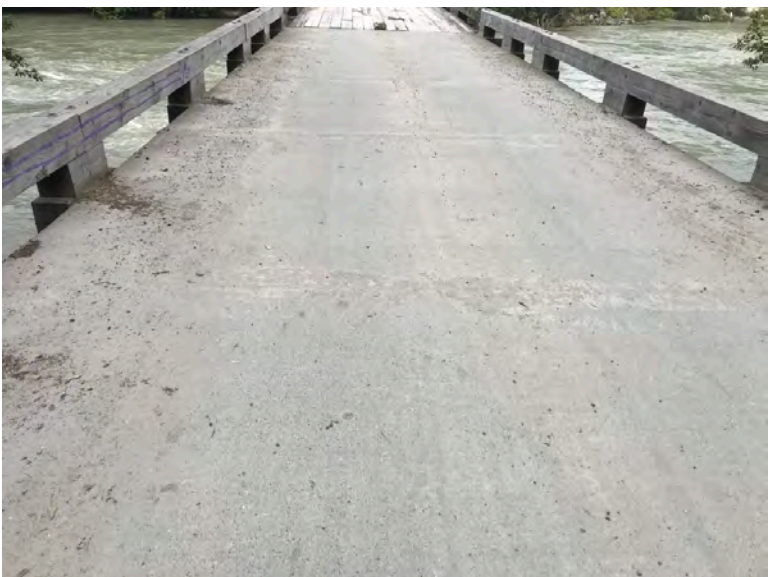
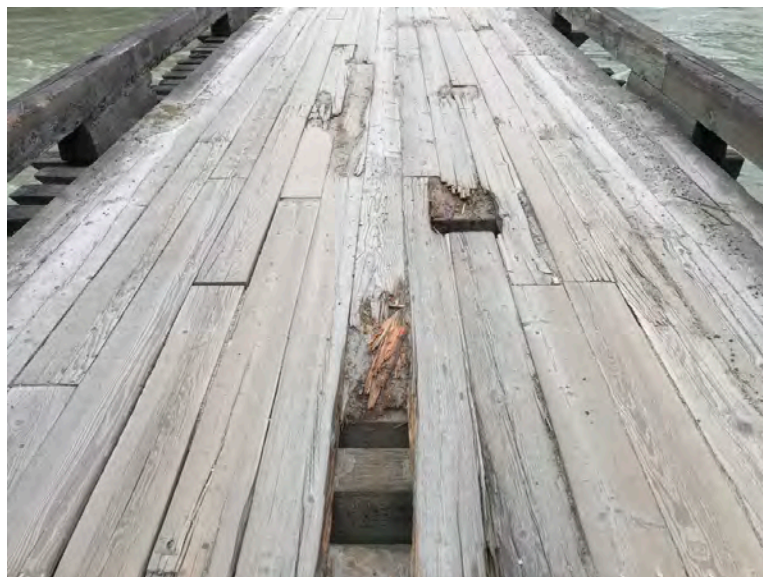
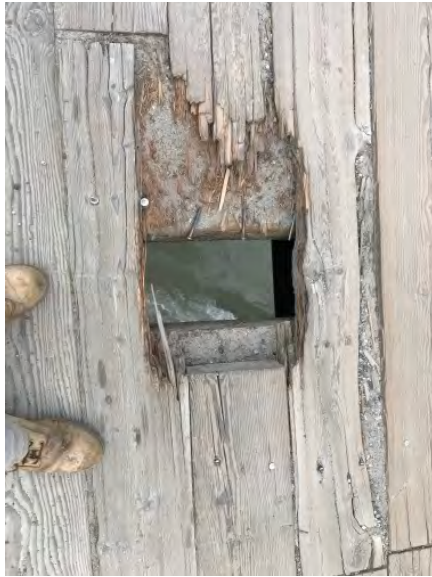
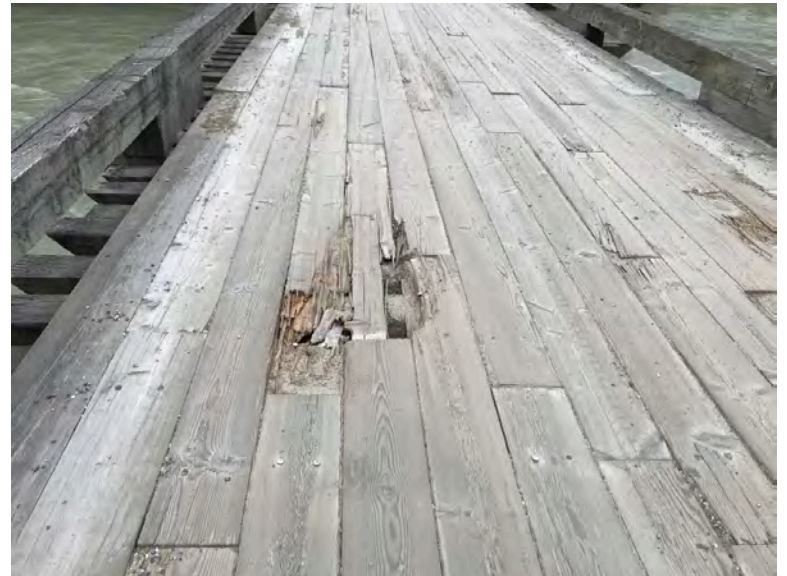
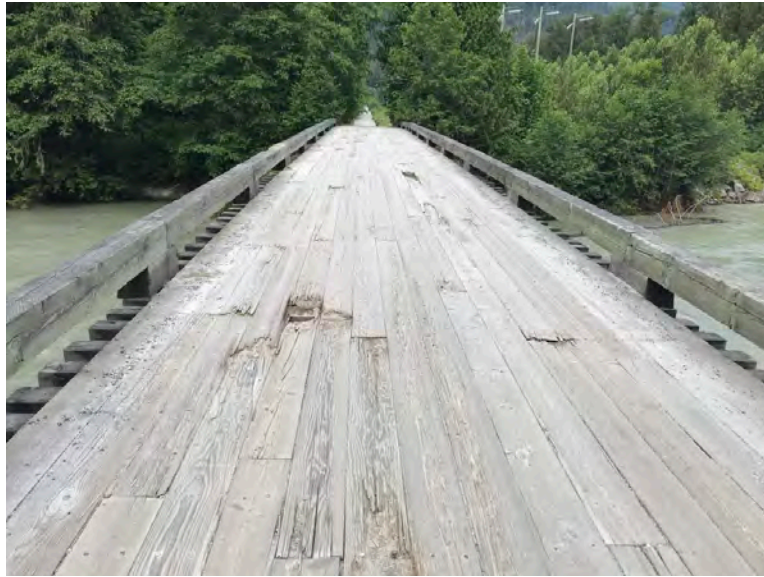
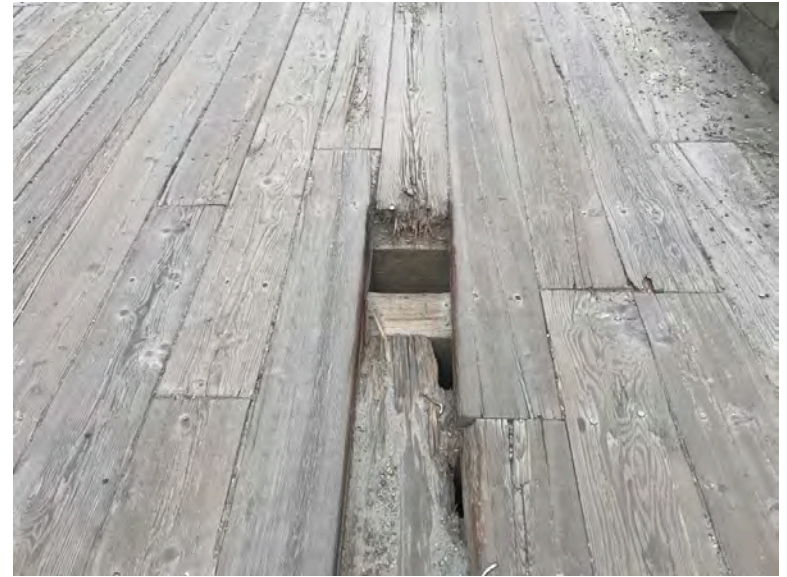
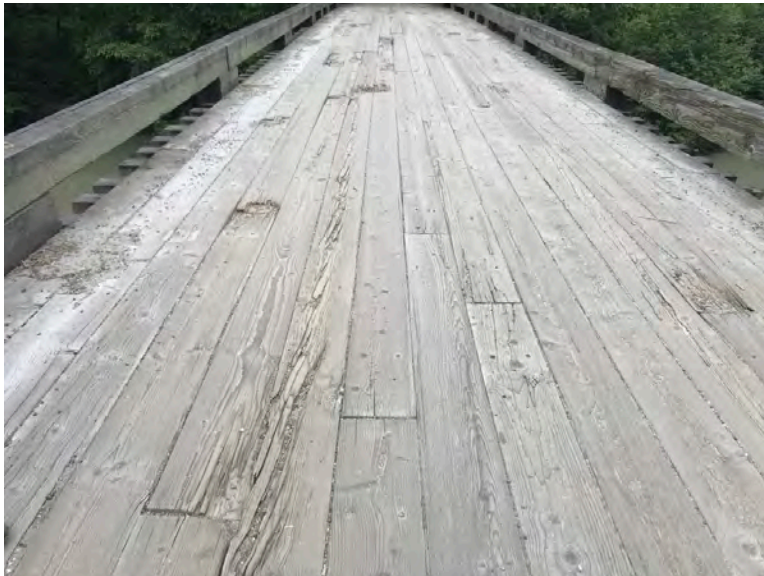
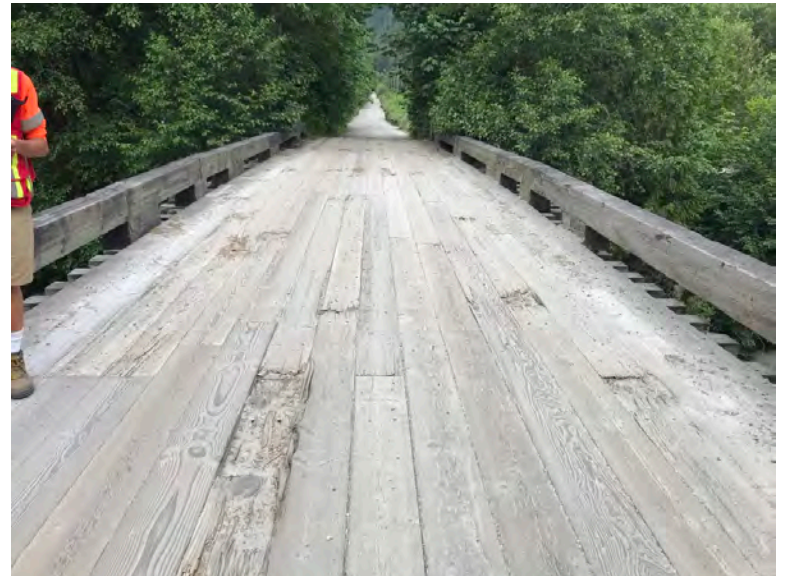
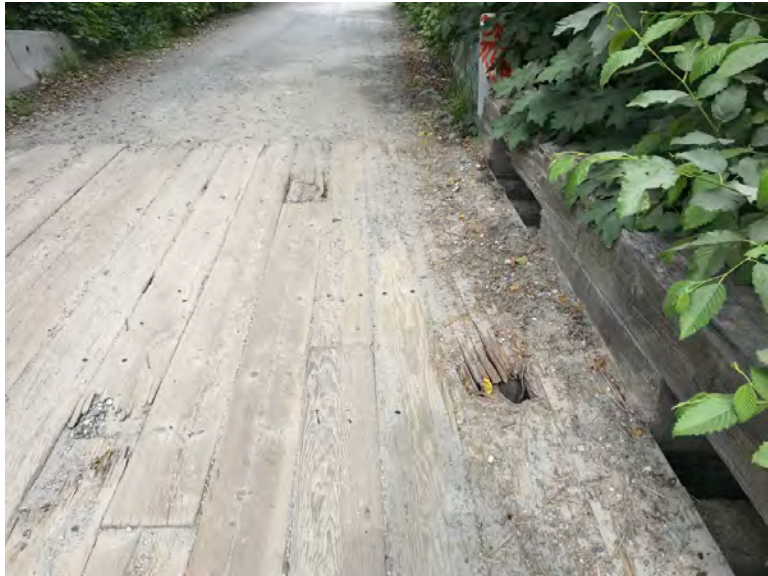
Sub Deck      Poor      Repair ASAP for continued use

Nails      Poor      Sticking thru broken planking

Deck

1 Structure. Timber deck  
maintenance.  
Priority:High

Sub deck has broken planks with holes in deck in urgent need of repair. Curb rails also needing repair particularly at town end of timber deck bridge section. Planks and curb rails to be repaired ASAP/immediately for continued use of bridge. Replace deteriorated riser blocks ASAP.

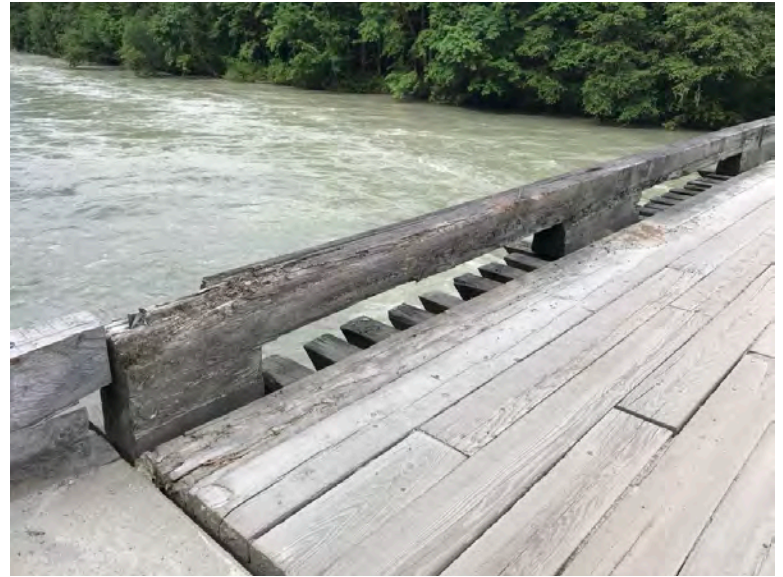
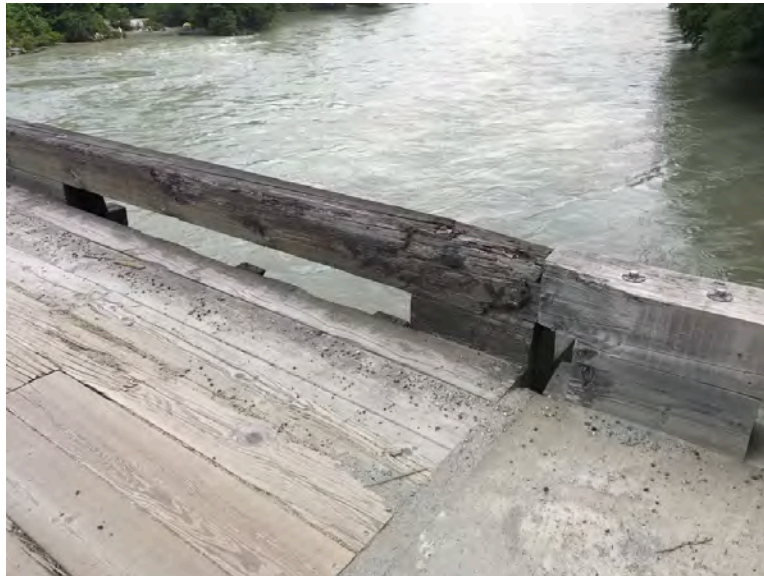
Curb Rail/Blocks/Posts      Fair      Fair to poor. Replace deteriorated riser blocks ASAP. Plan to replace all curb rails within 2 years

Guard Rail

2 Structure. Full Curb  
Replacement. .  
Priority:Medium

Plan to replace all curb rails within 2 years
