SQ-3157  
SQ-3157A

## SQUAMISH RIVER 53.9km

2021 Inspection

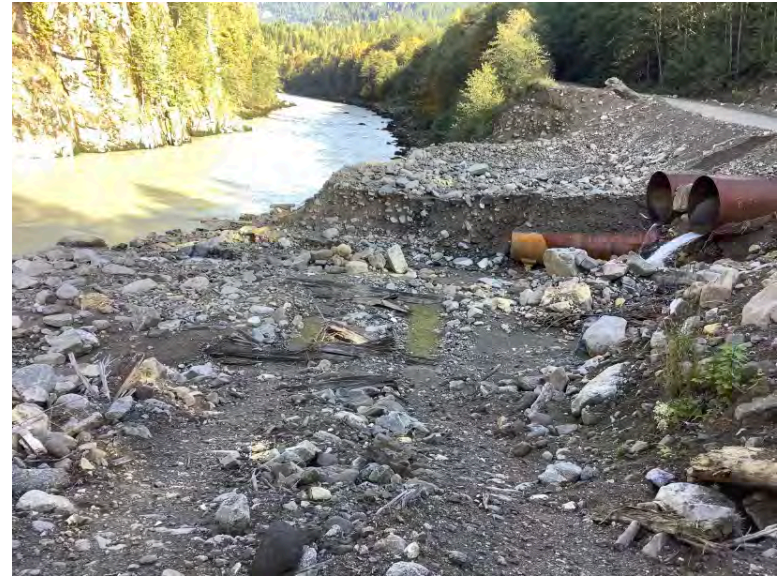
Downstream from Crossing

Road maintainer on site about to repair recent downstream fill washout
