SQ-3159  
SQ-3159

## SQUAMISH RIVER 25.1km

2021 Inspection

| Crossing Name | Terminal Creek |

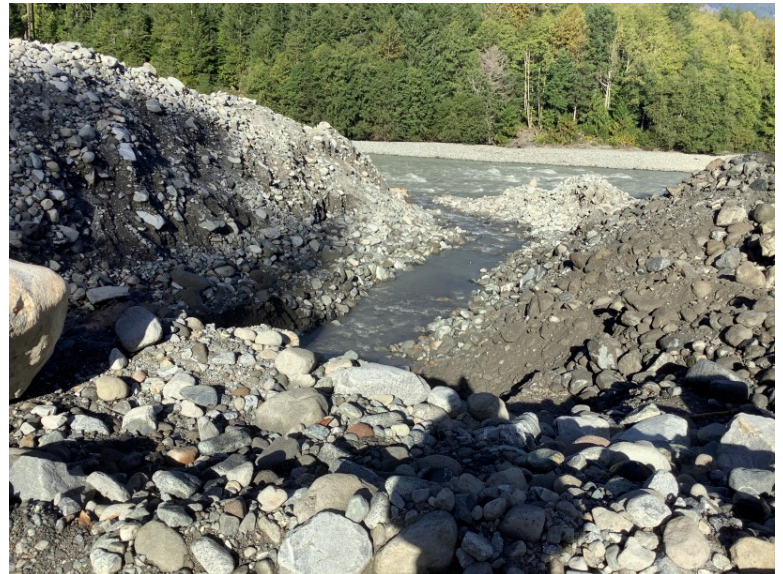
Downstream from Crossing

Road maintained just removed downstream sediment and smooth walled steel culvert at approximately 15% slope drained all sediment. Sediment removal downstream of culvert is required on a regular basis.
