SQ-3161  
SQ-3161A

ASHLU RIVER 35.6km

2021 Inspection

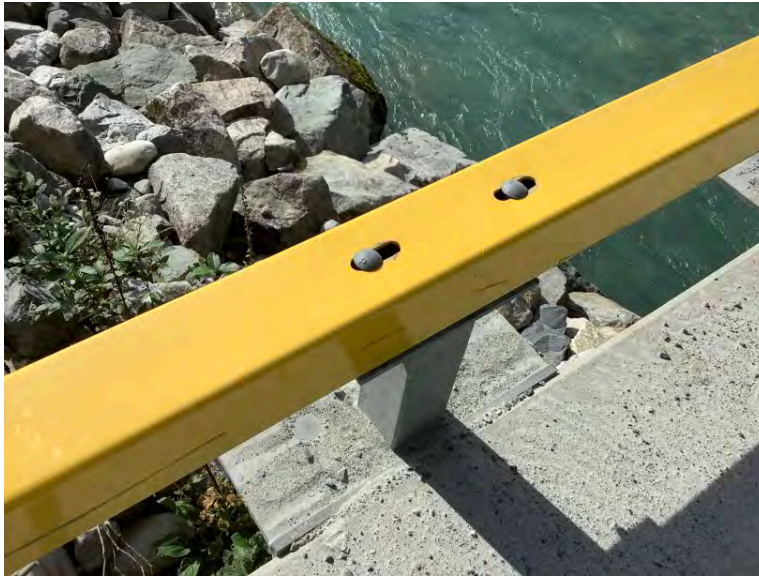
Guard Rail

Guard rail Appears to be missing top bearing plate - check standard detail.

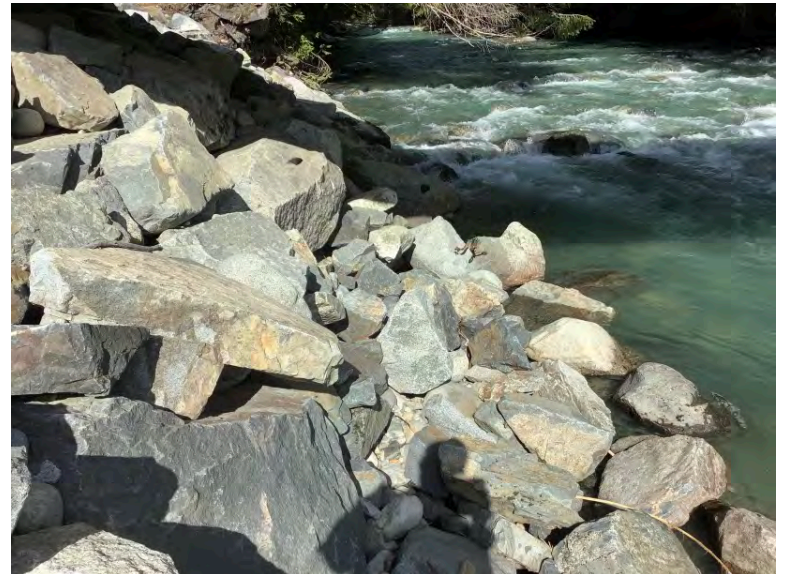
Right Bank Abutment when facing downstream - riprap unravelling a bit. Add large riprap to prevent unravelling.

Right Bank Abutment when facing downstream - riprap unravelling a bit

Load Rated by: MFLNRORD, Greg Dohm, PEng., Oct. 14, 2021  
Load Rating: L100 or 91 tonnes  
Next Inspection: 2024  
Comments: add riprap on downstream woods side prevent further riprap erosion.

| Repair Item | Repair Description |
|---|---|
| 1 Channel. Add Riprap (placed). 1 m <sup>3</sup> .<br>Priority:Medium | Right Bank Abutment when facing downstream - riprap unravelling a bit. Add large riprap to prevent unravelling. |
