SQ-3163  
SQ-3163

Ashlu river 6km

2021 Inspection

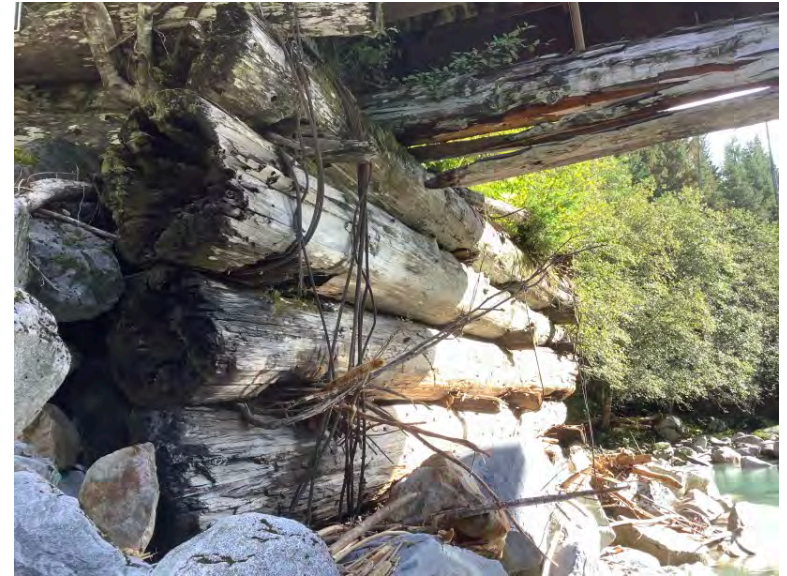
Left Bank Abutment when facing downstream

Log/Timber Cribbs Poor Condemned
