SQ-3172  
SQ-3172A

LILLOOET WEST 01 0.6km

2021 Inspection

| Crossing Name | Camp Creek |

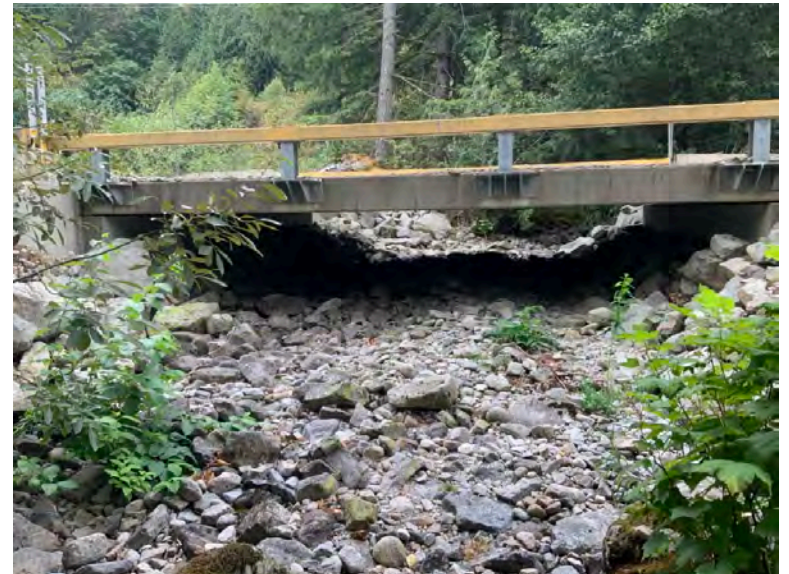
Downstream Profile

Comments    Water from upstream flowing underground. Low clearance
