SQ-3177  
SQ-3177

LILLOOET RIVER 01 44.5km

2021 Inspection

| Crossing Name | Truckwash Creek |

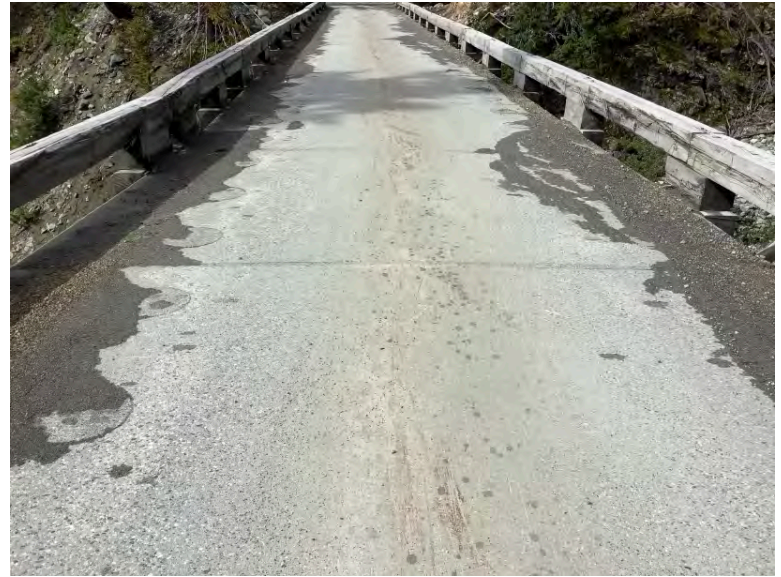
Deck

Curb Rail/Blocks/Posts      Fair

Comments: curb rails getting old, plan to replace over next few years with HSS steel guard rails CL3 rating ideally
