SQ-3191  
SQ-3191

MASHITER 02 0.7km

2021 Inspection

| Road Name | MASHITER 02 |

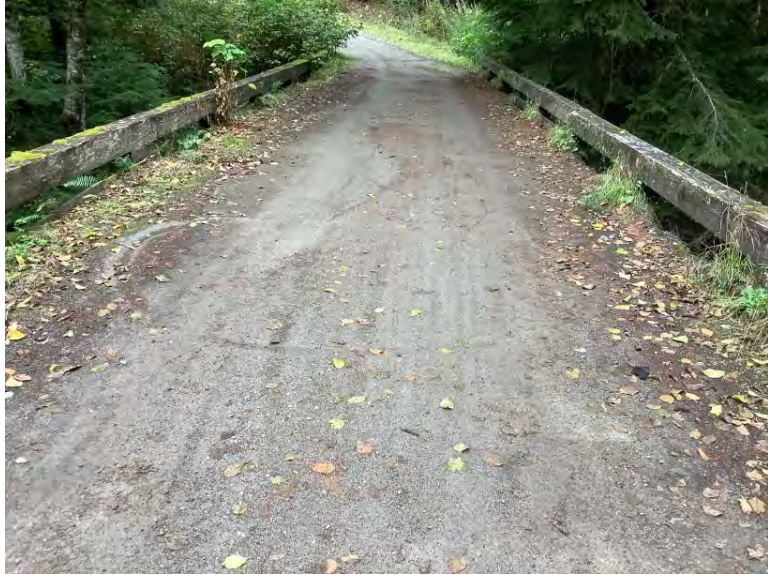
Overall Deck Condition Poor Poor due to rotten risers and rotten curb rails

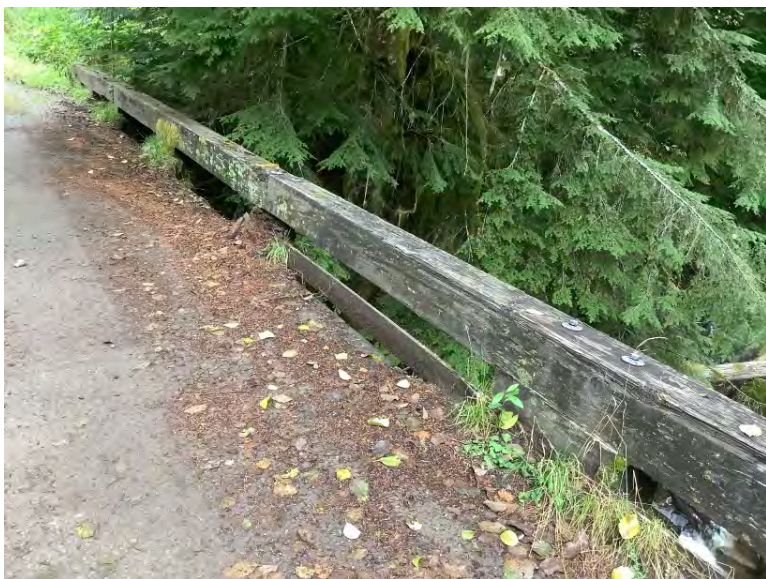
Guard Rail

Curb Rail/Blocks/Posts Poor Need replacing prior to use

| Repair Item | Repair Description |
|---|---|
| 1 Structure. Full Curb Replacement. 1 . Priority:High | Close bridge until curb rails replaced |

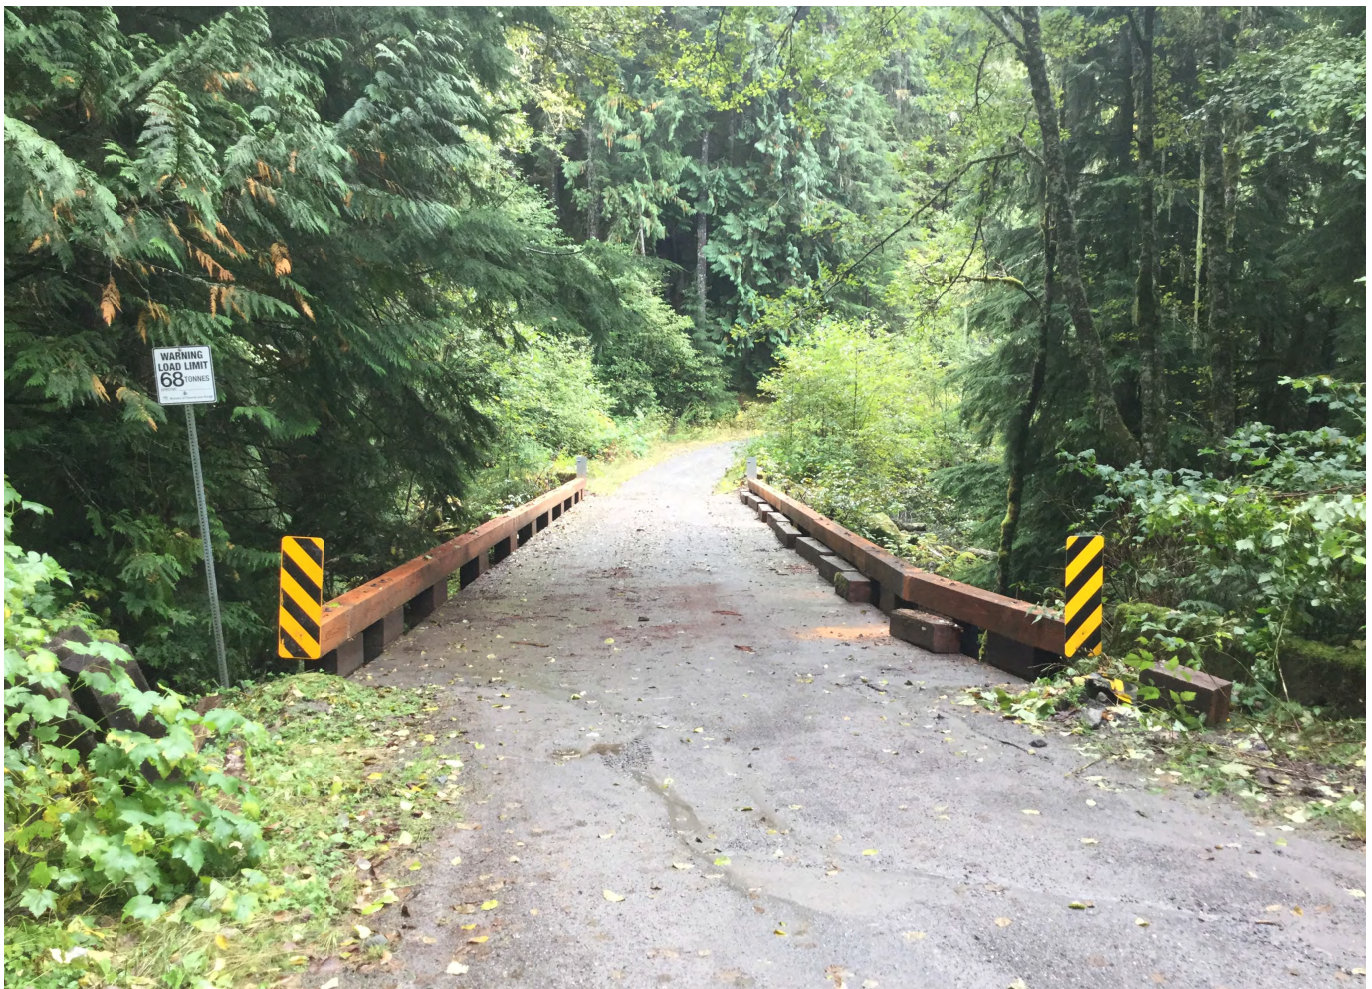
CURBS RECENTLY REPLACED, OCT. 15, 2021

Load Rated by: MFLNRORD, Greg Dohm, PEng., Oct. 15, 2021  
Load Rating: L75 or 68 tonnes  
Next Inspection: 2024  
Comments: guard rails were subsequently replaced since the inspection was completed
