SQ-3204  
SQ-3204

## SLOQUET CREEK MAIN 16.4km

2021 Inspection

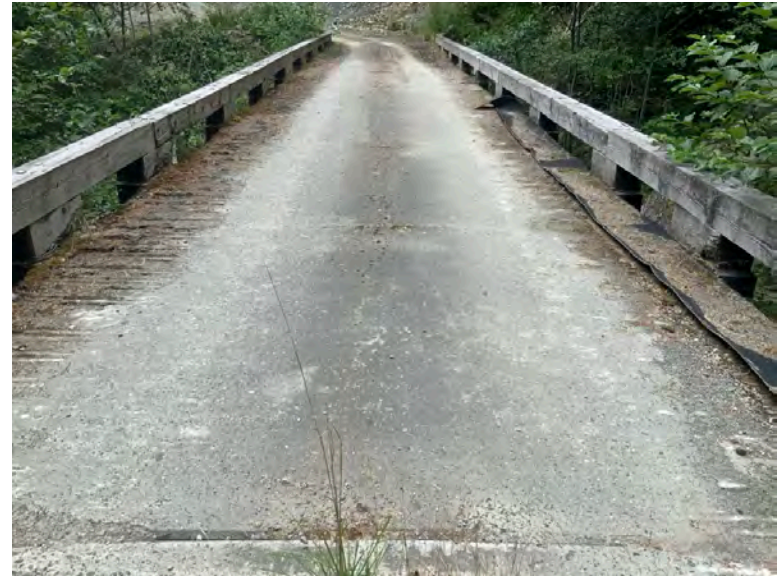
Deck

Replace all guard rails. Evidence of recent industrial use on road. Minor damage from walking tracked equipment on deck

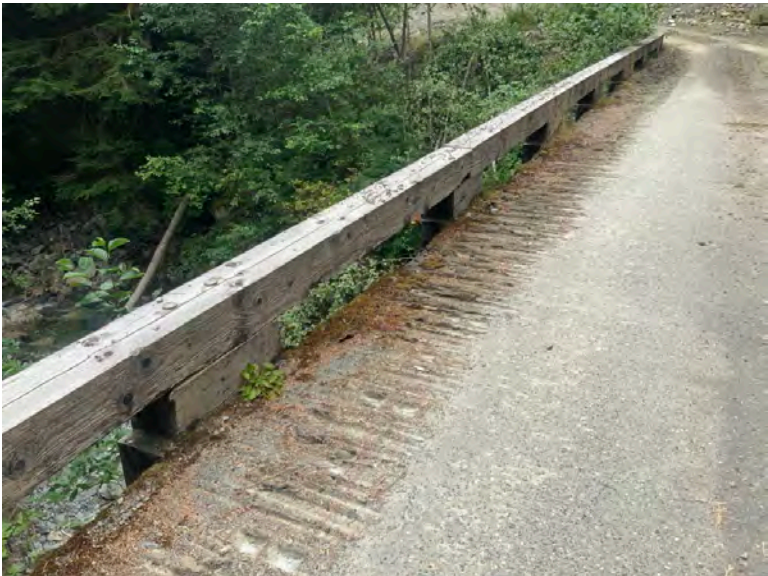
Guard Rail

Curb Rail/Blocks/Posts      **Poor**      Rotten

Overall Deck Condition      **Poor**      Due to guard rails

Load Rated by: MFLNRORD, Greg Dohm, PEng., Nov. 12, 2021  
Load Rating: L75 or 68 tonnes  
Next Inspection: 2022  
Comments: replace guard rails

| Repair Item | Repair Description |
|---|---|
| 1 Structure. Full Curb Replacement. .<br>Priority:High | Resolve all guard rails |

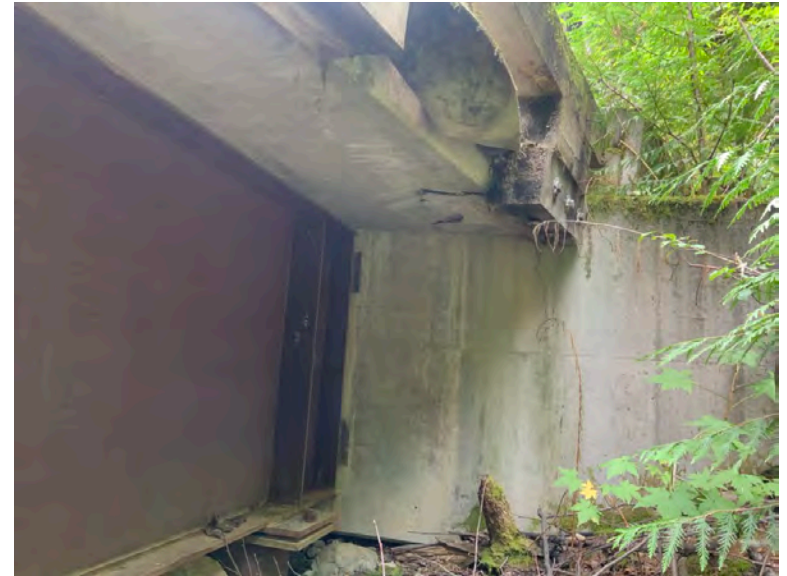
Deck, damage to underside. Right bank u/s
