SQ-3205  
SQ-3205

## SLOQUET CREEK MAIN 12km

2021 Inspection

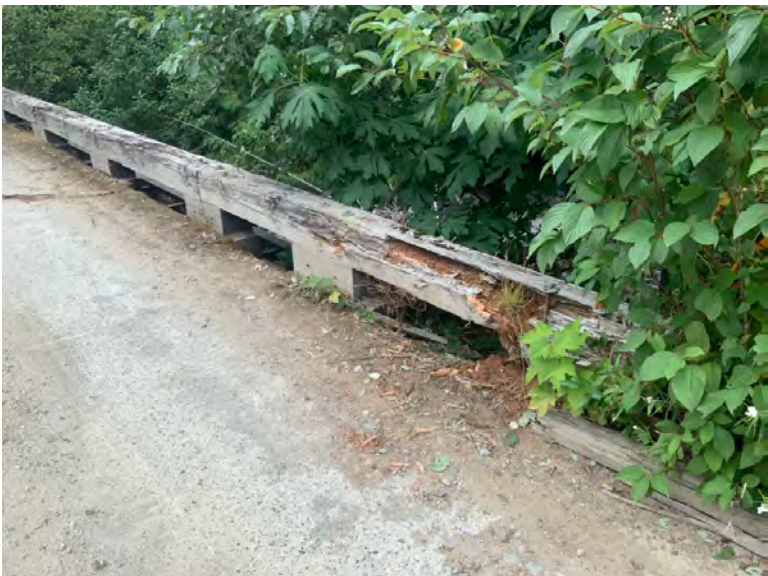
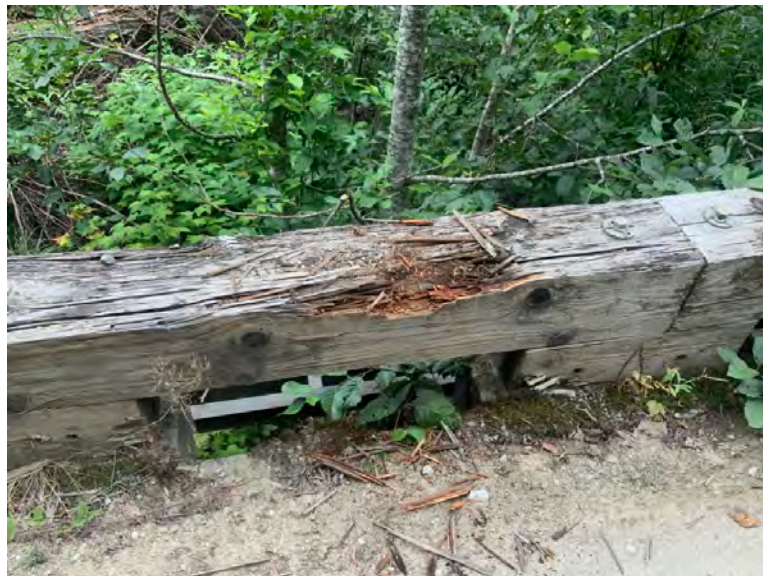
Guard Rail

Curb Rail/Blocks/Posts      **Poor**      Rotten wood

Overall Deck Condition      **Poor**      Due to guard rails

Replace guard rails.

| Repair Item | Repair Description |
|---|---|
| 1 Structure. Full Curb Replacement. .<br>Priority:High | Replace guard rails |

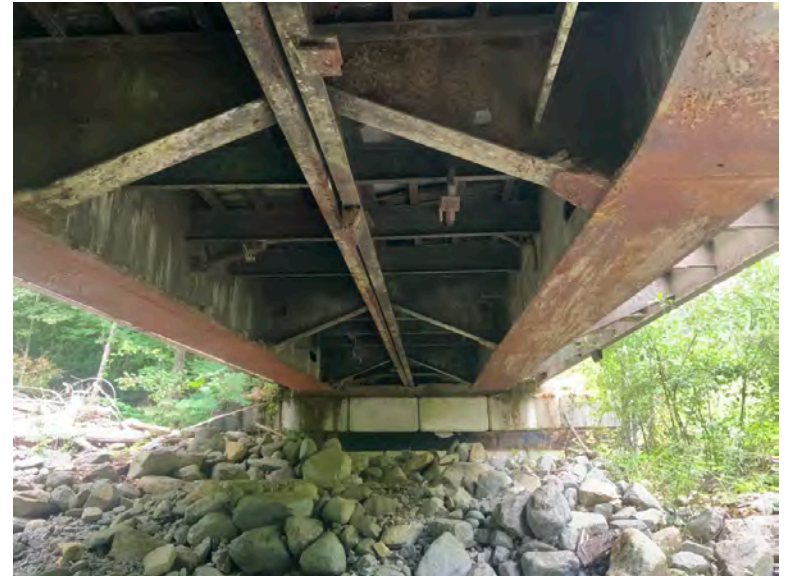
Superstructure

Girders Fair Rail car
