SQ-3208  
SQ-3208

SOO RIVER 01 10.1km

2021 Inspection

| Crossing Name | Soo River Tributary |

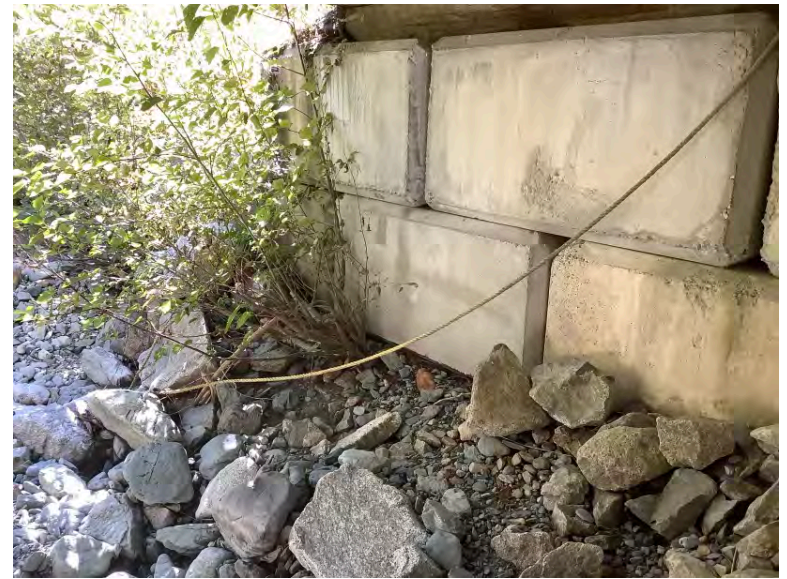
Lock blocks without pad footings. Riprap missing on woods side. Needs to be added to prevent undermining.

Missing on downstream woods side

Missing riprap - woods side downstream

Load Rated by: MFLNRORD, Greg Dohm, PEng., Oct. 14, 2021  
Load Rating: L75 or 68 tonnes  
Next Inspection: 2024  
Comments: repair riprap to prevent undermining lockblock abutments

| Repair Item | Repair Description |
|---|---|
| 1 Substructure. Piling/<br>pedestal maintenance. 1<br>m². Priority:Medium | Lock blocks without pad footings. Riprap missing on woods side. Needs to be added to prevent undermining. |
