SQ-3214  
SQ-3214

SQ\_SL2000 3.3km

2021 Inspection

| Crossing Name | Bear Claw |

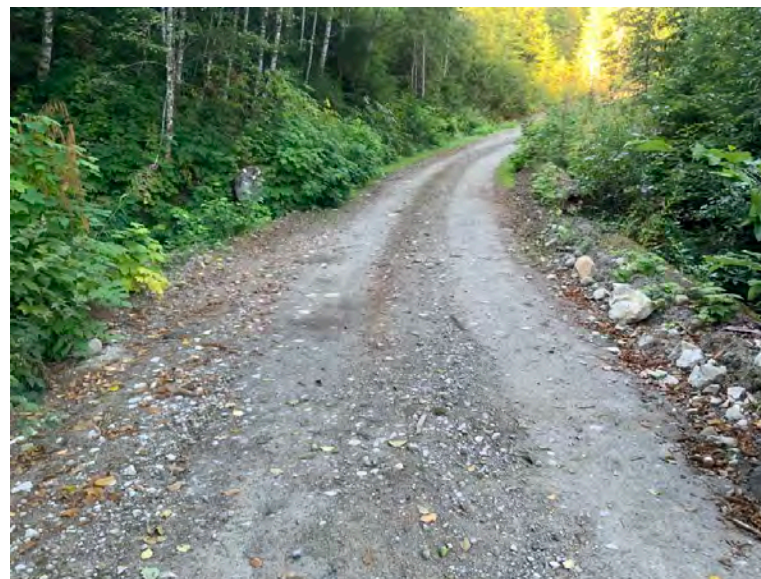
Curb Rail/Blocks/Posts      **Poor**      Very low

Overall Deck Condition      **Poor**      Due to Curb logs

Log Curbs    Poor    Very low, slightly above road level

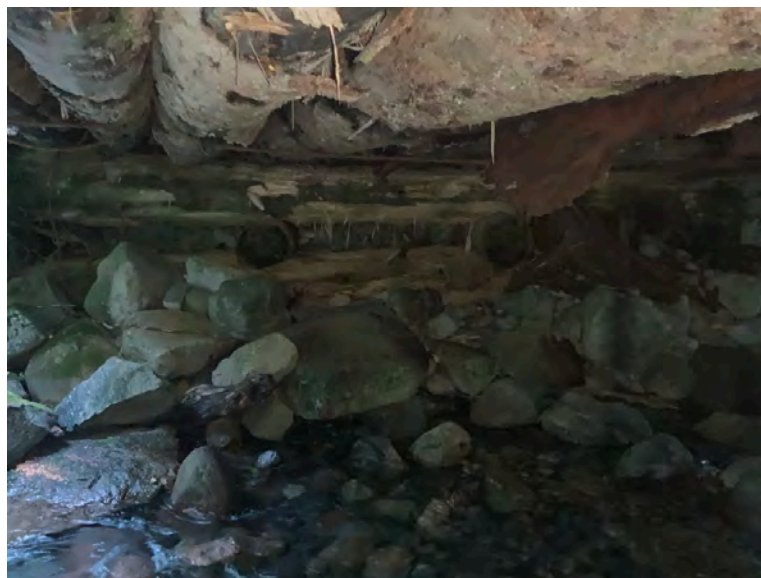
Left Bank Abutment when facing downstream

Log/Timber Cribs Fair

Tie Backs Fair

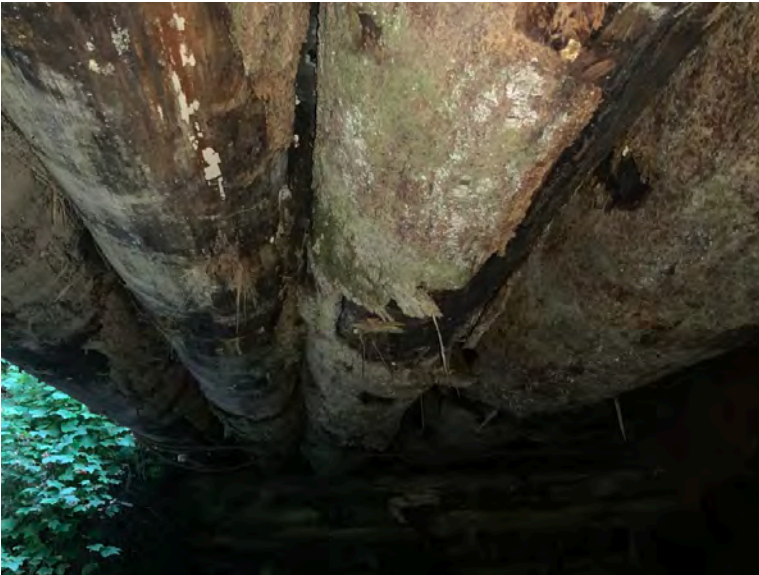
Stringers measured from upstream. Assumed fd. Fair condition all, minimal surface rot, no heart rot.
