SQ-3215  
SQ-3215

SQ\_SL2000 4.5km

2021 Inspection

Crossing Name Carley Creek

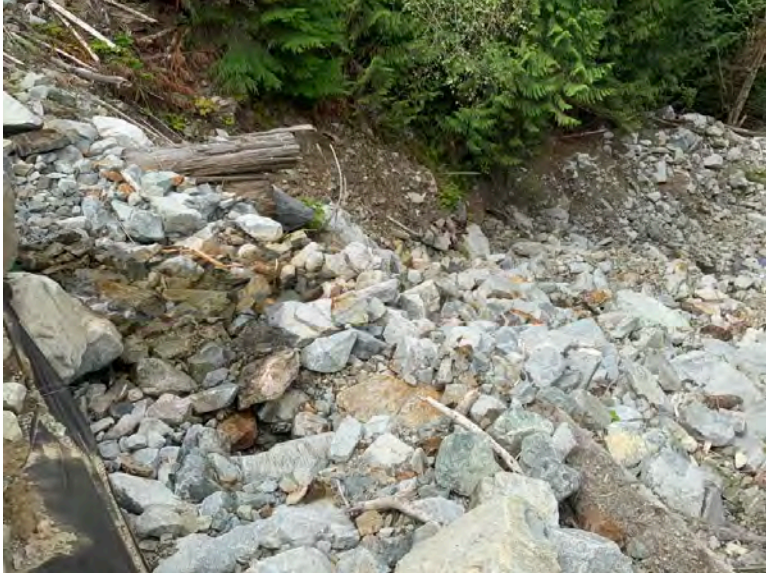
Outlet, riprap
