SQ-3218  
SQ-3218

## SOUTH SLOQUET 9.9km

2021 Inspection

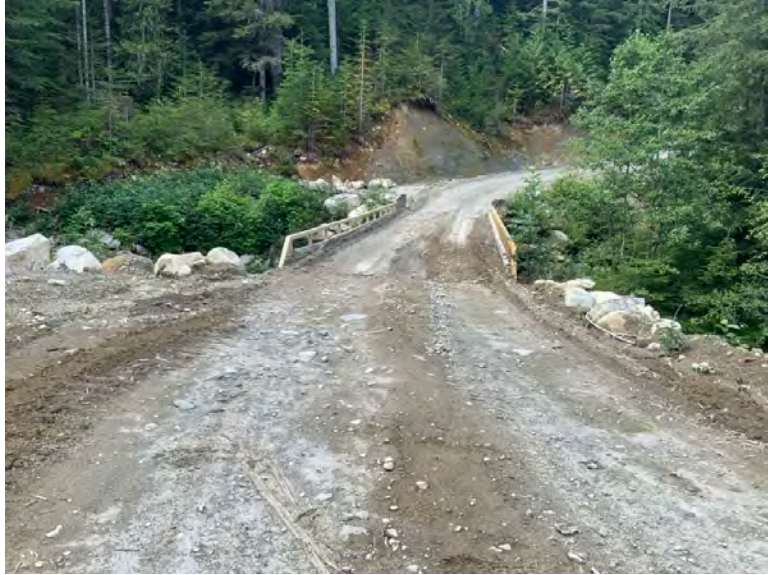
Approach from Right Bank when facing downstream

Fender Condition Poor Missing right approach

| Repair Item | Repair Description |
|---|---|
| 1 Approach. Approach fenders (install). 2 # of units. Priority:High | Add approach barriers to right approach |
| 2 Approach. Add Warning Signs. 4 # of signs. Priority:High | Delineators and bridge ahead |

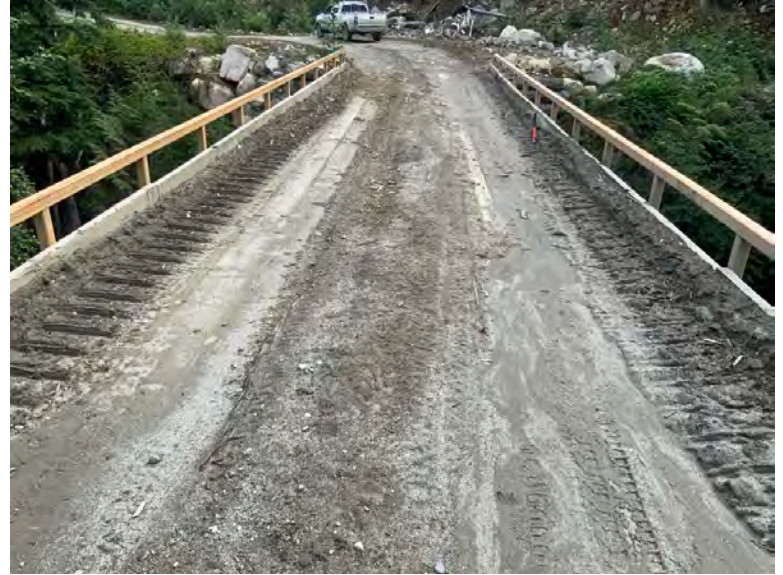
Sub Deck      Fair      Subdeck is running surface. Appears fine visually

Overall Deck Condition      Fair

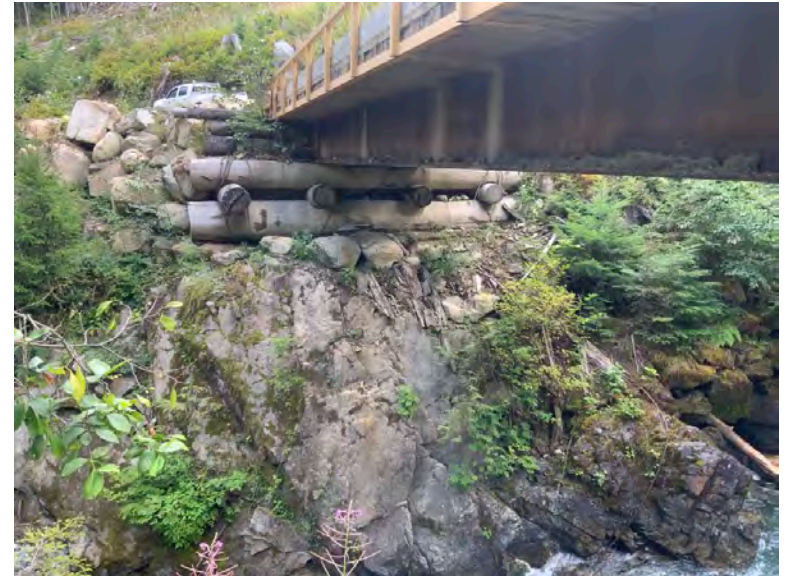
Right Bank Abutment when facing downstream

Log/Timber Cribs Good Large cribs appear solid

Ballast Wall Fair Logs

Wing Wall Fair Logs

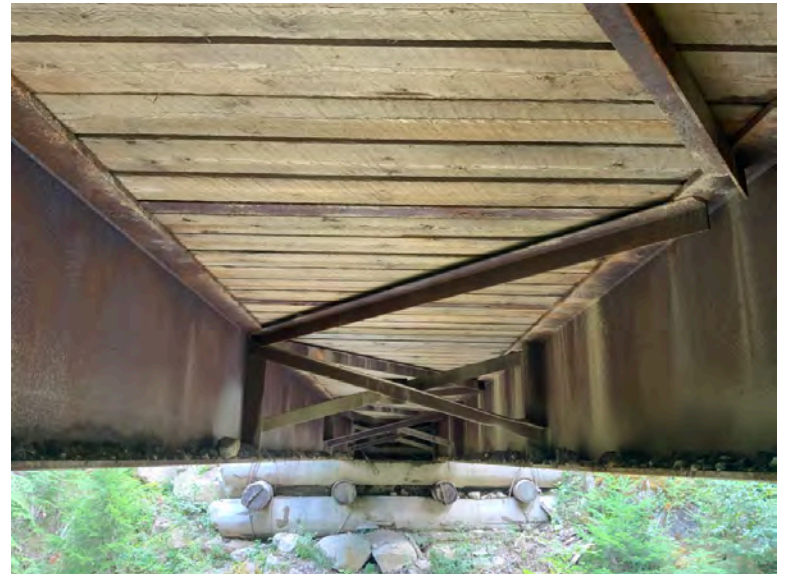
Superstructure

Girders Fair

Diaphragms Fair

Bracing Fair

Hardware Fair
