SQ-3225  
SQ-3225A

IN-SHUCK-CH FSR 25.7km

2021 Inspection

Crossing Name Tributary to Lillooet Lake

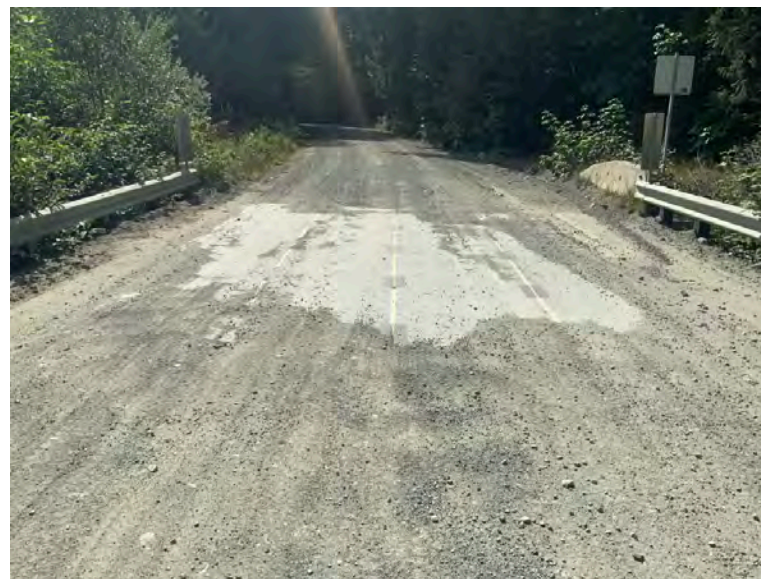
Overall Deck Condition      **Good**
