SQ-3249  
SQ-3249A

SL1100 0.2km

2021 Inspection

Crossing Name Trib to Sloquet

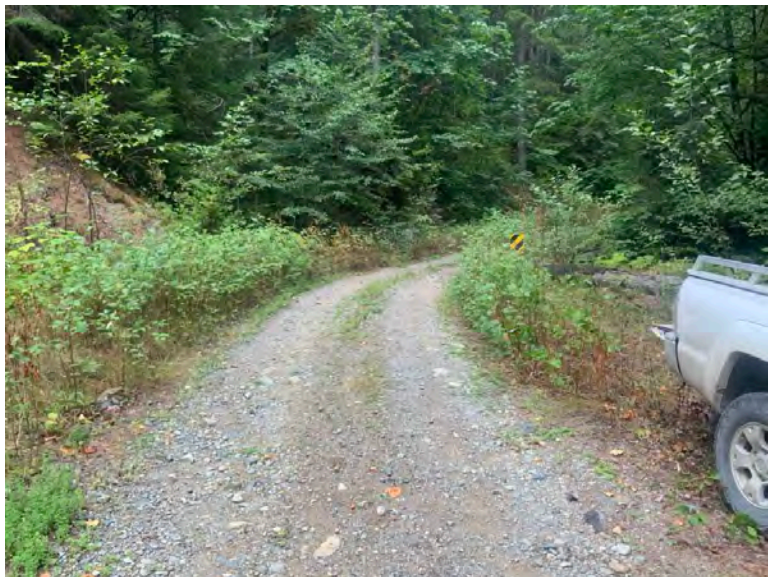
Fender Condition Poor Undersized/low

Approach from Right Bank when facing downstream

| Repair Item | Repair Description |
|---|---|
| 2 Approach. Approach fenders (re-Install). # of units. Priority:High | Raise approach barriers |

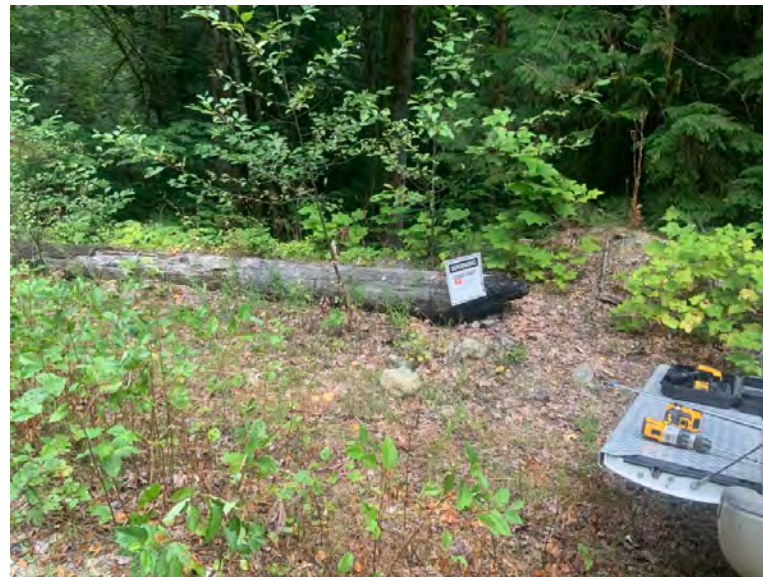
Posted Load Rating 62

Load Rating Sign

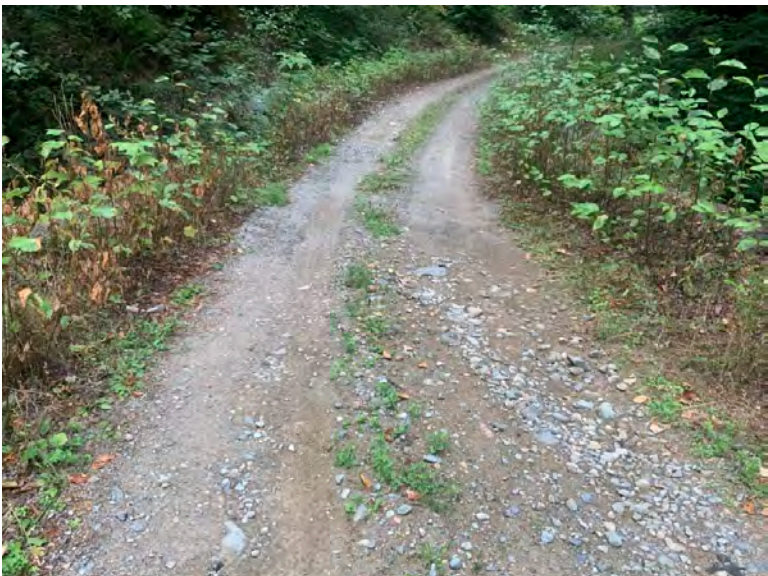
Curb Rail/Blocks/Posts      Poor      Low

Overall Deck Condition      Poor      Low curb logs

Deck

| Repair Item | Repair Description |
|---|---|
| 1 Structure. Log/timber stringer maintenance. m. Priority:High | Raise curb logs |

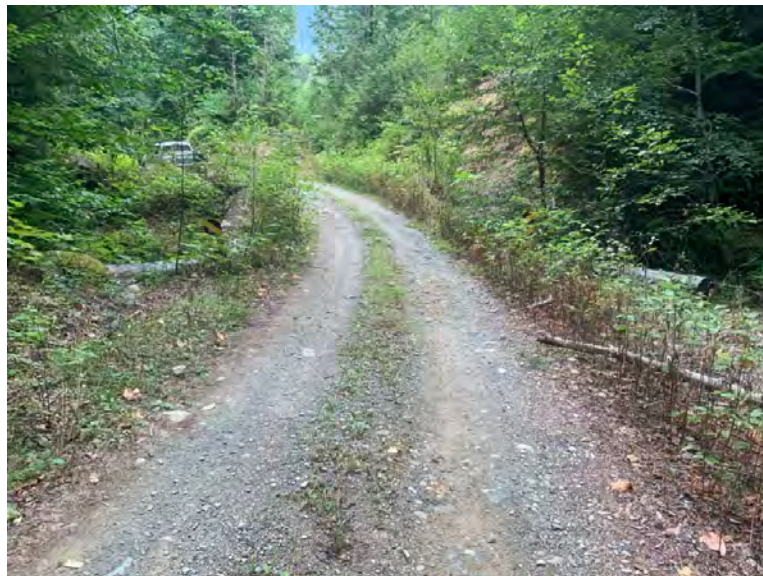
Approach from Left Bank when facing downstream

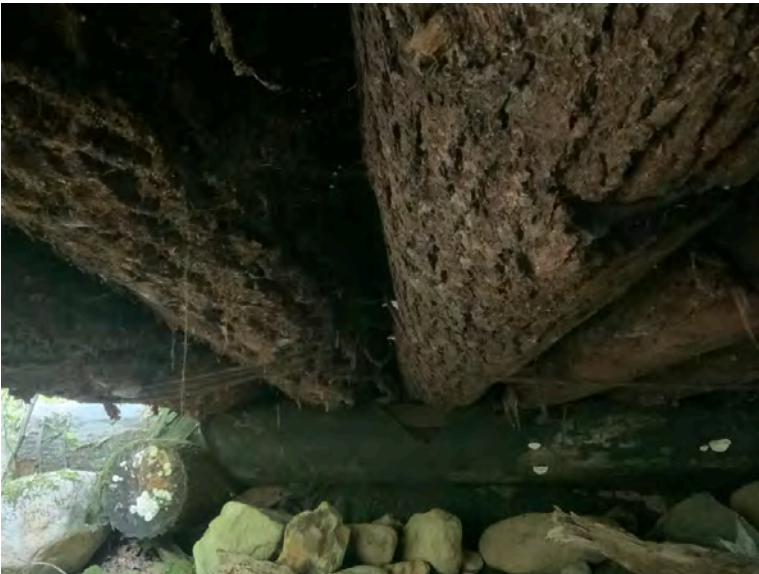
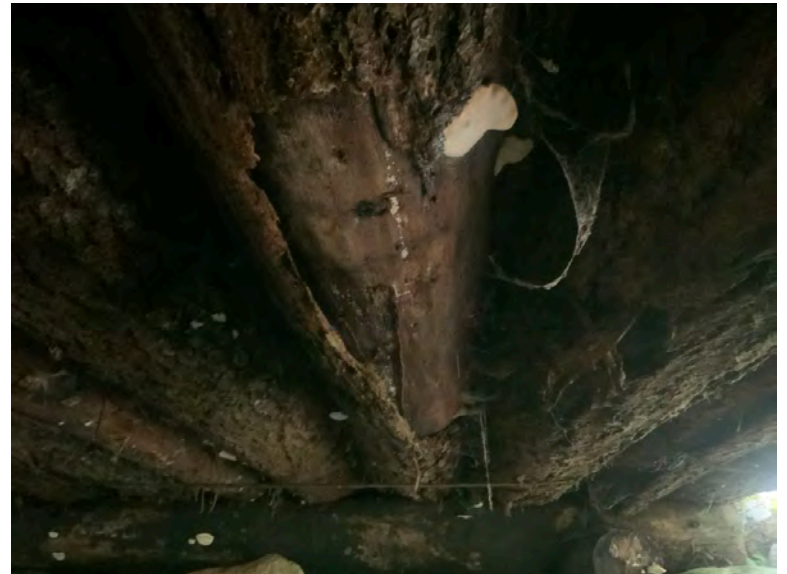
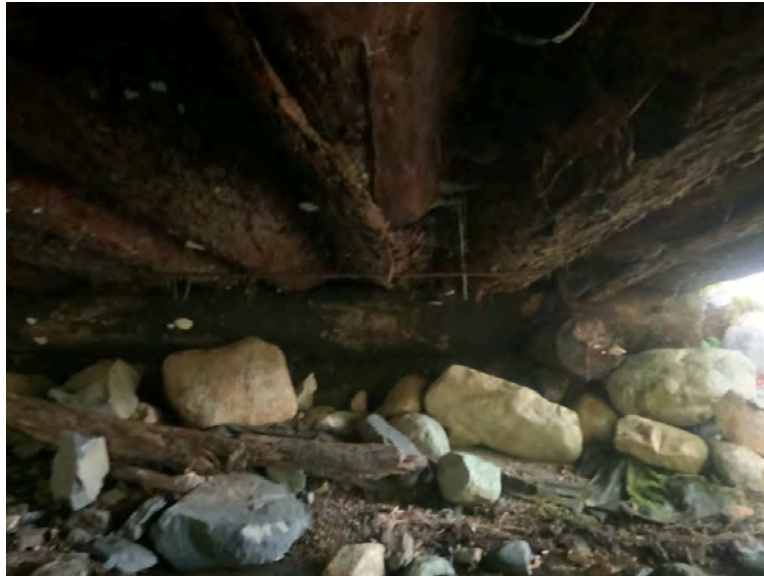
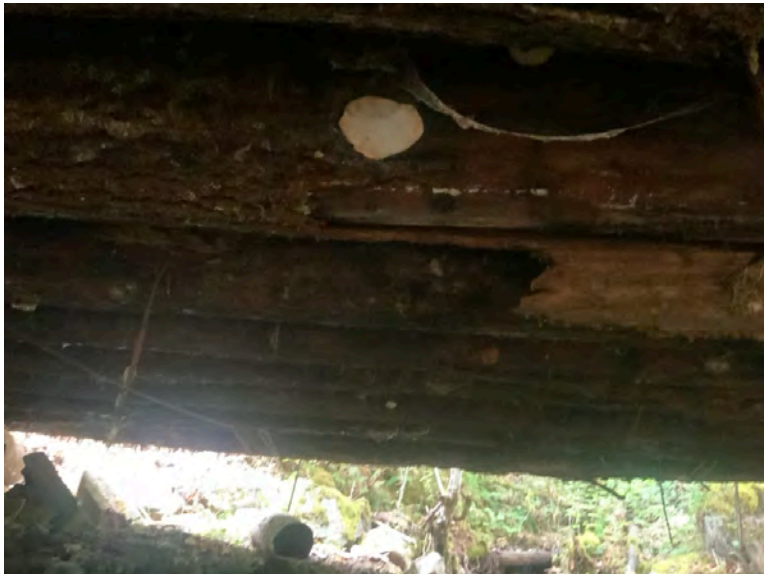
Stringers showing sign of age, but all appear sound with minimal (<10mm) surface rot except stringer 6 (30-40mm rot).

Load Rated by: MFLNRORD, Greg Dohm, PEng., Nov. 12, 2021  
Load Rating: BCL625 or 63 tonnes  
Next Inspection: 2022  
Comments: conk showing on some hemlock stringers. Plan to replace bridge soon.

Stringers

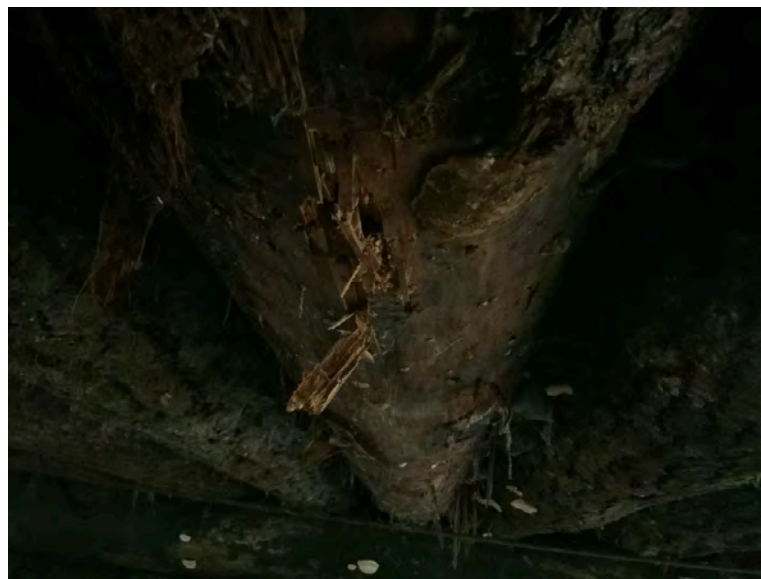
| Stringer<br>Number | Species | Peeled | Diameter<br>(mm) | Rot Depth<br>(mm) | Condition | Comment |
|---|---|---|---|---|---|---|
| 6 | | Y | 520 | 40 | Poor | |

| Item | Monitor Description | Frequency |
|---|---|---|
| 1 | Stringer 6 for rot | Anually |
