SQ-3005  
SQ-3005

## STAWAMUS-INDIAN MAIN

2022 Inspection

Crossing Name Forestry Creek

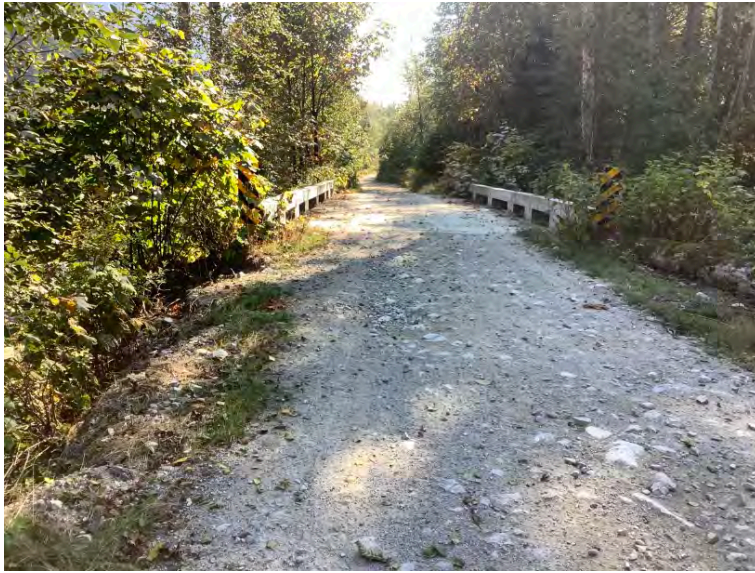
Approach from Left Bank when facing downstream

Road Surface **Fair** **Some erosion of river left bank, suggest armouring fill with riprap.**

| Repair Item | Repair Description |
|---|---|
| 1 Approach. Reconstruct fill. m³. Priority:Low | Consider armouring approaches on the downstream sides. |

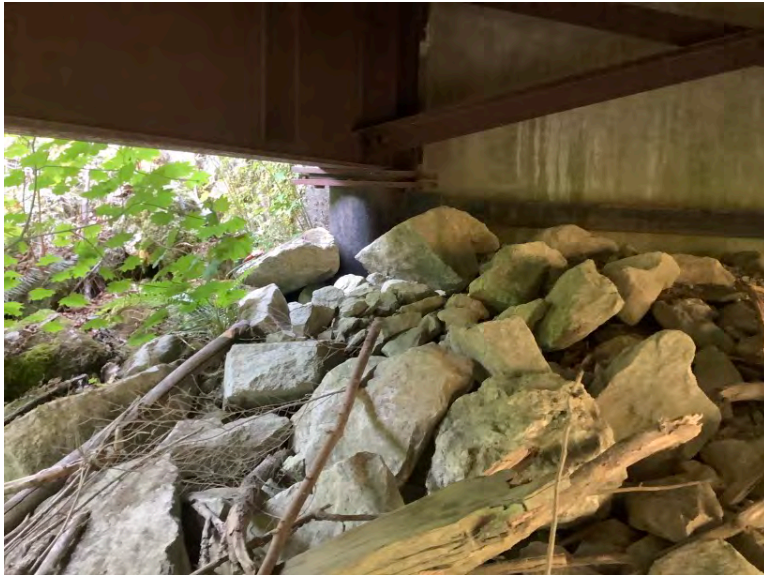
Bearing

Bearings **Good**
