## STAWAMUS-INDIAN MAIN

2022 Inspection

Crossing Name Forestry

Load Rated by: MOF, Greg Dohm, PEng., Oct. 14, 2022  
Load Rating: L120 or 108 tonnes  
Next Inspection: 2025  
Comments:

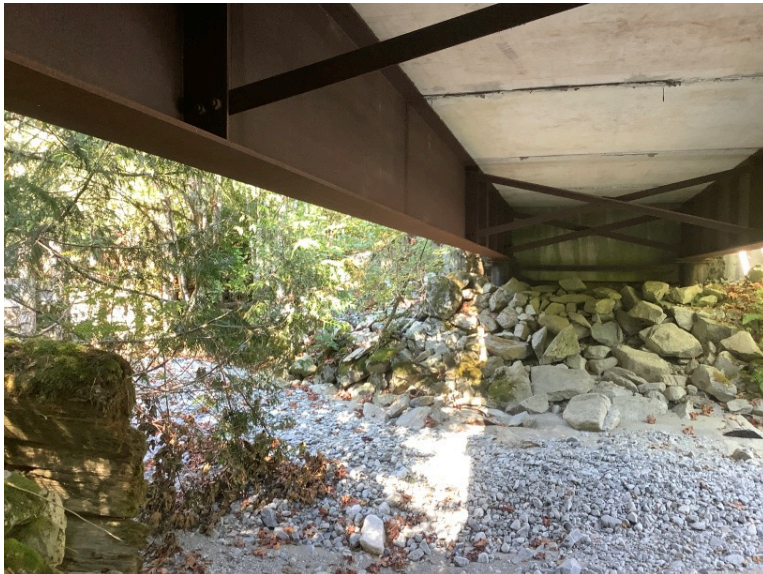
Stringers

Girders Fair

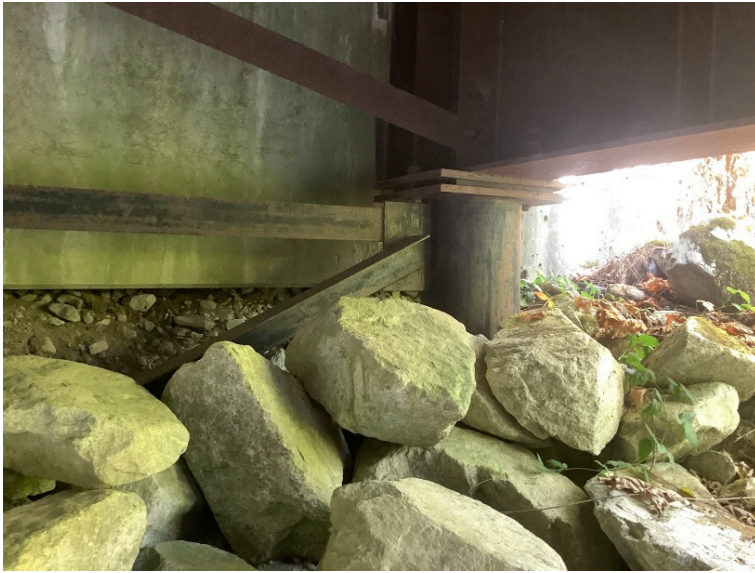
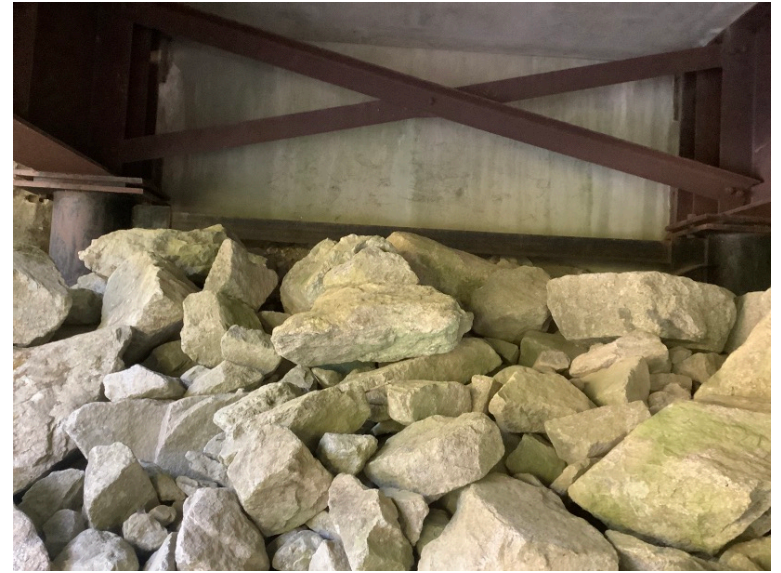
Bearing

Bearings **Good**
