## STAWAMUS-INDIAN MAIN

2022 Inspection

Crossing Name Indian River

Load Rated by: MOF, Greg Dohm, PEng., Oct. 14, 2022  
Load Rating: L120 or 108 tonnes  
Next Inspection: 2025  
Comments:

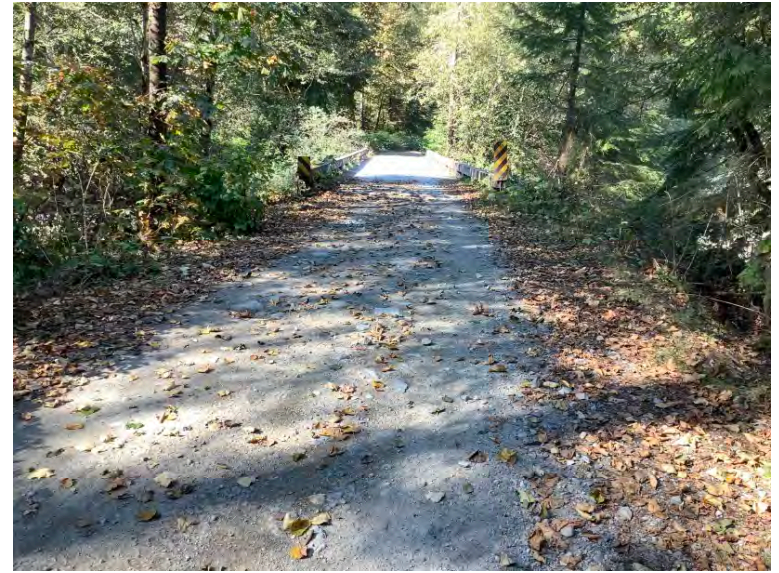
Approach from Left Bank when facing downstream

Delineator Missing  
Right ☒ 0 ☐ 1 ☐ 2 One has fallen off

Fender Condition **Poor** Replace fenders

2 Approach. Approach fenders  
(install). # of units.  
Priority:Medium

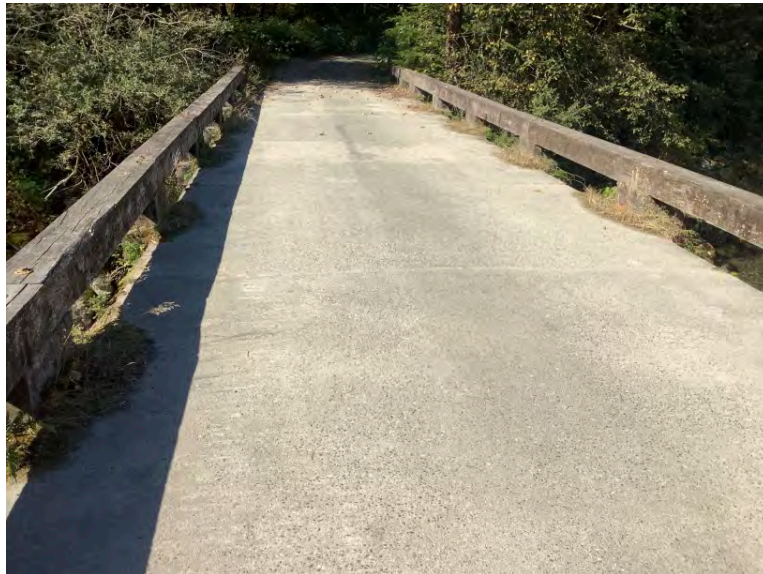
Deck

Curb Rail/Blocks/Posts      **Poor**      **Rotten**

1 Structure. Full Curb  
Replacement. . Priority:High
