SQ-3008  
SQ-3008

## STAWAMUS-INDIAN MAIN

2022 Inspection

Crossing Name Indian River

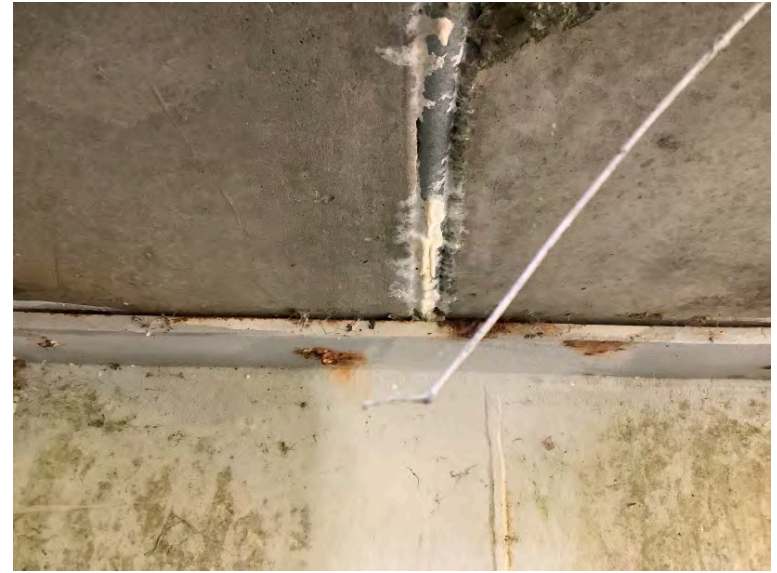
| Concrete Deck | Fair | Efflorescence protruding through underside of deck. Some pitting occurring on underside. |

| Curb Rail/Blocks/Posts | Poor | Rotten |

| 2 Structure. Full Curb Replacement. . Priority:High |

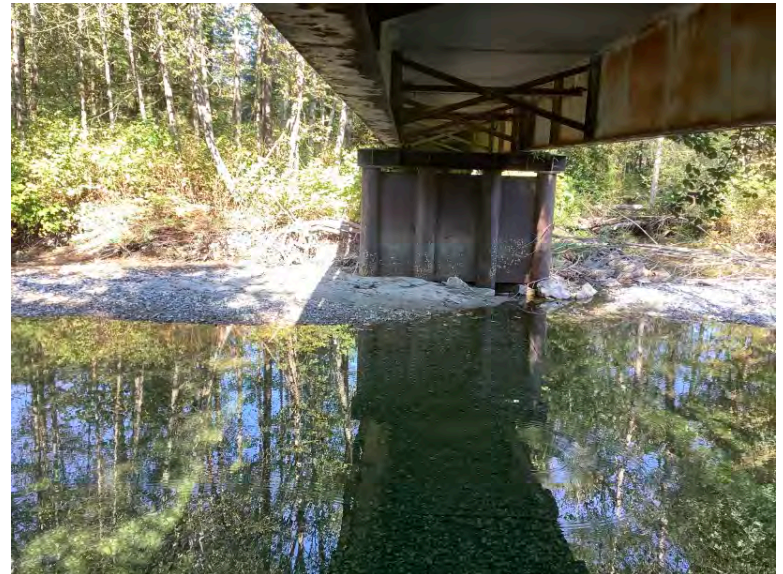
Pier **Fair**
