SQ-3009  
SQ-3009A

## STAWAMUS-INDIAN MAIN

2022 Inspection

Crossing Name Tributary to Indian River

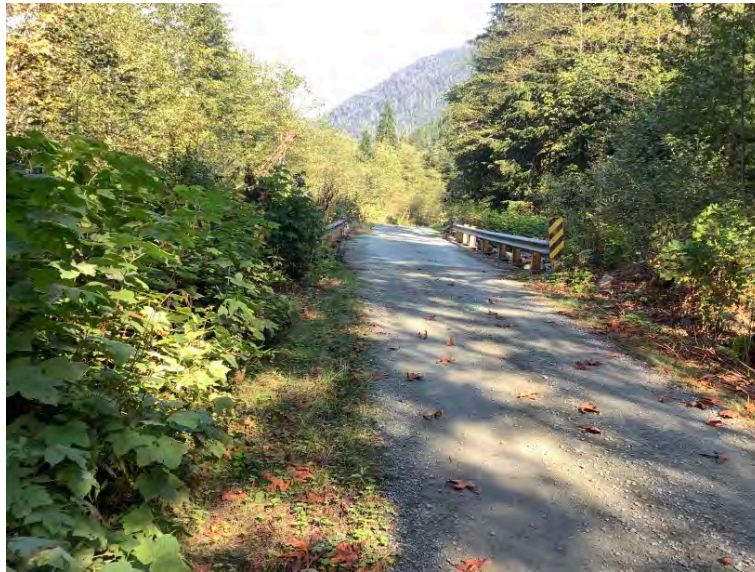
Approach from Left Bank when facing downstream

Delineator Missing  
Left ☐ 0 ☒ 1 ☐ 2 Delineators not well installed

| Repair Item | Repair Description |
|---|---|
| 1 Approach. Add Warning Signs. # of signs.<br>Priority:Low | Fix delineators |

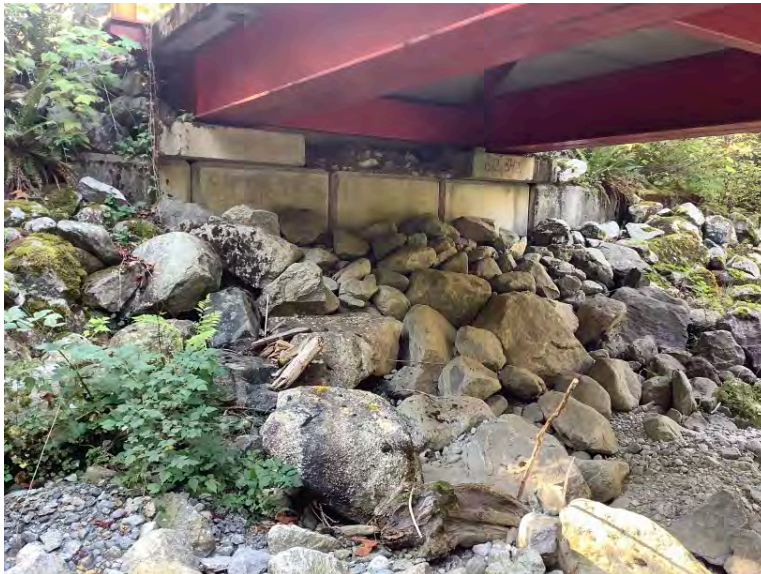
Left Bank Abutment when facing downstream

Concrete **Good** Odd configuration with reused footing.

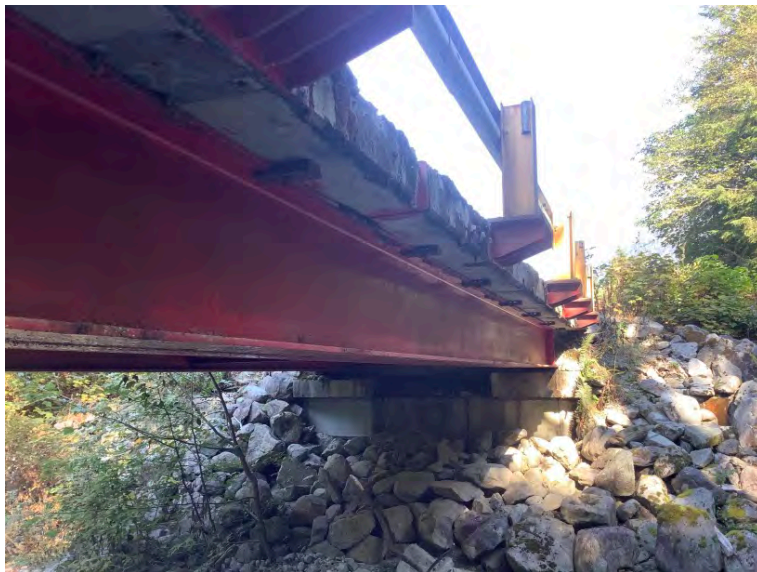
Overall Deck Condition **Good**

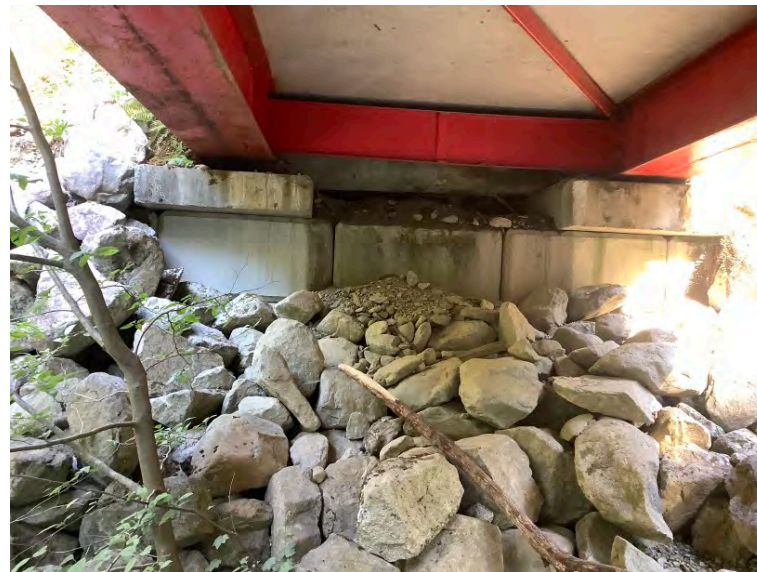
Bearing

Bearings **Good**

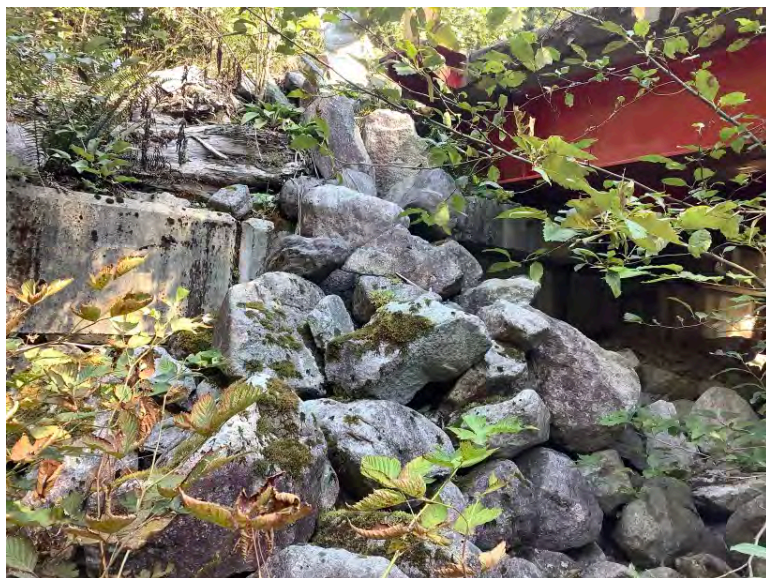
Ballast Wall **Poor** Too short, fill spilling onto girders
