SQ-3010  
SQ-3010

RUTHERFORD 01 4.1km

2022 Inspection

Crossing Name Trib to Rutherford

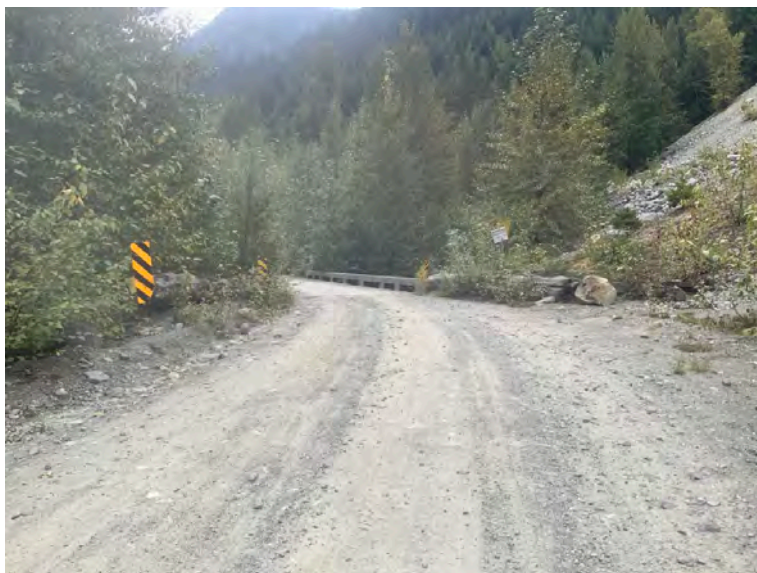
Approach from Left Bank when facing downstream

Woods approach missing

| Repair Item | Repair Description |
|---|---|
| 2 Approach. Approach fill repair. m³. Priority:Medium | Fill potholes, prevent damage to deck ends |
| 3 Approach. Area/sight line brushing. m². Priority:Low | |

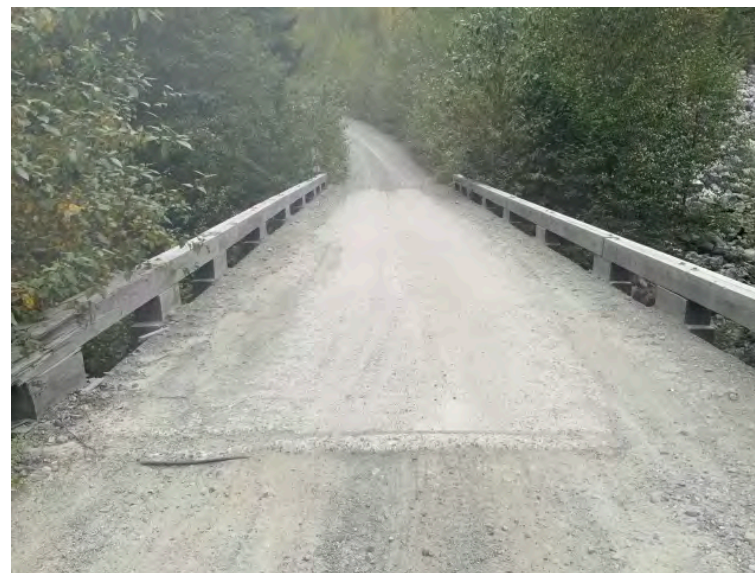
Concrete Deck      Fair      Surface wear, and damage to edges.

Overall Deck Condition      Fair
