SQ-3011  
SQ-3011

RUTHERFORD 01 6.5km

2022 Inspection

Crossing Name Tributary to Rutherford Creek

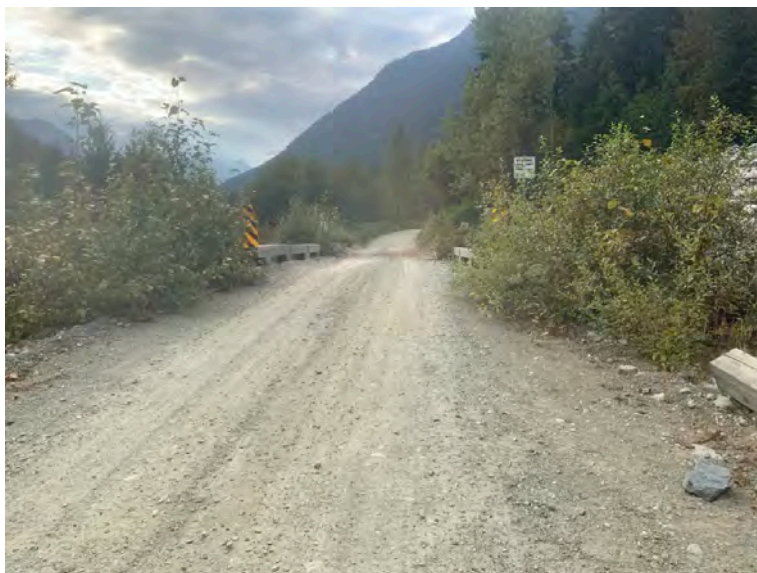
Approach from Left Bank when facing downstream

Fender Condition Poor

Missing all

| 2 Approach. Approach fenders (install). # of units. Priority:High | Install approach barriers |

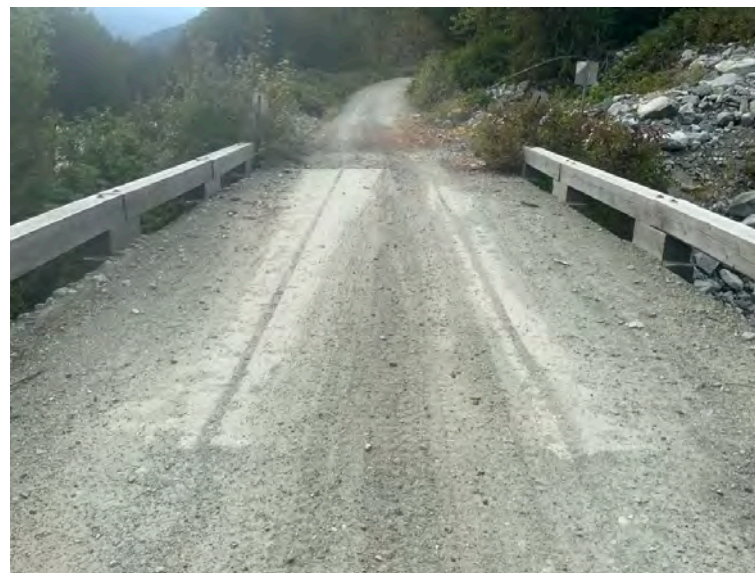
Concrete Deck      **Fair**      Significant surface wear. Damage ballast wall

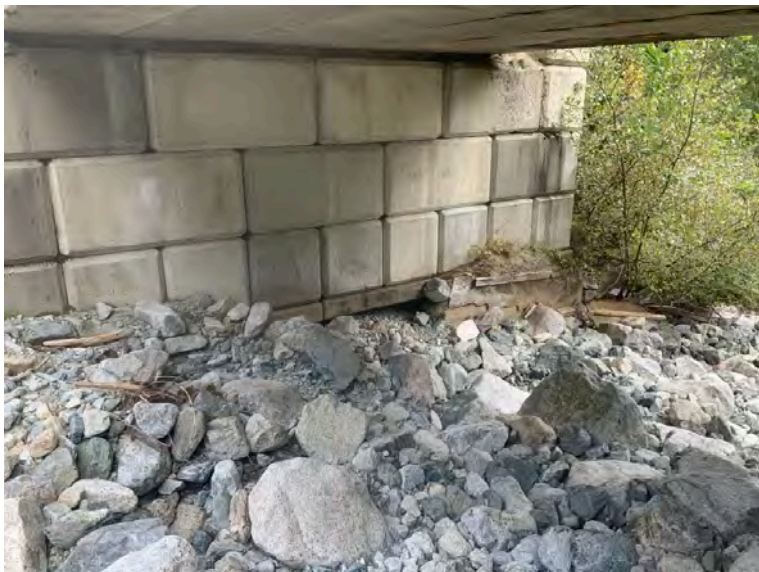
Left Bank Abutment when facing downstream

Left bank footing exposed. CIP concrete has been previously added to address this in the distant past. Scour has increased upstream of protection measure. Roughly 2.2m long x 0.25m (at deepest). Both footings halves exposed. Right bank has a berm built up to protect abutment (natural or not?) Seems to be functioning.

Comments: Undermined footing for 1.2m long section on town end must be repaired prior to industrial use, with formed cast-in-place concrete to fill under footing. A 300mm deep x 200mm cut off trench may be constructed within the formed area outside of the footing and filled with concrete to mitigate future erosion potential. Attend to other noted repairs as well noted in this inspection as well.

| Repair Item | Repair Description |
|---|---|
| 1 Structure. . . Priority:High | Address exposed footing, left bank. |

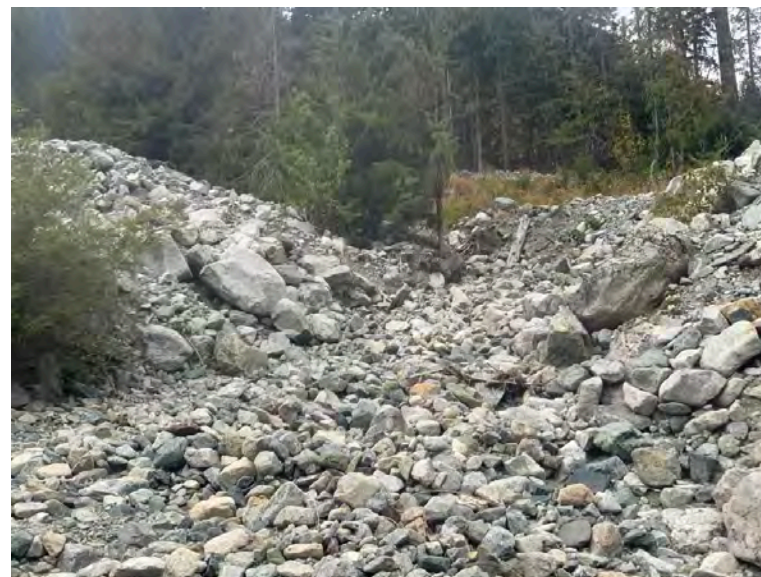
Upstream from Crossing

Comments Debris flow (rock) channel on fan

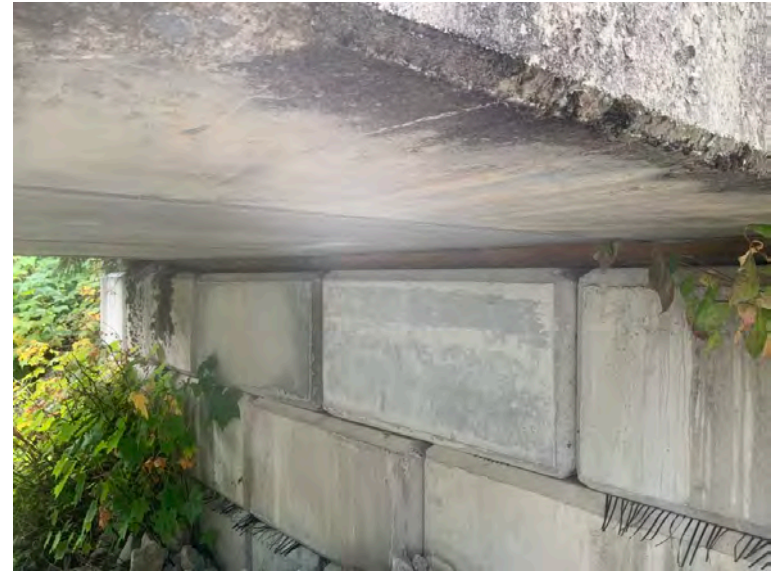
Bearing

Bearings Good

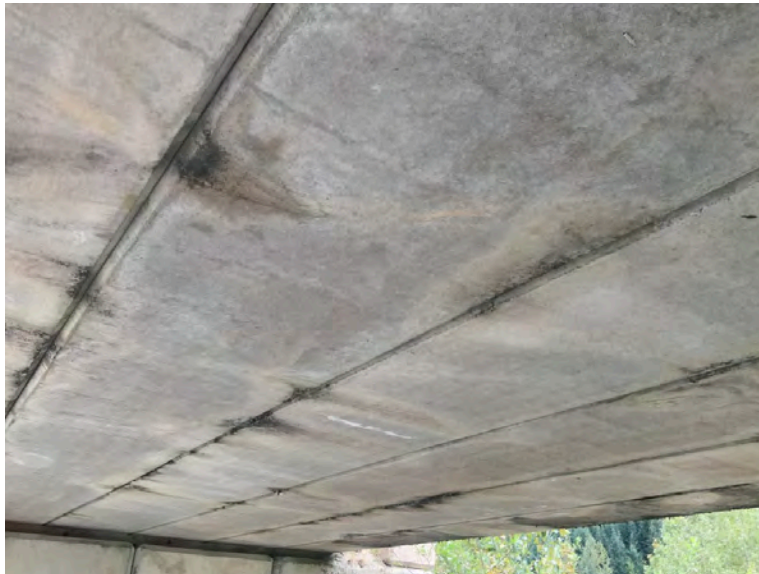
Superstructure

Girders **Good**
