SQ-3012  
SQ-3012

RUTHERFORD 01 8km

2022 Inspection

Crossing Name Tributary to Rutherford Creek

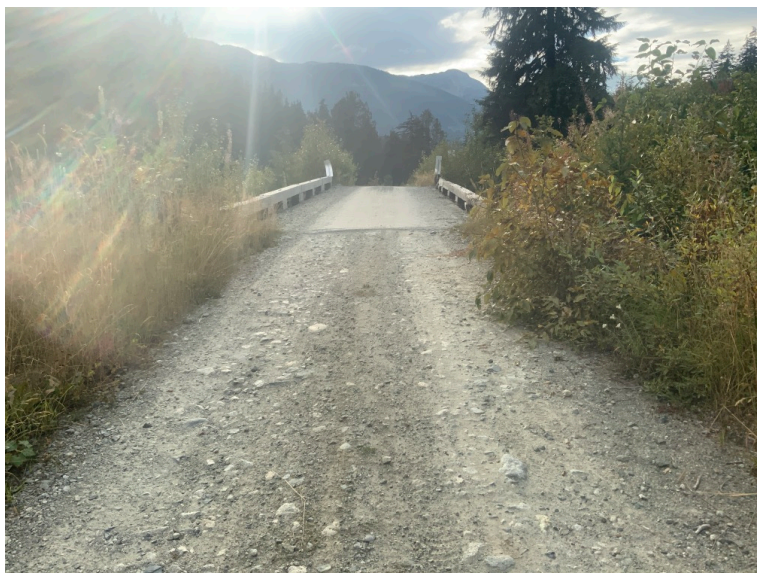
Approach from Left Bank when facing downstream

2 Approach. Area/sight line brushing. m². Priority:Low

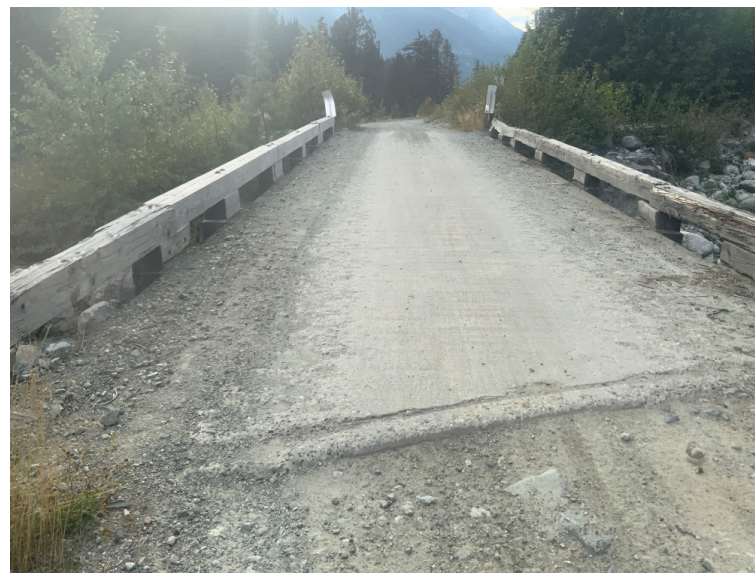
Concrete Deck      **Fair**      Significant surface wear . Ballast wall damag/ wear

Deck

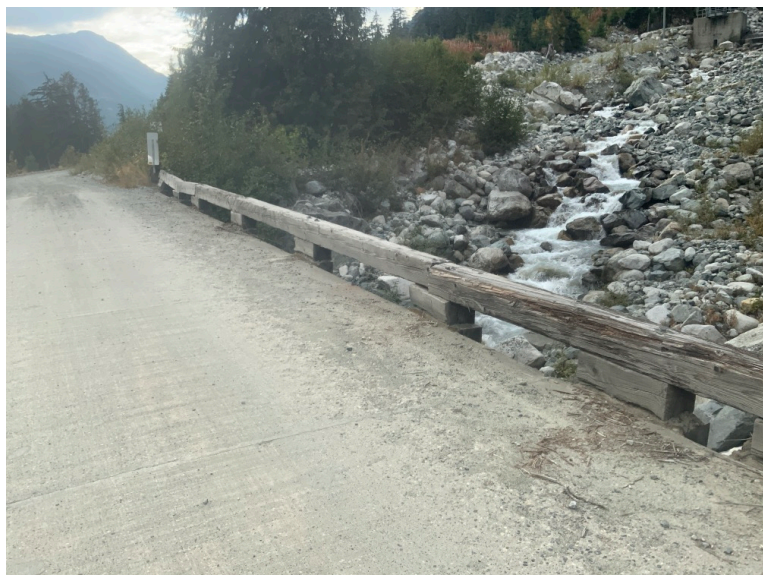
Curb Rail/Blocks/Posts      **Poor**      All but three section are rotten and need replaced.

Hardware      **Fair**      Loose rails

Guard Rail

| Repair Item | Repair Description |
|---|---|
| 1 Structure. Full Curb Replacement. . Priority:High | Replace all rails and risers (except three sections look new |

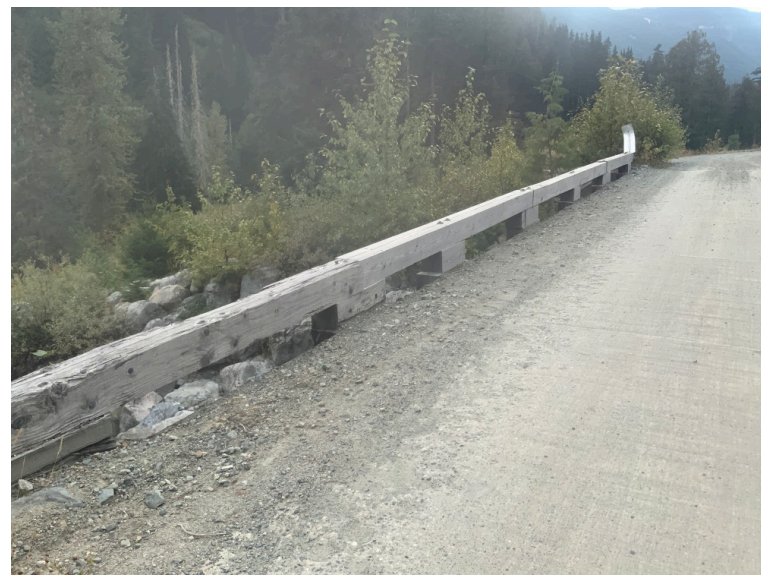
Guard Rail

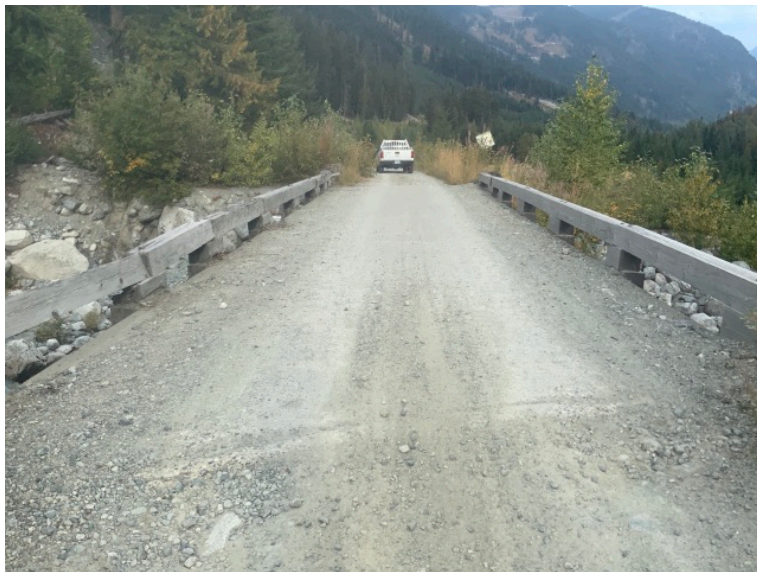
Deck

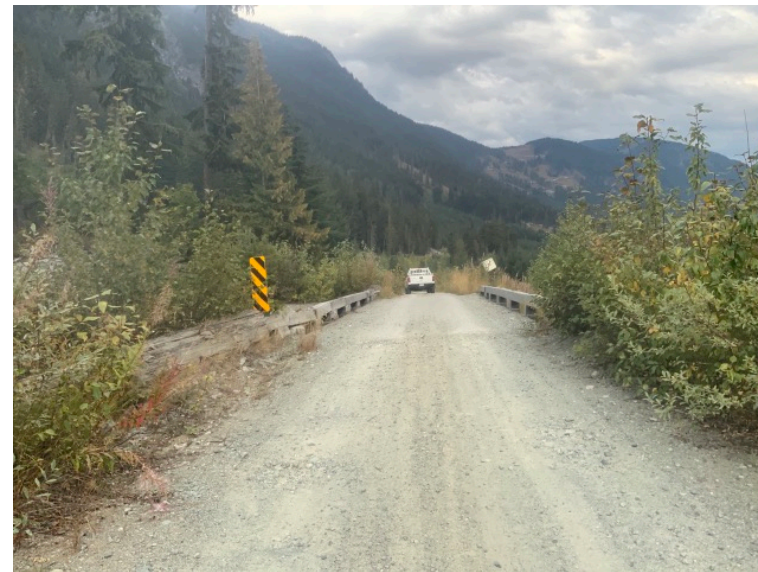
Approach from Right Bank when facing downstream

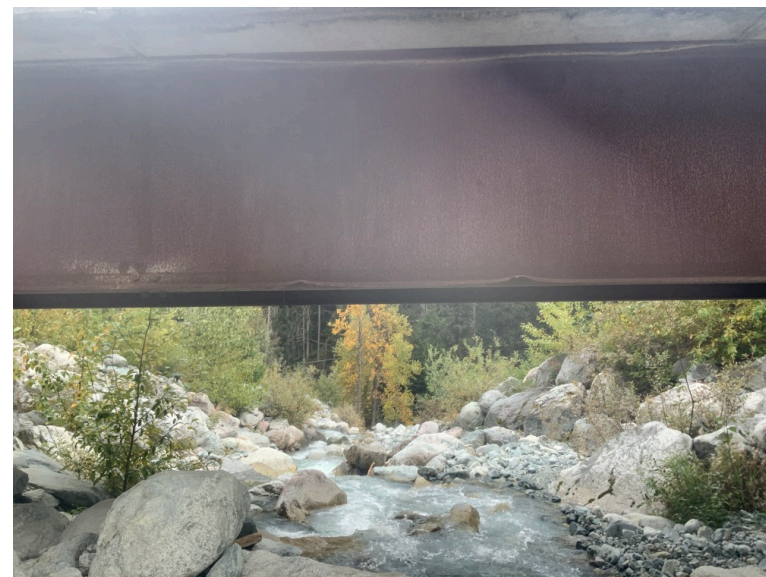
Evidence of debris hitting upstream girder. Bottom flange bent in two places.

Superstructure, damage from debris
