SQ-3013  
SQ-3013

RUTHERFORD 01 10km

2022 Inspection

Crossing Name Trib to Rutherford

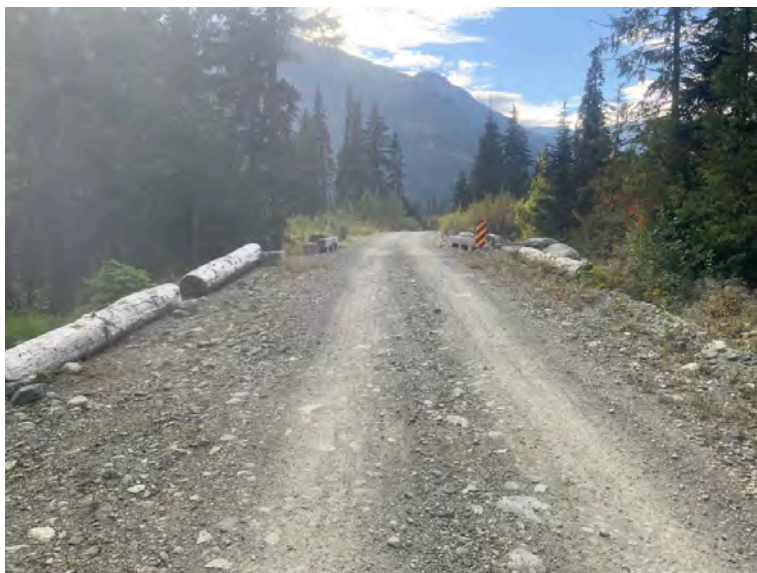
Approach from Left Bank when facing downstream

Delineator Missing  
Left ☐ 0 ☒ 1 ☐ 2

| Repair Item | Repair Description |
|---|---|
| 1 Approach. Add Warning Signs. 1 # of signs. Priority:High | Install delineator |

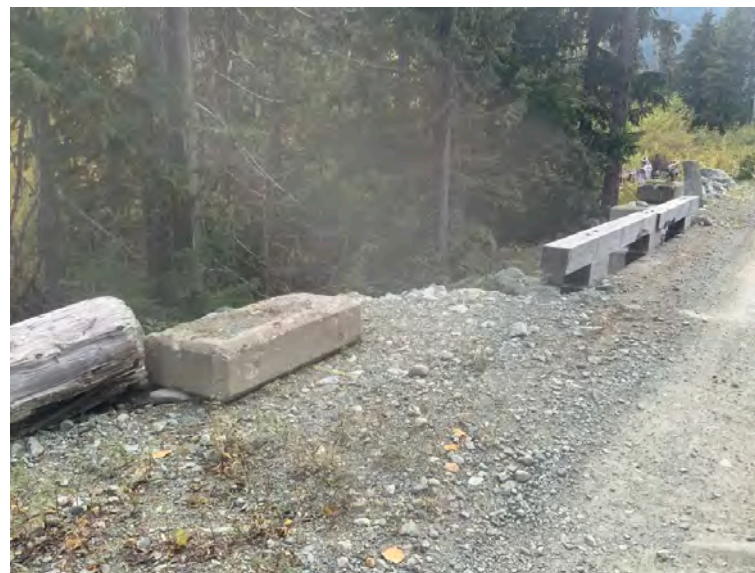
Approach Barrier

Fender Condition **Poor** Half lock blocks. Small logs

| Repair Item | Repair Description |
|---|---|
| 2 Approach. Approach fenders (install). 2 # of units. Priority:High | Add approach barriers woods approach |
| 3 Approach. Approach fenders (re-Install). 2 # of units. Priority:Low | Re align barriers on town approach |

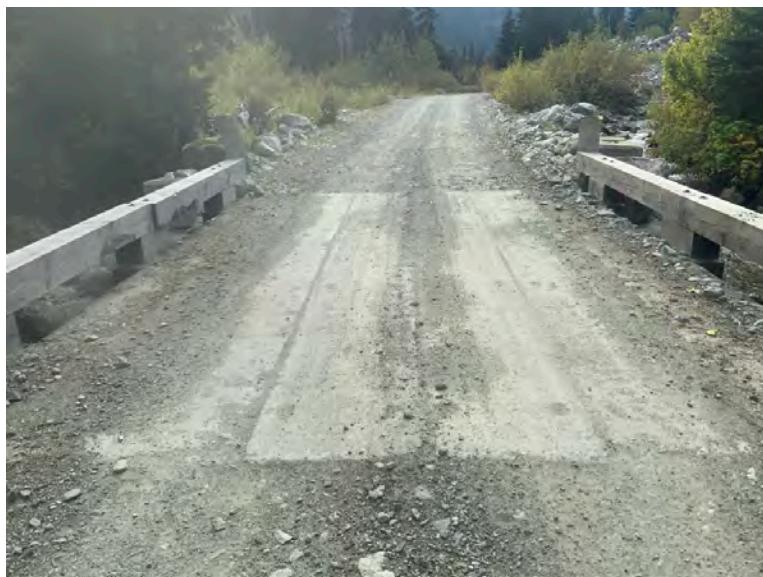
Concrete Deck      **Fair**      Surface damage/wear

Deck Joints      **Unrated**      No shear connectors. Does not appear to be grouted

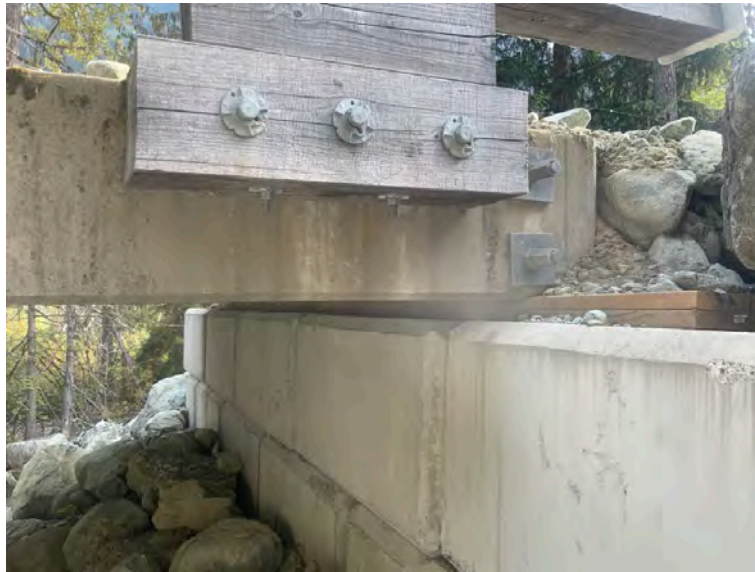
Bearing

Bearings **Good**

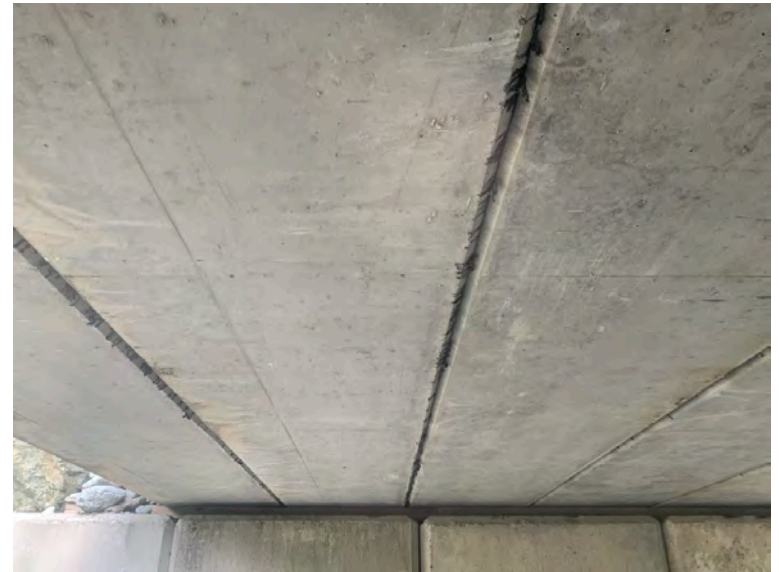
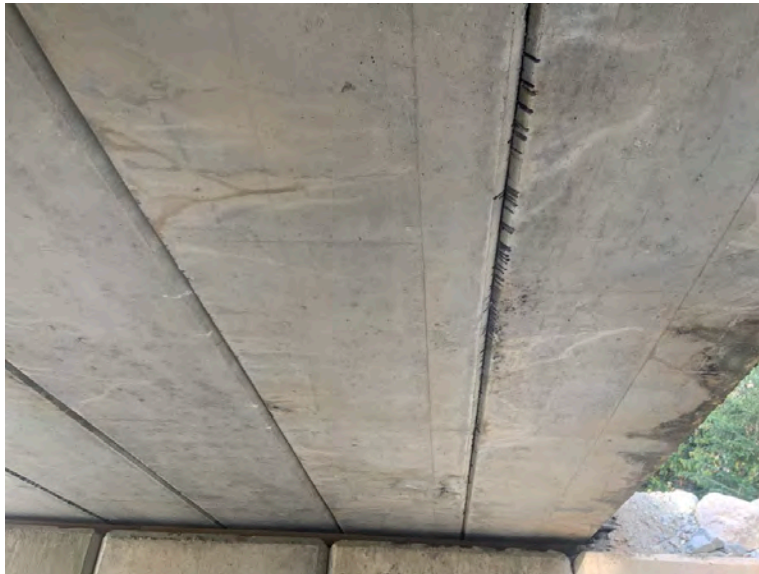
Superstructure

Girders **Good**

Welded/grouted  
shear connectors **Unrated**

None. Check records
