SQ-3015  
SQ-3015

SOO RIVER SOUTH km

2022 Inspection

Crossing Name Soo River

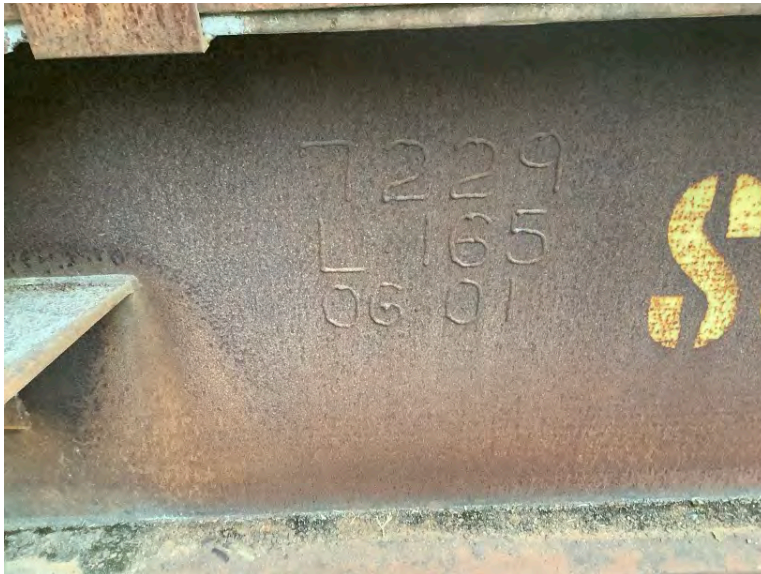
Structure ID

Inspector Comments Serial/ID Plate 7229 L-165 06/01

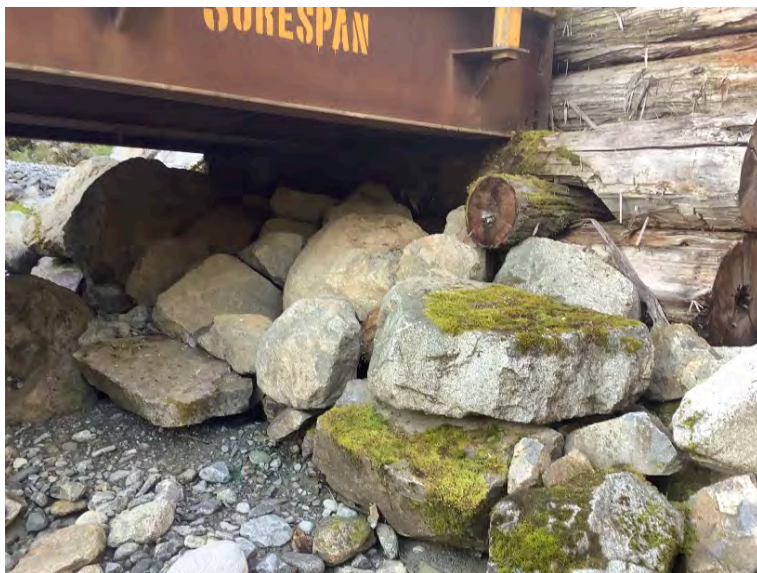
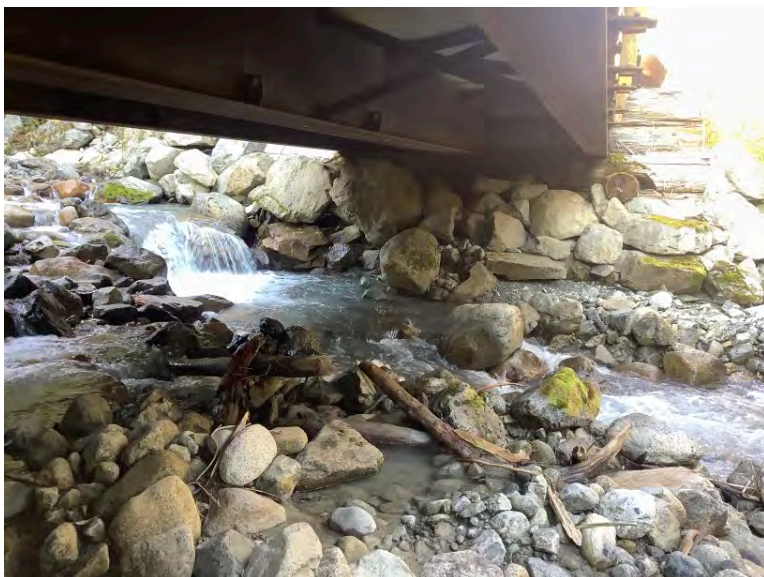
Left Bank Abutment when facing downstream

Log/Timber Cribs **Fair** Top face log on river left side is over notched. Tieback not directly under girders. Face log starting to crack.

Riprap **Fair** River left upstream side subject to erosion.

1 Monitor river left abutment for erosion and further cracking.

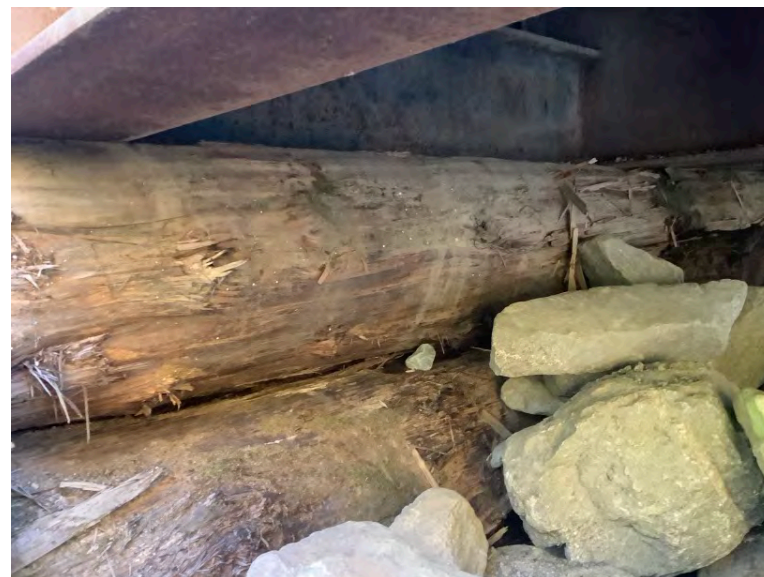
Bearing

Bearings **Good**
