SQ-3018  
SQ-3018

RUTHERFORD 01 15.7km

2022 Inspection

Crossing Name Tributary to Rutherford Creek

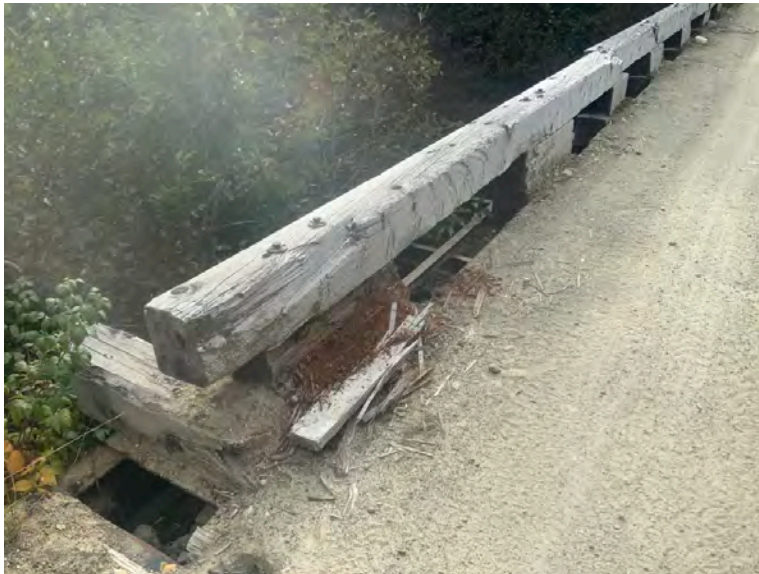
Guard Rail

Curb Rail/Blocks/Posts      **Poor**      Damaged rails, rotten risers

Hardware      **Fair**      Loose rails

| Repair Item | Repair Description |
|---|---|
| 3 Structure. Full Curb Replacement. . Priority:High | Replace all guard rail components |

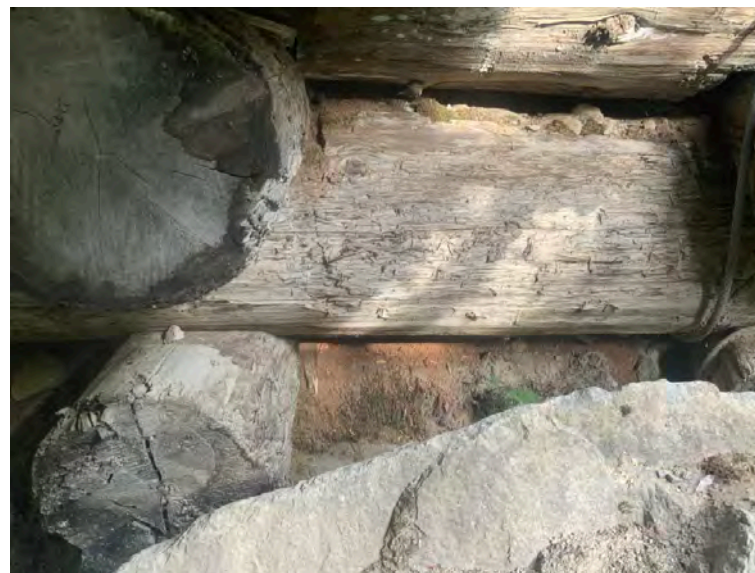
Saw dust (from insects) noted in right bank crib logs.

Left Bank Abutment when facing downstream, saw dust.
