SQ-3019  
SQ-3019

HAYLMORE CREEK MAIN 1.8km

2022 Inspection

Crossing Name Haylmore Creek

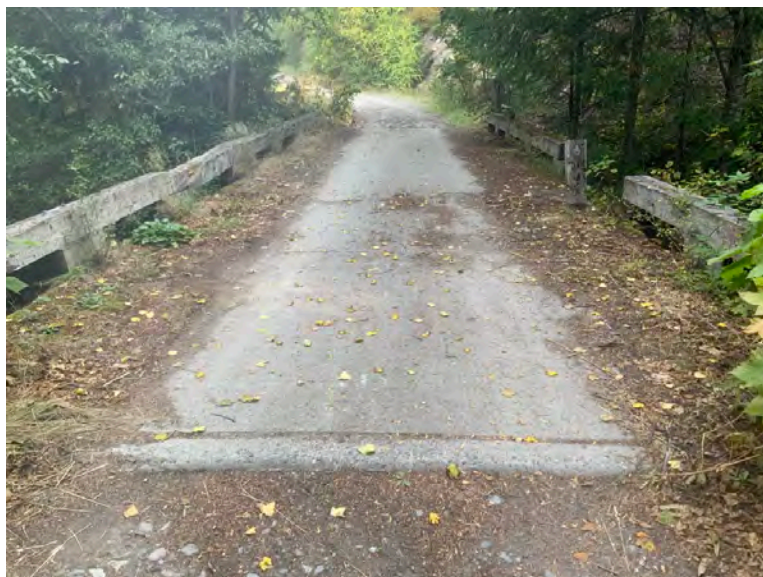
Concrete Deck      Fair      Damage to deck and ballast wall. Minor.

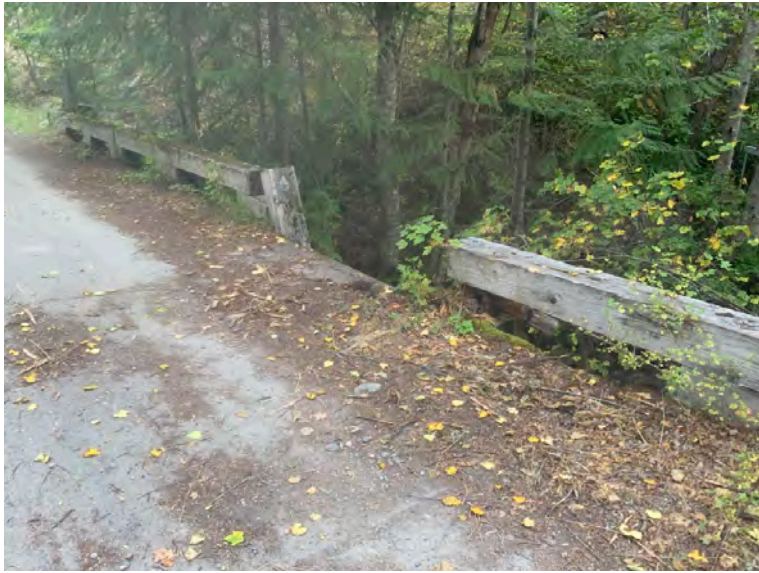
Guard Rail

Curb Rail/Blocks/Posts      Poor      Rotten and falling off

Hardware      Poor      Loose rails

Overall Deck Condition      Poor      Due to guardrails

Load Rated by: MOF, Greg Dohm, PEng., Oct. 5, 2022  
Load Rating: 0 tonnes  
Next Inspection: 2023  
Comments: Close bridge to public until curb rails repaired or replaced.

| Repair Item | Repair Description |
|---|---|
| 1 Structure. Full Curb Replacement. . Priority:High | Replace all guardrail components |

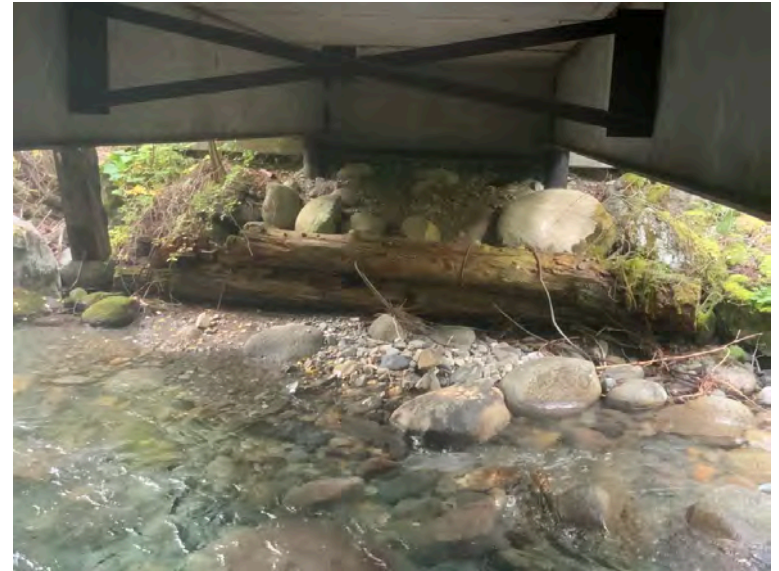
Left Bank Abutment when facing downstream

Both abutments at risk of scour, fill eroding from behind sill logs. Right bank worse, loosely lashed, tie backs completely shot. Footings appear not very deep, based on exposed cross brace angle. Consider increasing inspection frequency to every year.

Eroding from behind sill log. At risk of further scour

None. Sill logs undermining, at risk of further scour.

| Item | Monitor Description | Frequency |
|---|---|---|
| 1 Both abutments for scour | | Routine Inspection |

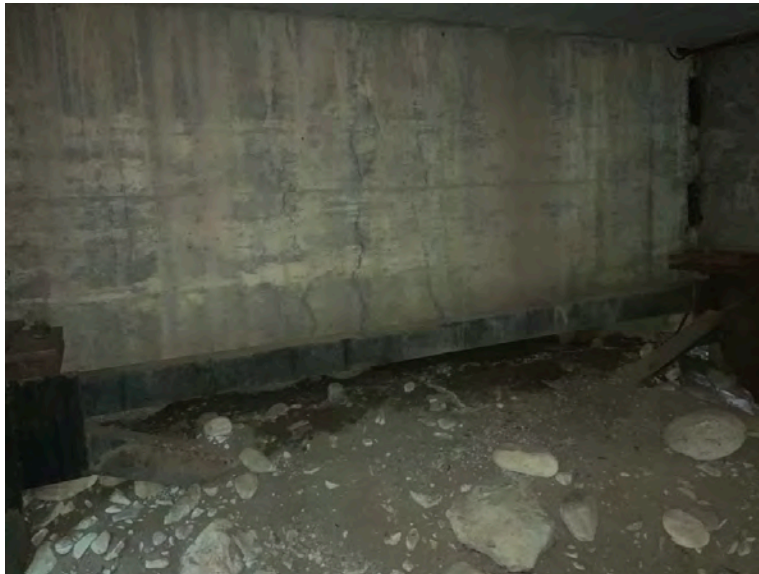
Right Bank Abutment when facing downstream

Rotten logs, retaining fill.

Rotten, gone.

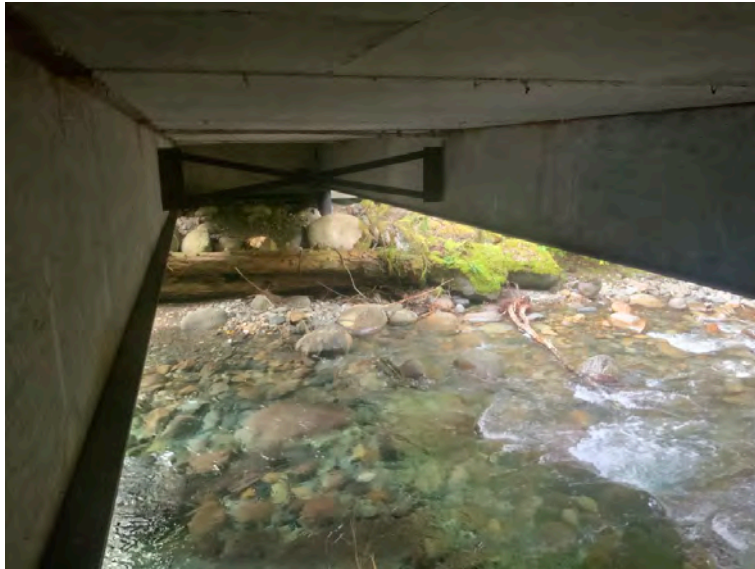
Superstructure

Concrete/steel. Steel components rusting
