SQ-3026  
SQ-3026

BIRKENHEAD MAIN 9.2km

2022 Inspection

Crossing Name Birkenhead River

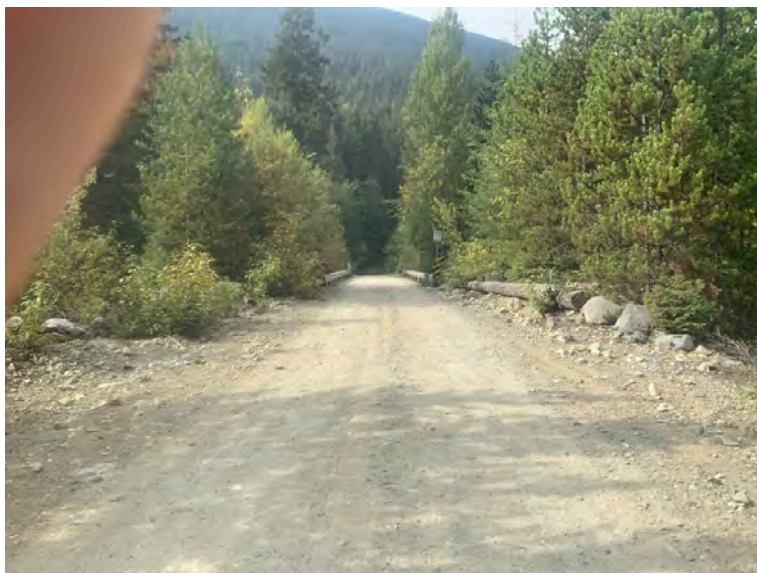
Approach from Right Bank when facing downstream

Bridge Ahead Signs  
Missing ☐ 0 ☐ 1 ☒ 2

Fender Condition Fair

Logs, rocks, undersized

Hairline cracks running vertically along entire length of girders. Check records. Consider adding approach barriers and signage. Post Inspection: hairline cracks have existed since installation and not changing significantly, per g.dohm

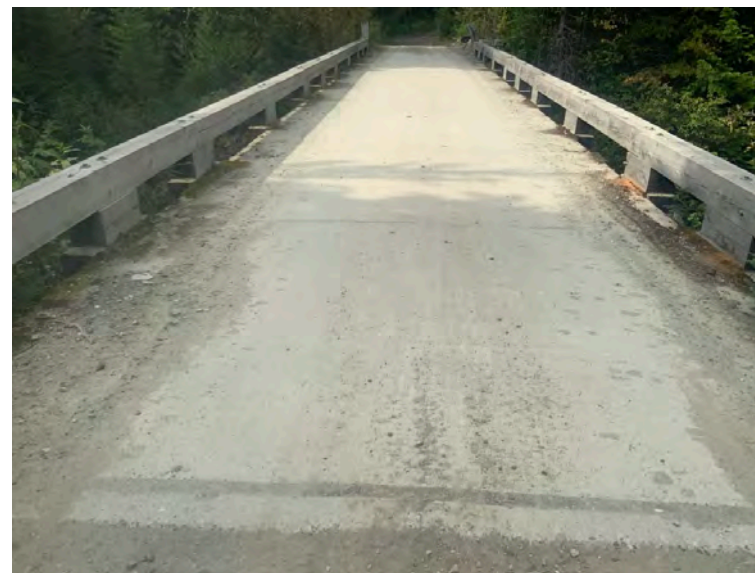
Concrete Deck      **Fair**      Minor surface damage

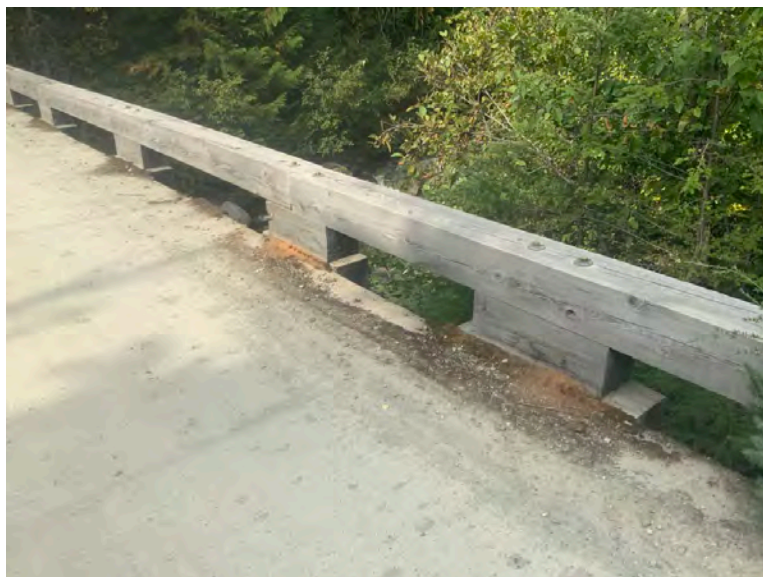
Guard Rail

Curb Rail/Blocks/Posts      **Fair**      Wood rails ageing. Risers sign of rot

Hardware      **Fair**      Rails loose

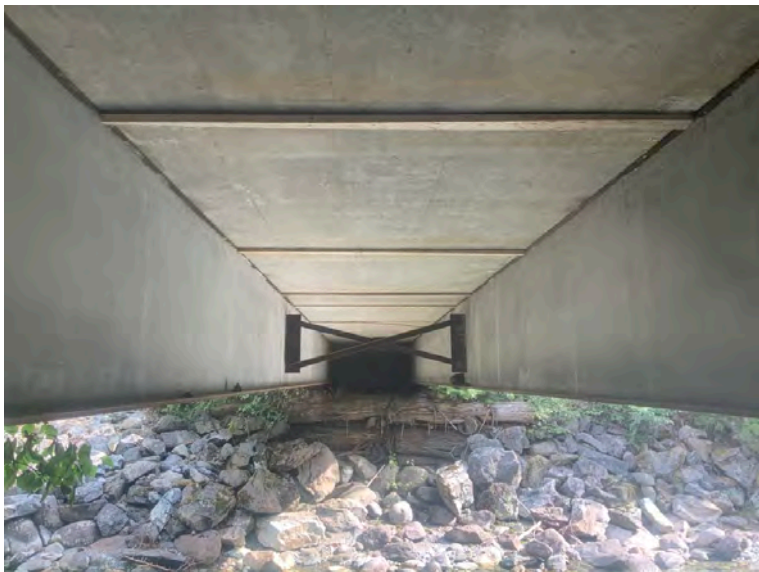
Superstructure

Girders Fair Ageing, hairline cracks, see notes

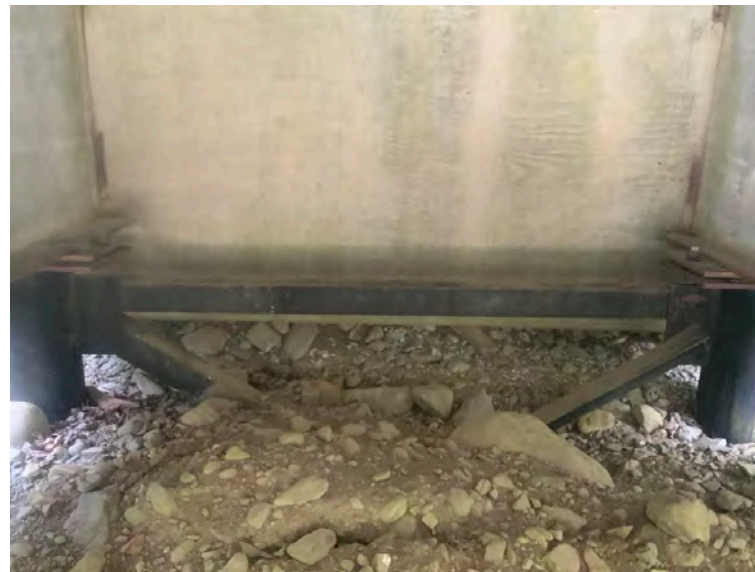
Left Bank Abutment when facing downstream

Log/Timber Cribbs Fair

Old, but retaining fill

Tie Backs Fair

Old
