SQ-3027  
SQ-3027

BIRKENHEAD MAIN 15.7km

2022 Inspection

Crossing Name Cerulean Creek

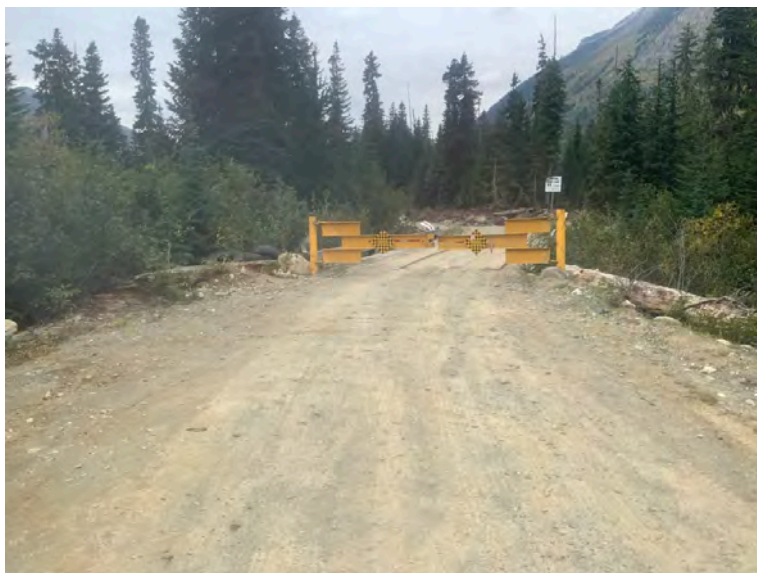
Approach from Right Bank when facing downstream

Delineator Missing  
Right ☐ 0 ☒ 1 ☐ 2

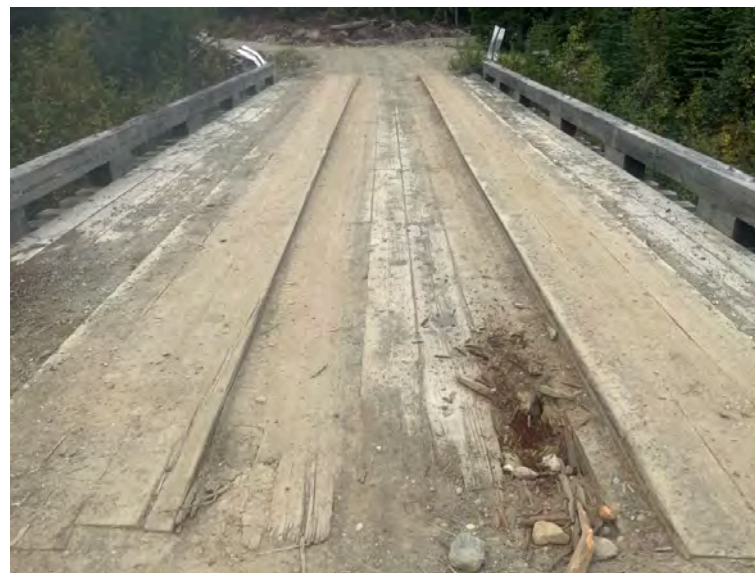
Running Planks      Fair      Fair to poor. Rotting

Sub Deck      Fair      Fair to poor rotting and punching through in places

Overall Deck Condition      Poor      Rotting timber components

Deck is nearing end of life. Could not access underside of ties due to old rail car decking remaining. Plan for replacement of deck and guardrails. Bridge behind gate, but evidence of recent industrial activity on woods side of crossing. Approach barriers signage and delineators needed.

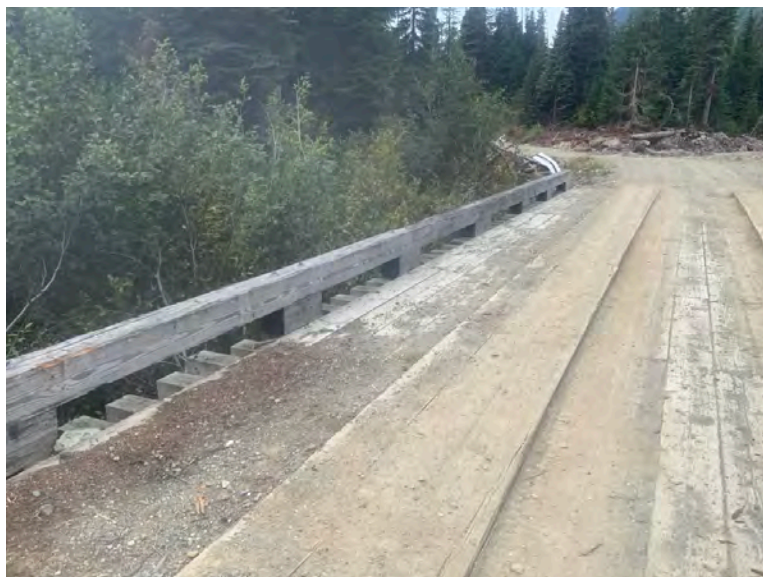
Guard Rail

Curb Rail/Blocks/Posts      Fair      Ageing rails. Need replacement

Hardware      Fair      Loose rails

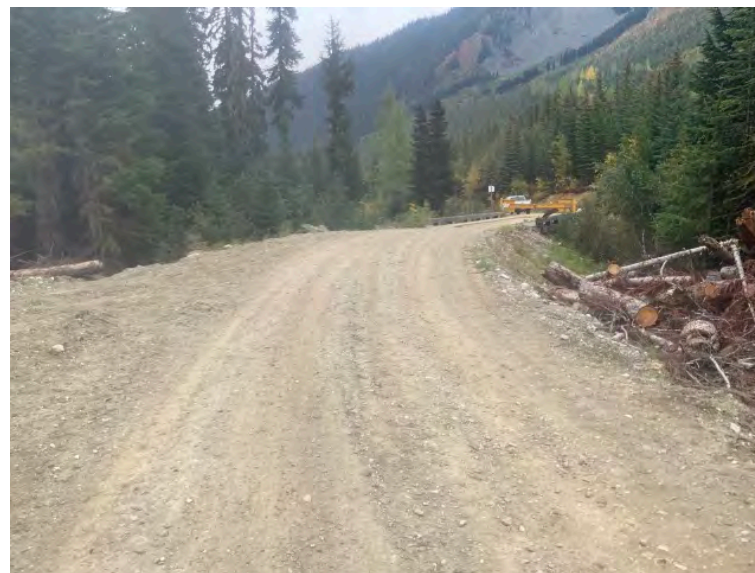
Approach from Left Bank when facing downstream

Fender Condition Poor

Missing woods approach

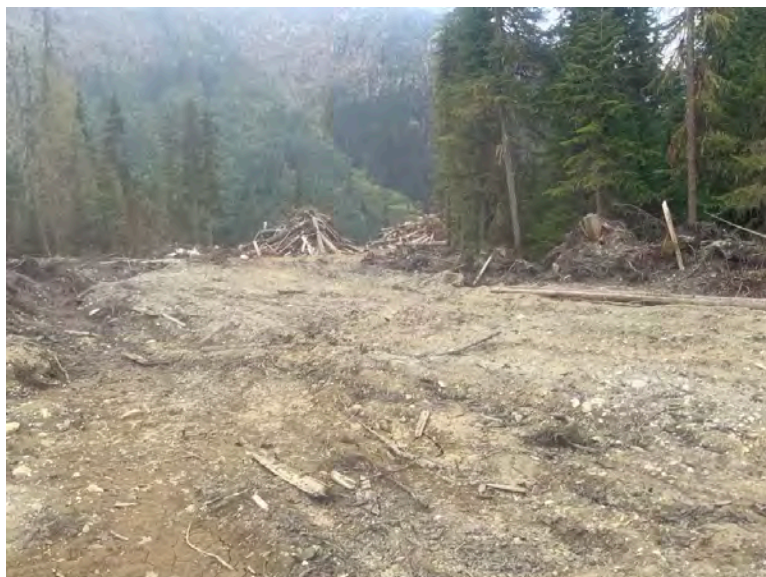
Bridge has seen industrial use

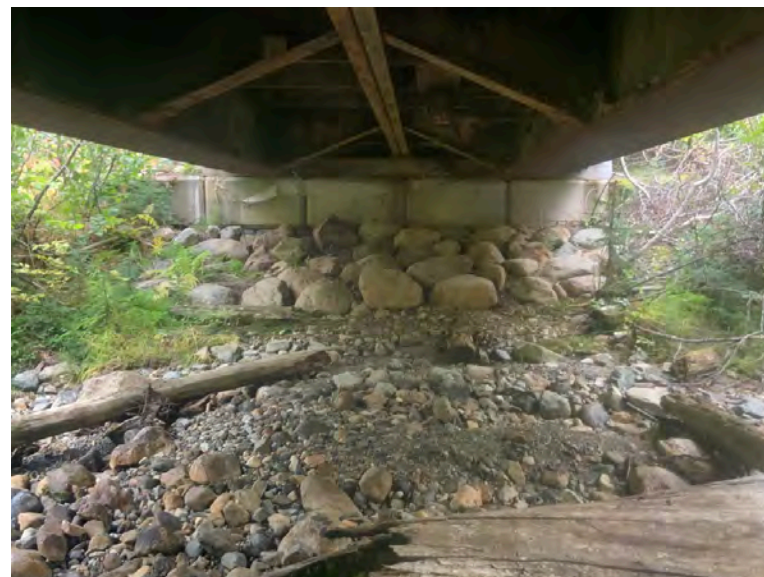
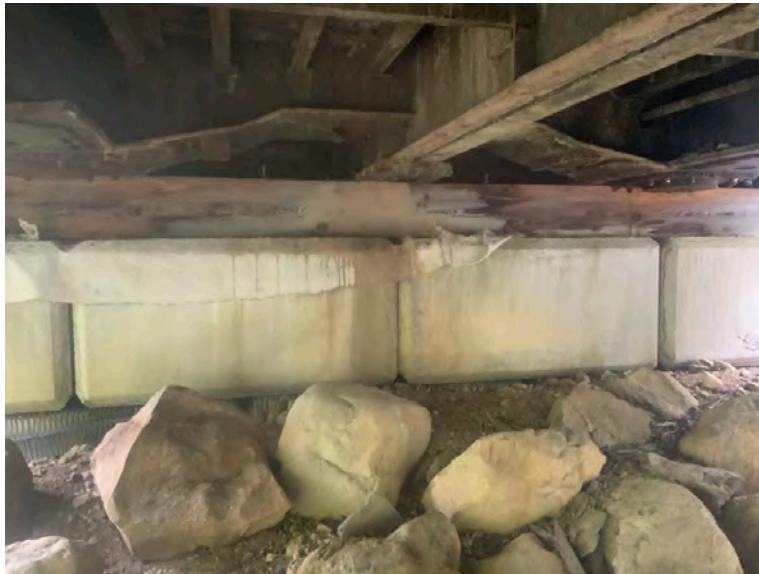
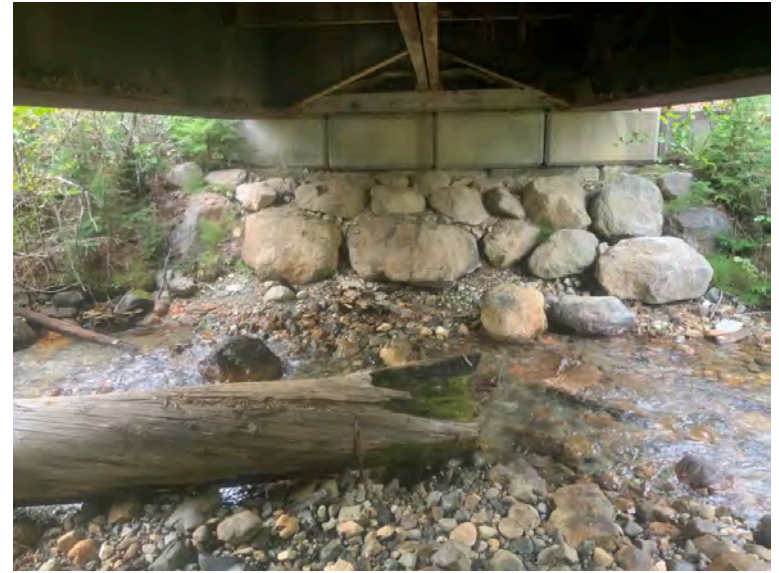
Riprap Fair

Minimal, not keyed in.

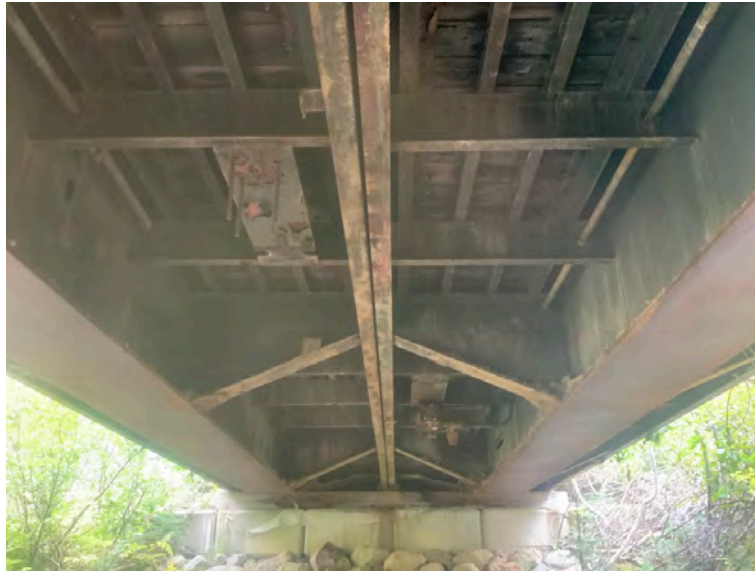
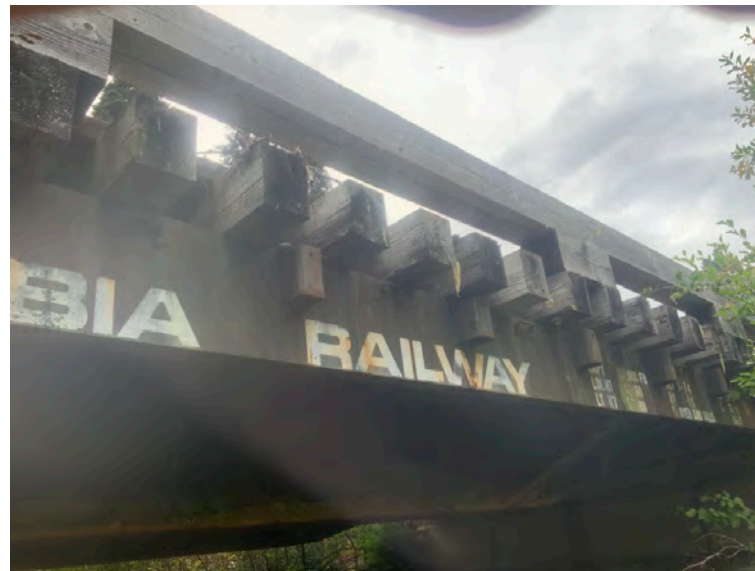
Superstructure

Girders Fair

Old rail car
