SQ-3033  
SQ-3033

LILLOOET WEST 70.2km

2022 Inspection

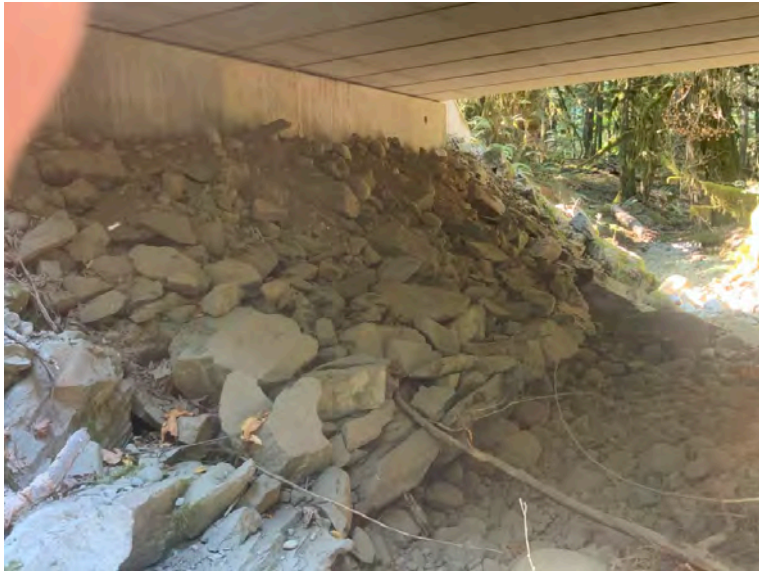
Left Bank Abutment when facing downstream

Riprap Good Monitor left bank for undermining

| Item | Monitor Description | Frequency |
|---|---|---|
| 1 | Left bank riprap for undermining | Routine Inspection |

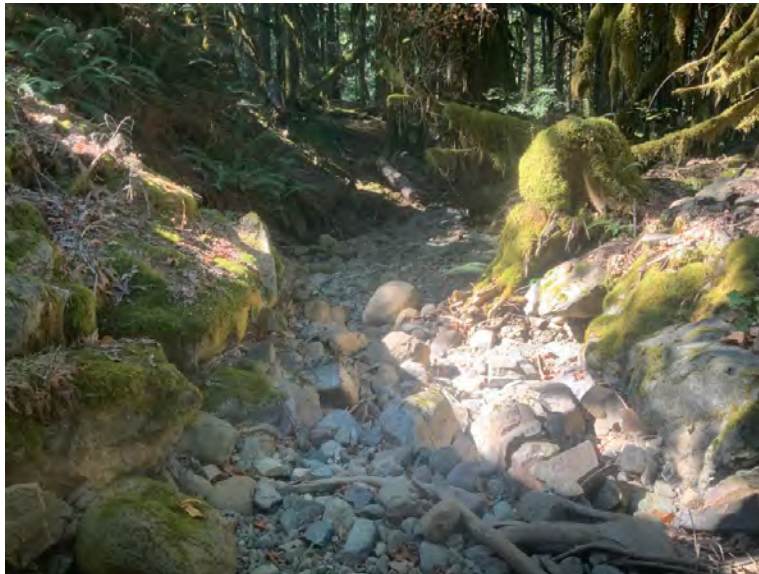
Downstream from Crossing

Comments Scour downstream from crossing
