SQ-3034  
SQ-3034

LILLOOET WEST 74km

2022 Inspection

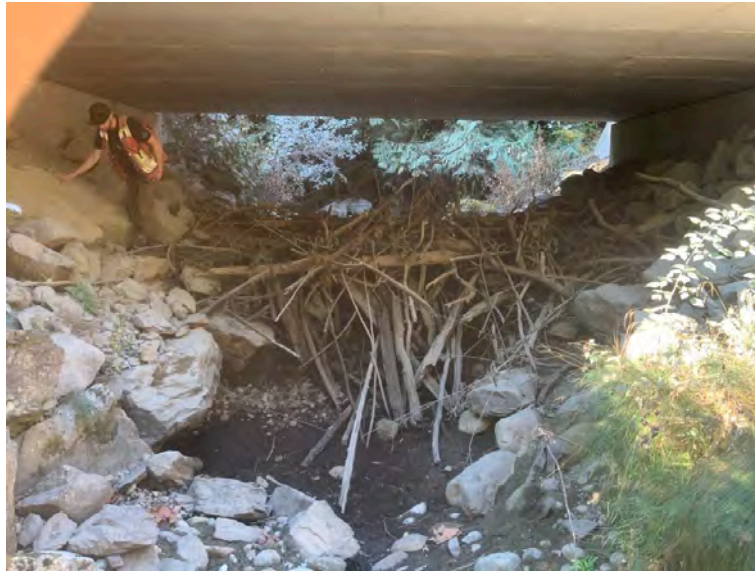
Appears to be beaver dam built under structure. Woods bank riprap scoured. Monitor. Check records re environmental report...

Beaver dam
