SQ-3035  
SQ-3035

LILLOOET RIVER 01 0.1km

2022 Inspection

Crossing Name Salmon River

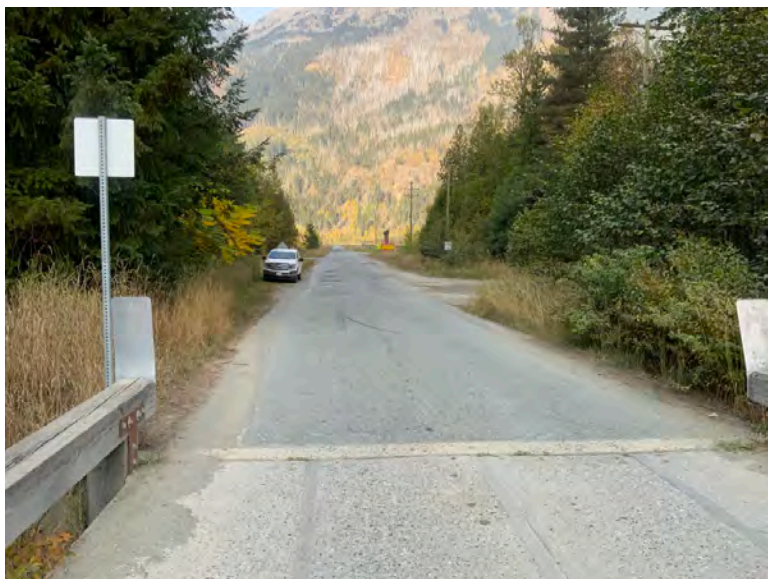
Approach from Left Bank when facing downstream

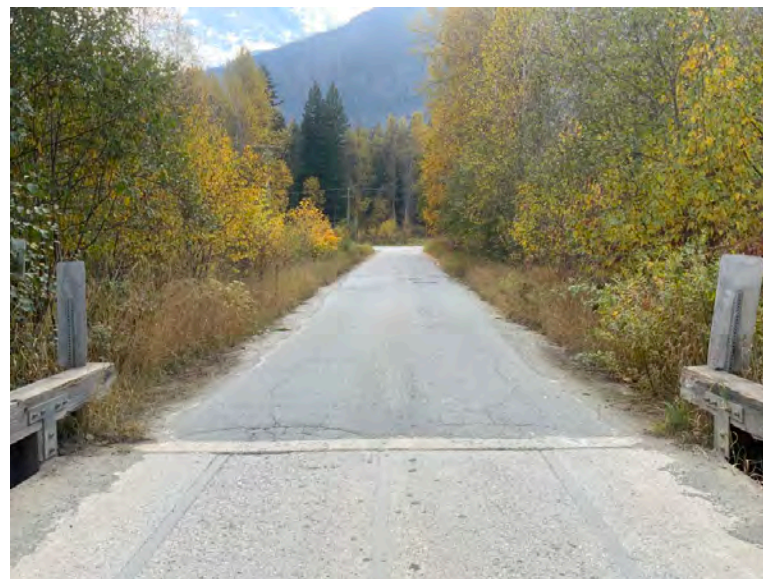
Approach from Right Bank when facing downstream

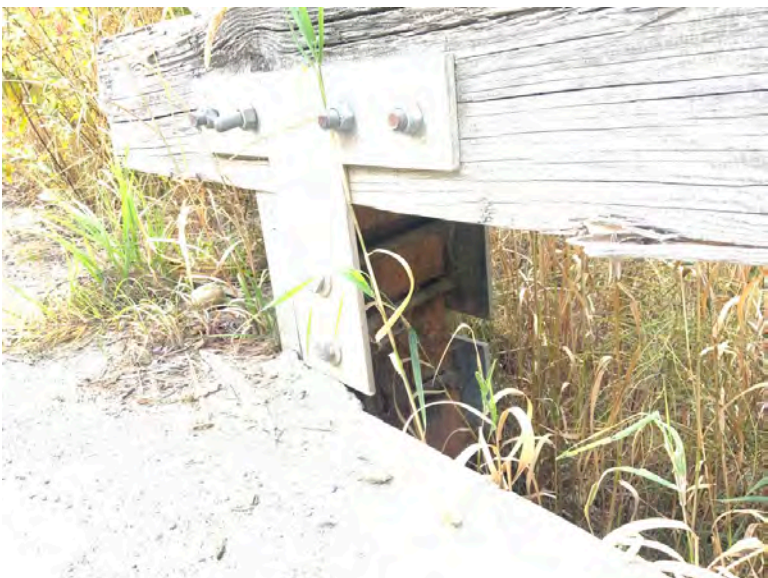
Curb Rail/Blocks/Posts      Poor      Fully rotten

Overall Deck Condition      Poor      Due to rails rotten

Rotten guardrails

| Repair Item | Repair Description |
|---|---|
| 1 Structure. Curb<br>Maintenance. # sites.<br>Priority:High | Replace sideblock posts and rails both sides as they are fully rotten |

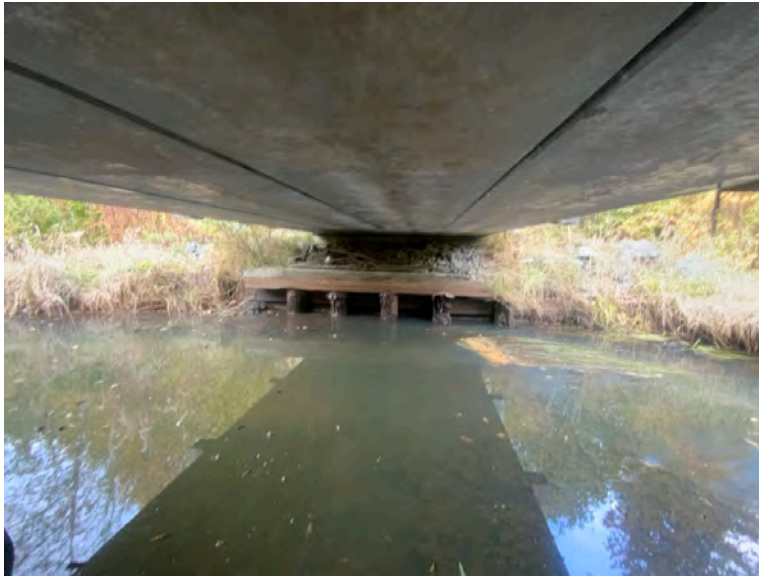
Left Bank Abutment when facing downstream

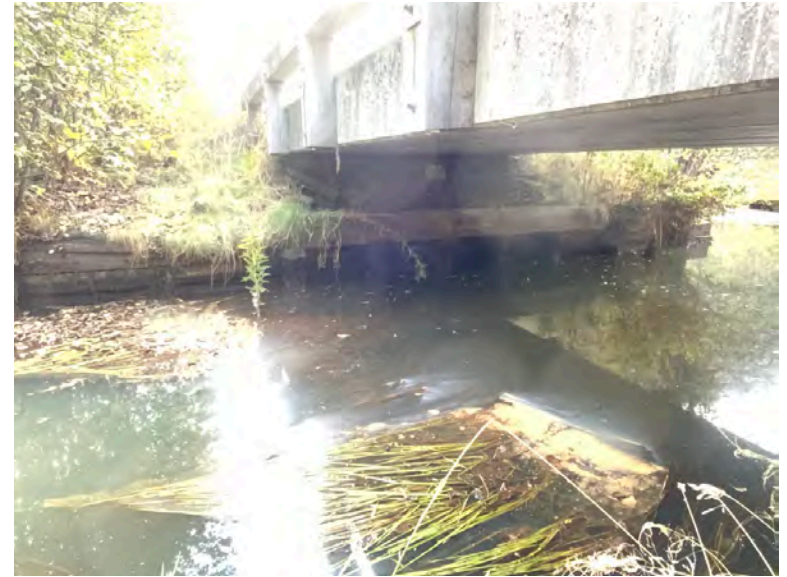
Right Bank Abutment when facing downstream

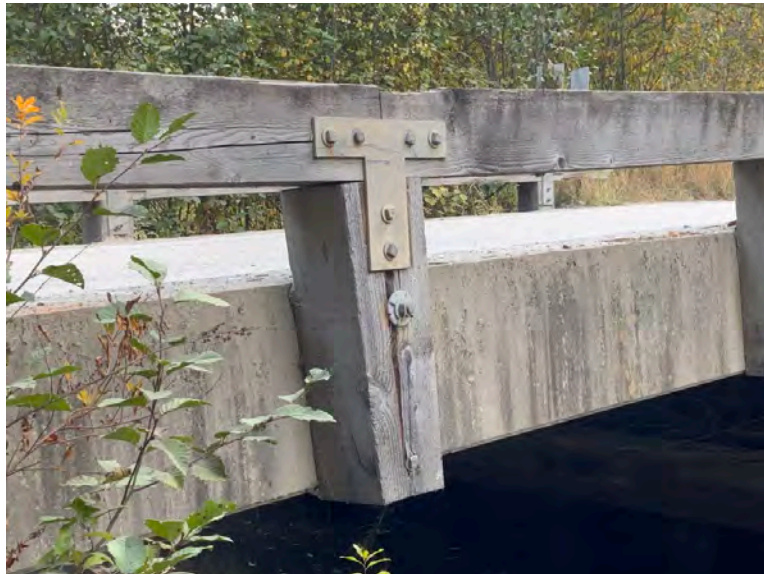
Cracked and rotten post rails
