SQ-3048  
SQ-3048

LILLOOET RIVER 01 34.5km

2022 Inspection

| Crossing Name | Silva Creek |

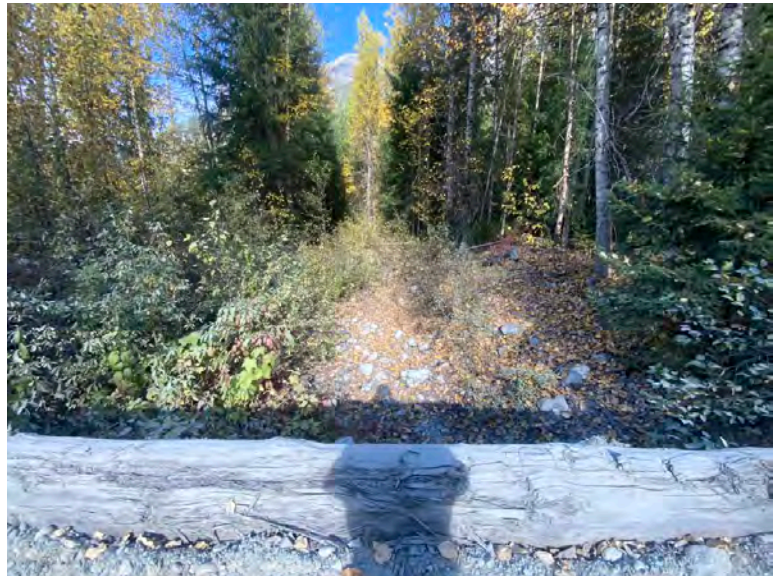
Upstream from Crossing

Bridge has not seen water flow since last inspection. Remove structure and fill in as per 2020 inspection. If left, remove deck and clean out debris.

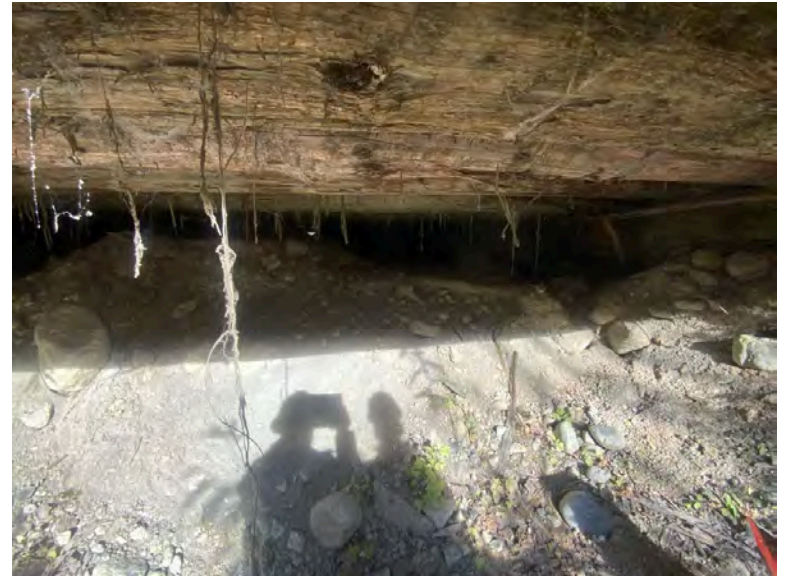
Accumulation under bridge

| Repair Item | Repair Description |
|---|---|
| 1 Structure. Log/timber stringer maintenance. m. Priority:Medium | Remove structure and fill in hole. No water flow here. Otherwise remove stringers and clean out structure. |

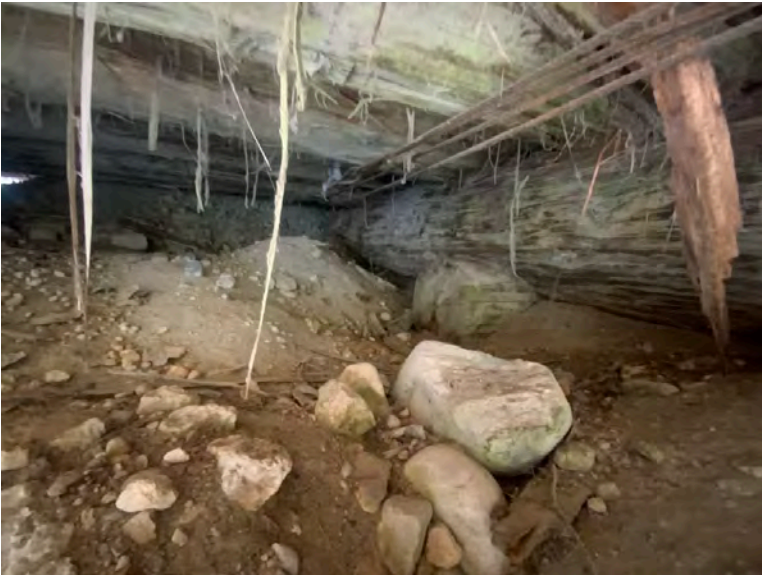
Left Bank Abutment when facing downstream

Log/Timber Cribs N/A Crib left side all filled in and acting as sill log only.
