SQ-3051  
SQ-3051A

## LEVETTE LAKE 2.7km

2022 Inspection

Crossing Name Evans Creek

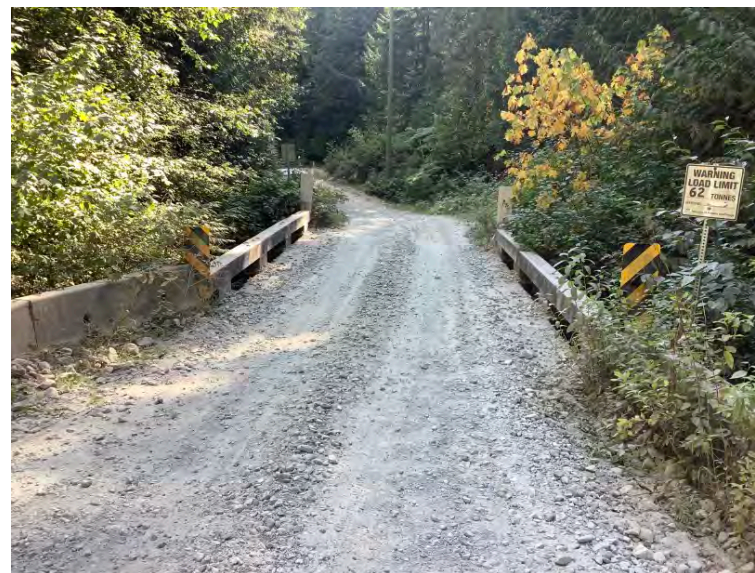
Approach from Left Bank when facing downstream

Alignment **Poor**

Steep vertical grade causing material to collect on bridge.

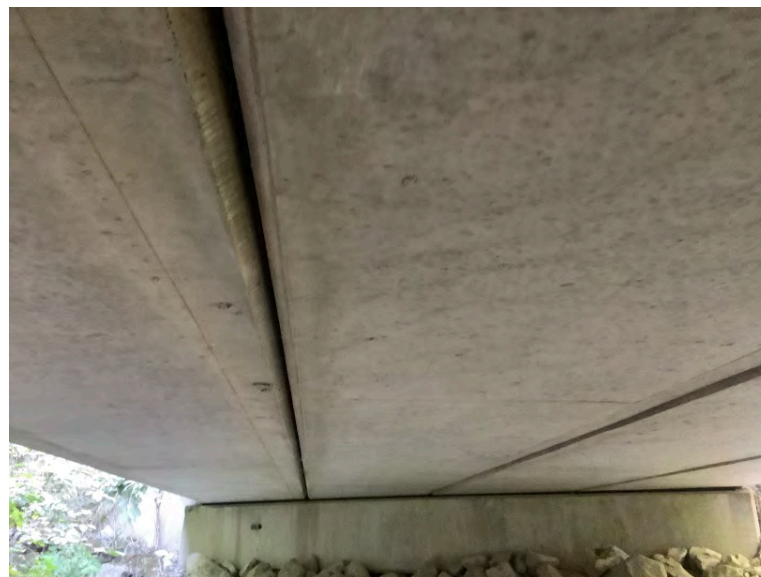
Stringers

Girders **Good**

Welded/grouted  
shear connectors **Good**

Not able to assess all due to gravel deck.
