SQ-3055  
SQ-3055

## BROHM CREEK 3.3km

2022 Inspection

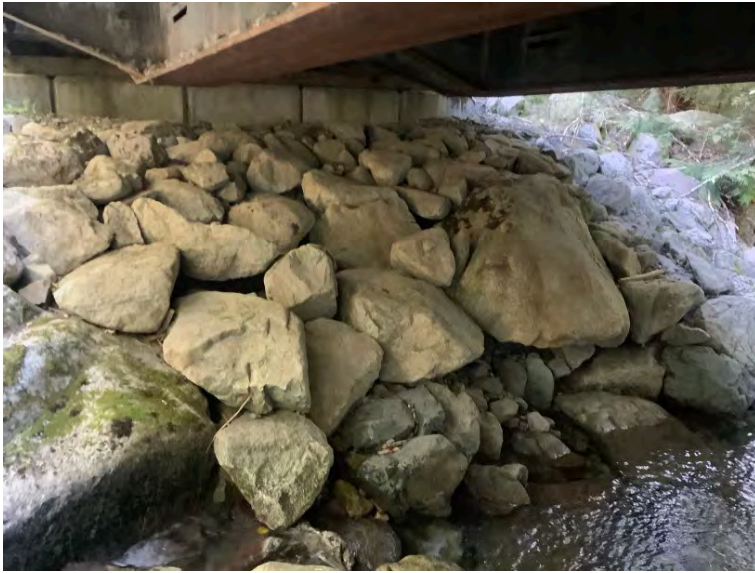
Left Bank Abutment when facing downstream

Riprap **Poor** Well above stream bottom. Potential for degradation.

1 Monitor riprap for erosion.
