SQ-3057  
SQ-3057

IN-SHUCK-CH 7.7km

2022 Inspection

Crossing Name Catiline Creek

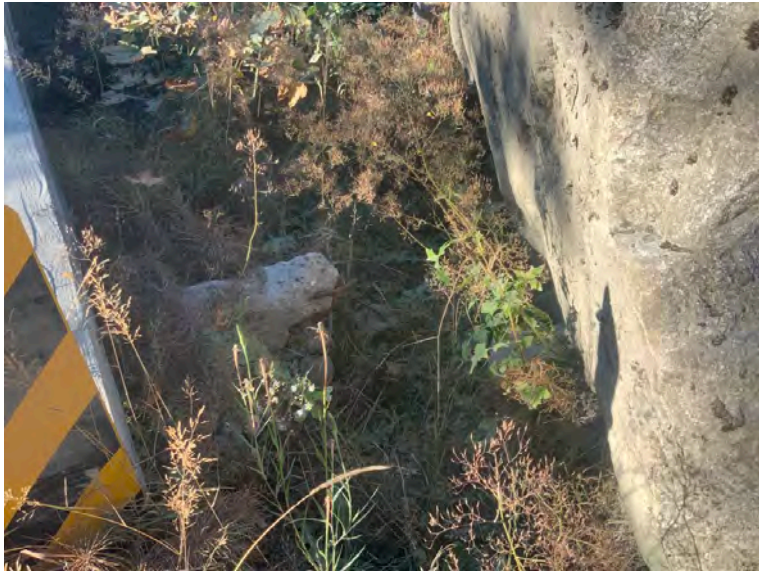
Ballast Wall **Fair**

Ballast wall. Exposed rebar. Likely during install to fit around large rock

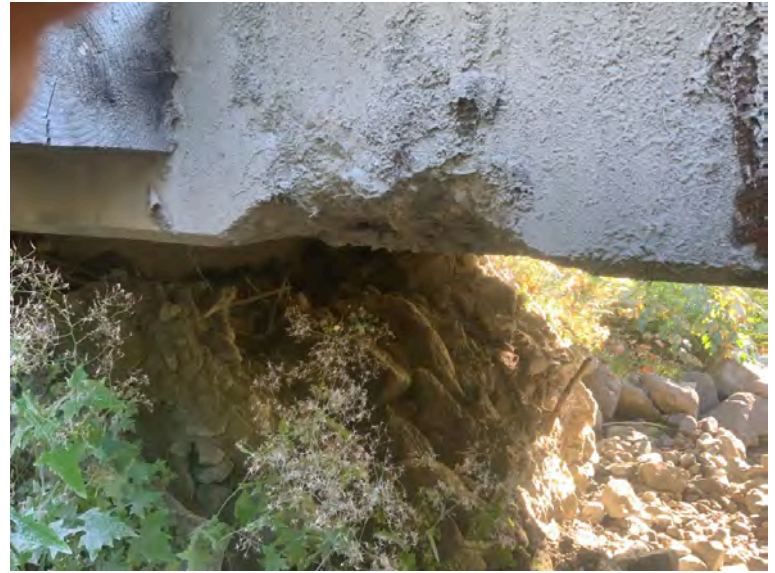
Slab damage. 40x10x15 cm. Exposed rebar

| Item | Monitor Description | Frequency |
|---|---|---|
| 1 | Monitor all damage to concrete | Routine Inspection |
