SQ-3058  
SQ-3058

IN-SHUCK-CH 10km

2022 Inspection

Crossing Name Twin One Creek

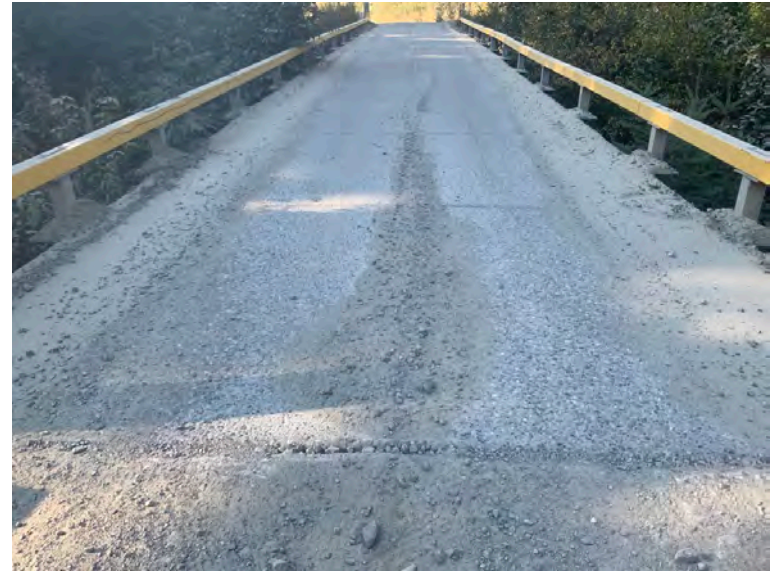
Overall Deck Condition      **Fair**      Surface wear

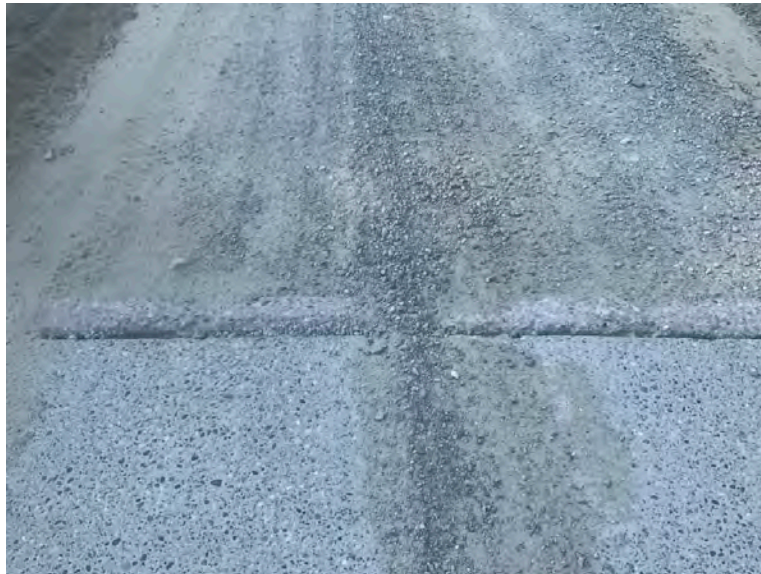
Ballast Wall **Fair** Worn. Rebar exposed right bank top

Deck, ballast wall. Rebar showing. Right bank

| Item | Monitor Description | Frequency |
|---|---|---|
| 1 | Top of ballast wall (right bank) for further damage | Routine Inspection |

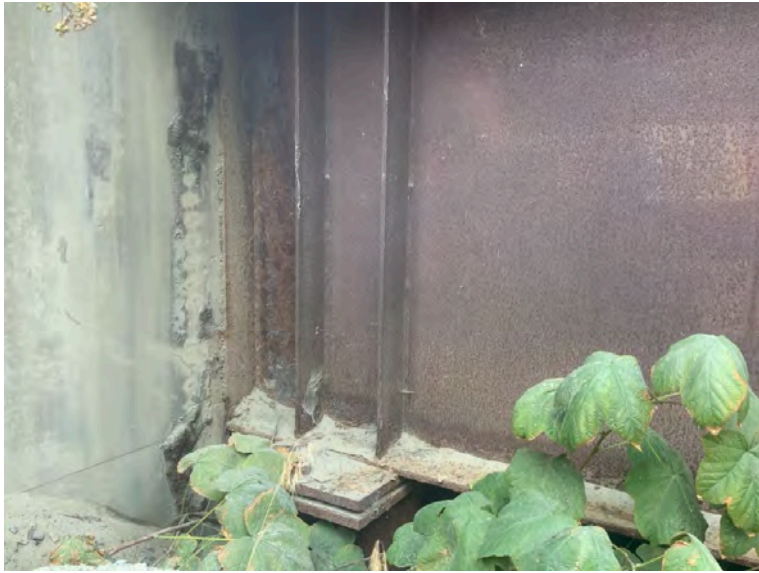
Superstructure

Steel ageing. Rusting and scaling, worse at bearings and splice (top and bottom flanges). Monitor and consider close proximity inspection.

All steel components rusting

| 2 | All steel components for rust | Routine Inspection |
