SQ-3061  
SQ-3061

IN-SHUCK-CH 15.9km

2022 Inspection

Crossing Name Lizzie Creek South

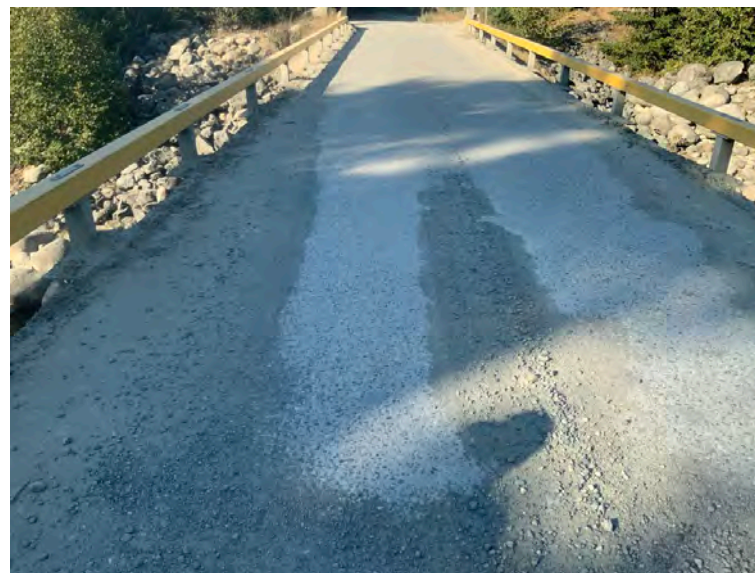
Concrete Deck      **Fair**      Surface wear

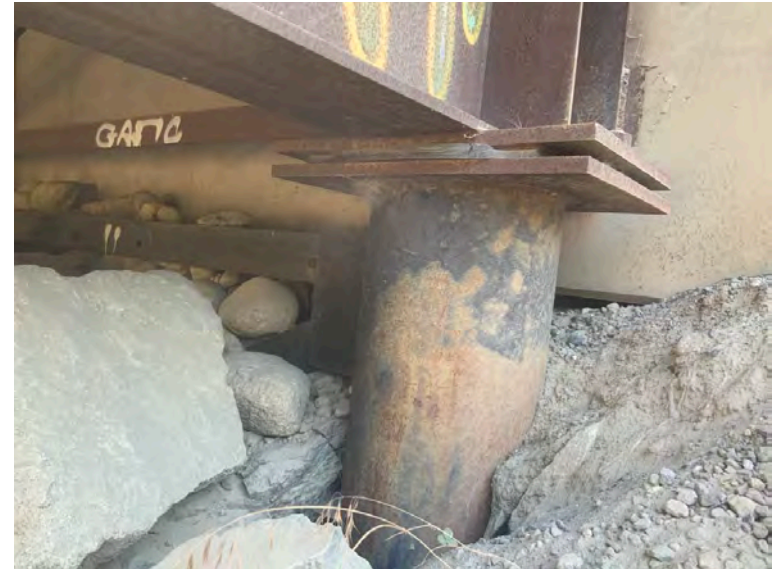
Bearing

Bearings Fair Bulging, left bank ds
